# STABILITY ANALYSIS OF OLD BREAKWATERS: CASE STUDIES OF FAILURES AND SUCCESSES

Dr. William ALLSOP, Principal, William Allsop Consulting Ltd., UK. [william.allsop51@outlook.com](mailto:william.allsop51@outlook.com)  
 Professor Tom BRUCE, School of Engineering, University of Edinburgh, UK.

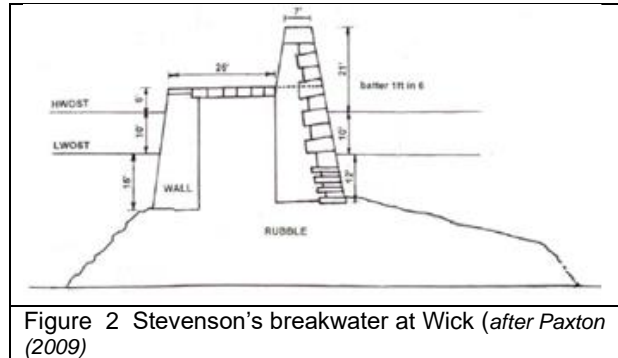
Figure 2 Stevenson's breakwater at Wick (after Paxton (2009))

Both sliding and overturning Factors of Safety for the section in Fig 2 fell below unity for all of the 1870 hindcast conditions<sup>(6)</sup>. Even for smaller waves, this breakwater would only have been stable ( $FoS>1$ ) for waves  $H_s<4.7m$  (overturning) or  $H_s<6.3m$  (sliding).

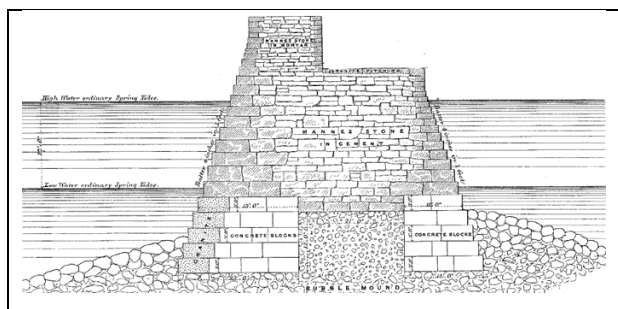
Figure 3 Alderney breakwater wall section used in Factor of Safety analysis (after Vernon-Harcourt, 1873)

For calculations starting with ch. 620, the local water depth in front of the mound (at +3.5mCD water level) reaches  $h_s = 12m + 3.5m = 15.5m$ , and depth over the foundation mound,  $d = h_s - h_c = 3.9m$ . So  $h_c^* = 0.75$ , a 'high mound' in the PROVERBS classification<sup>(10)</sup>. Calculations of wave breaking and resultant impulsive wave loads suggest that probability of breaking onto the Alderney wall reaches  $P_{b\%} = 6-25\%$  in 1:50 year waves. Factors of Safety (sliding, ignoring dynamic up-lift) for 1:50 year fall between  $FoS = 0.96$  and 1.1 depending on water level. Including the effects of wave up-lift forces on the wall section would however drop  $FoS = 0.65$  to 0.8, i.e. failure.

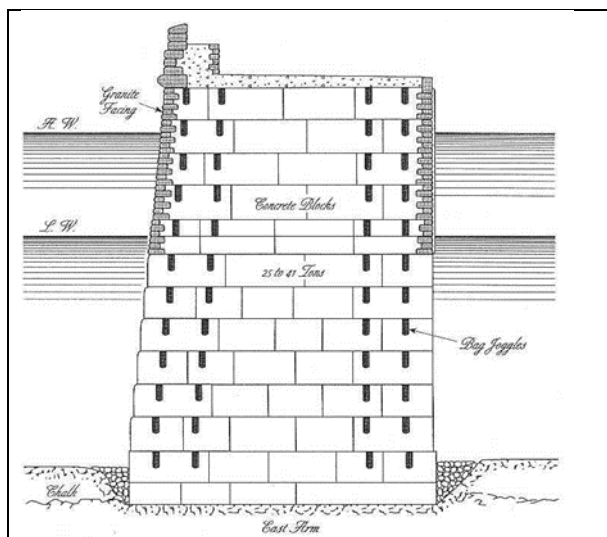
Figure 4 Construction of Dover outer breakwater wall section (after Vernon-Harcourt, 1873)

The Coode design was rapidly approved, and a contract was let to S Pearson & Son in November 1897<sup>(13)</sup>. The new walls (Fig. 4) were formed by 24-40t concrete blocks (2.3m wide and 1.8m high, depth from 2.4 to 4m) to accommodate the 12:1 batter and ensure adequate bonding. Jointing was strengthened by half-height joggle joints, filled by 4:1 concrete rammed into canvas bags. Around the outer ends, tensile connections were provided by bull-headed rails turned down at the ends and let into chased channels / holes filled with 2:1 cement mortar.

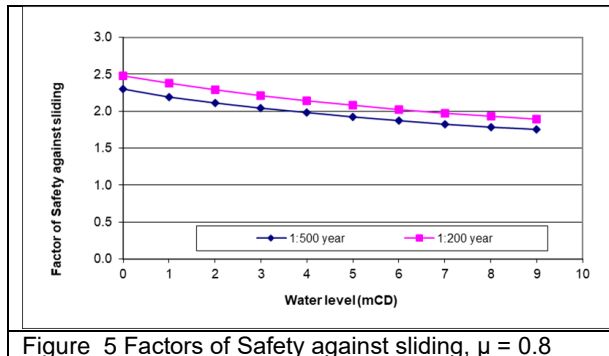
Wave loads were calculated<sup>(7)</sup> using Goda's<sup>(16)</sup> method, primarily to give the total horizontal (sliding) force. The seabed here is relatively flat, and this breakwater includes no berm or mound, so impulsive loads will be infrequent. Even for the 1:200 year conditions and elevated water levels, these stability calculations give  $FoS = 1.4-1.8$ , so fully stable.
