ANALYSIS ON FAILURE CAUSES OF DOCK DUE TO ABNORMAL WIND WAVES

Kyu-Tae Shim, Catholic Kwandong University, aiqshim@gmail.com

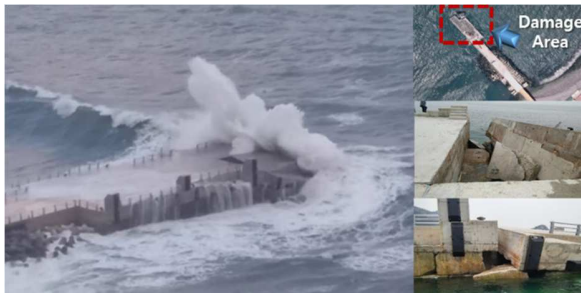
The southern and northern coasts of Hongdo Island located in the western coast of South Korea face the ocean side, and are directly affected when a typhoon or a high wave occurs. Therefore, structural damage due to wave generation frequently occurred in the coasts, and repair and reinforcement work were carried out several times. In particular, the high wind wave generated in August 2016 caused large-scale damage to the dock located in the north side of the island (Fig.1).

Figure 1 - Scene of Wave Action (L) and Damage Occurrence (R) at Hong-Do Island, Korea

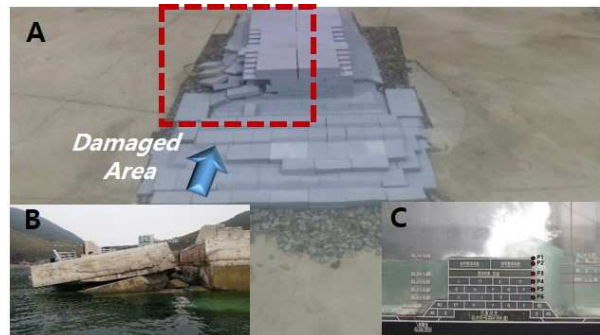
buoy and through a correlation analysis. The wave field and damage status in the shallow water were reproduced through the hydraulic model test. In the 2D model test, the wave pressure and structural stability under the condition at the time of the damage were examined. The damage characteristics were also investigated with the topography, wave direction, and structure installation condition as parameters, through the 3D model test (Fig.2).

Figure 2 - Analysis of Damage Causes (A: Stability test in the 3D- wave basin, B: Damage section in the real site C: Wave pressure test in the 2D-wave flume)

The failure mechanism of the dock structure was confirmed by 2D and 3D hydraulic model tests. The exfoliation and reduction of frictional force due to reinforcement work repeated over the years were also found to affect block displacement.
