HOW MUCH LONGER CAN AN OLD SEAWALL LAST? DESIGN, CONSTRUCTION AND MAINTENANCE LESSONS TAUGHT BY NORTH CRONULLA'S PRINCE STREET SEAWALL

Adrian Turnbull, Royal HaskoningDHV, adrian.turnbull@rhdhv.com
 Erin Sellers, Sutherland Shire Council, esellers@ssc.nsw.gov.au
 Patrick Cai, Sutherland Shire Council, pcai@ssc.nsw.gov.au

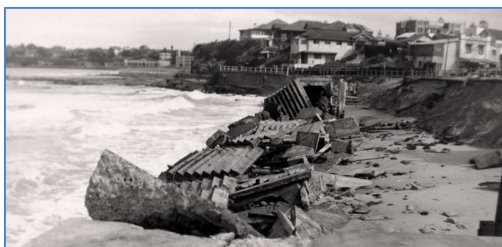
The sandy beach and dunes of North Cronulla, where the main settlement was established, has a well-documented history of being impacted by coastal erosion events over the past 100 years. Modification of the foreshore started around 1919, using dune sand to infill the low-lying swamp in the hind-dune, creating more 'useable' land. Feeling the impacts of erosion not long after, between 1922-24 a stepped seawall was built around Cronulla, the headland and 21 metres along North Cronulla. From 1936-41 the stepped seawall was extended by some 350m to the north, protecting the elevated foreshore of Prince Street (approx. 16m AHD). However the seawall collapsed following storms in 1949 (Fig. 1), the SLSC was relocated, and the seawall rebuilt.

Figure 1: Storm damage at North Cronulla Beach, collapse of stepped seawall, circa 1949 (source: Sutherland Shire Council)

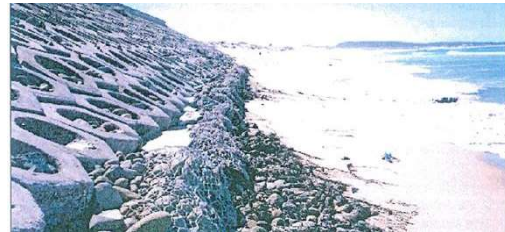
Significant storms in 1967 and 1974 caused extensive erosion and damage, including complete collapse of the Prince Street seawall. In 1985-86 Council decided to invest in a 360m "Seabee" coastal protection structure at Prince Street; a sloping gravity stack wall of hexagonal concrete blocks (internal holes for wave dissipation), (Fig. 2), however the gabion toe soon failed. (Fig. 3).

Figure 3: Original Prince Street seawall with failed rock gabion mattress

Rectification works were undertaken in 2008, comprising the installation of contiguous bored piles with concrete capping beam and permanent ground anchors in place of the gabion toe and reno mattress.

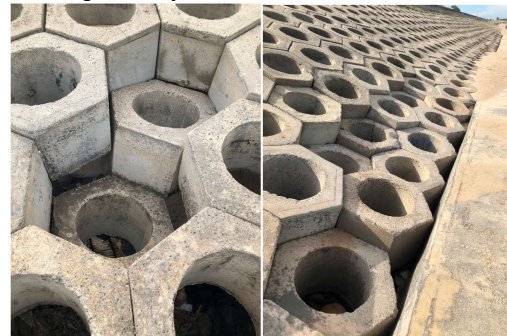
Unfortunately, construction of the 'contiguous bored piles' was not supervised as well as it could have been, resulting in significant gaps between piles. When the beach level is lowered due to loss of sand in front of the piles, ongoing tidal and wave action through the gaps undermines and erodes the sand fill beneath the Seabee units. The removal of the sand fill creates voids beneath the rock underlayer (and geotextile) and Seabee units, into which some units have subsided.

Treatment measures such as infilling gaps and voids with expanding foam have been trialled, but were found to be unsatisfactory. Ongoing loss of subbase material has resulted in subsidence of the Seabee units (Fig. 4), creating a safety hazard.

Figure 4 Undermined Seabee units at Prince Street Seawall, 2020

Sutherland Shire Council engaged Royal HaskoningDHV in 2020 to advise on interim works to address existing hazards, resulting in pumping approximately 320m³ of 4:1 stabilised sand to infill cavities.
