CHAPTER 43

THE INFLUENCE OF SHORE PROTECTION WORKS ON GULLIES

T. Groot
Engineer, Rijkswaterstaat
Research Division Vlissingen

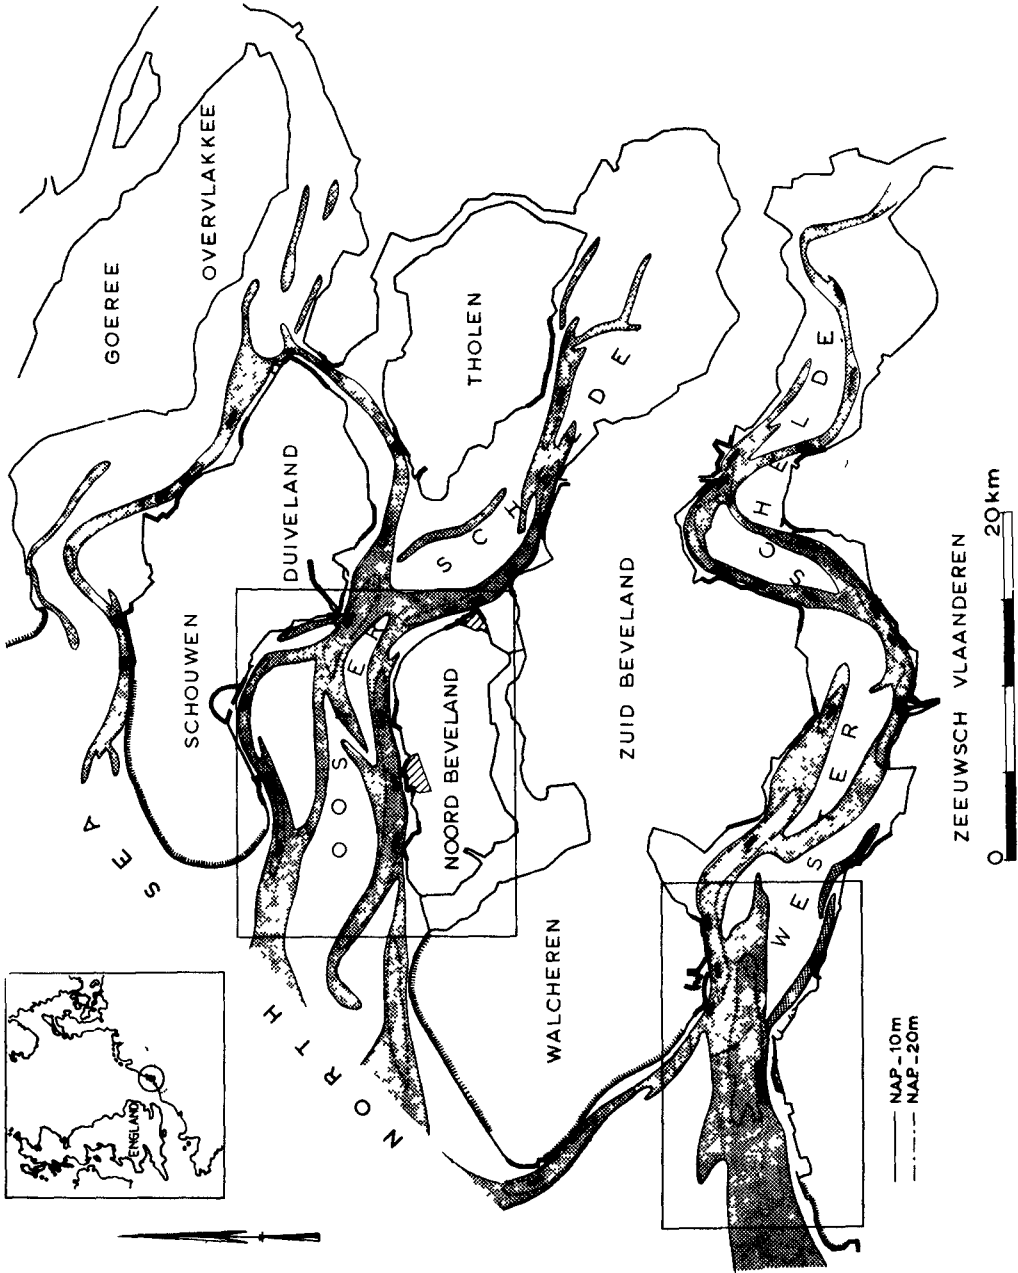
The gullysystem in the south-west of the Netherlands has been reproduced on figure 1, on which depths greater than N.A.P. - 10 m have been shaded, while scour holes are indicated as black spots. (The Netherland ordnance datum N.A.P. is practically equal to mean sea level). Shore-protection works are shown as fat parts on the shoreline. The connection between shore protectionworks and scour-holes is clearly visible.

Fig. 1. Shore-protection works and scourholes in the south-west of the Netherlands.

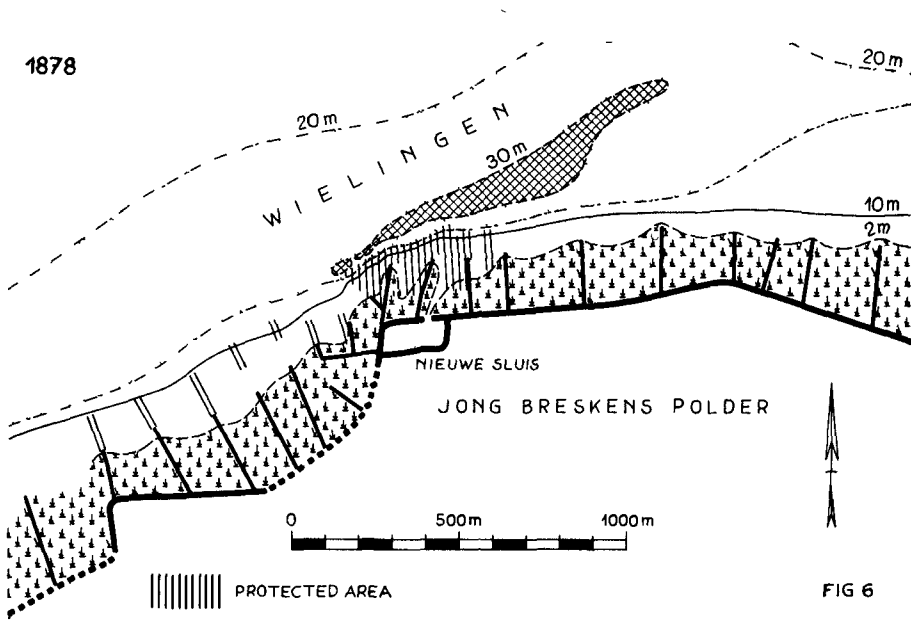
Fig. 6. Early-development near Nieuwe Sluis (1878).

Before 1830 the shore was already protected at some points by means of rip-rap. At several points mattresses (willow mattings) have since then been placed. They are indicated on the figures nos. 6 and 7.

Because of the irregular shape of these constructions the current pattern was unfavourably influenced, causing considerable deepenings to the adjacent unprotected shore, which were attended with dozens of falls and slides. Parts of the protection works were thus lost. Extension proved to be necessary.

This bastion has influenced the stream in the gully. Local scouring of the sand-bed occurred; see the figures nos. 6 and 7 with the situations of 1878 and 1936. The bottom topography shows that the scourholes are due to turbulence and not to the normal tidal stream.

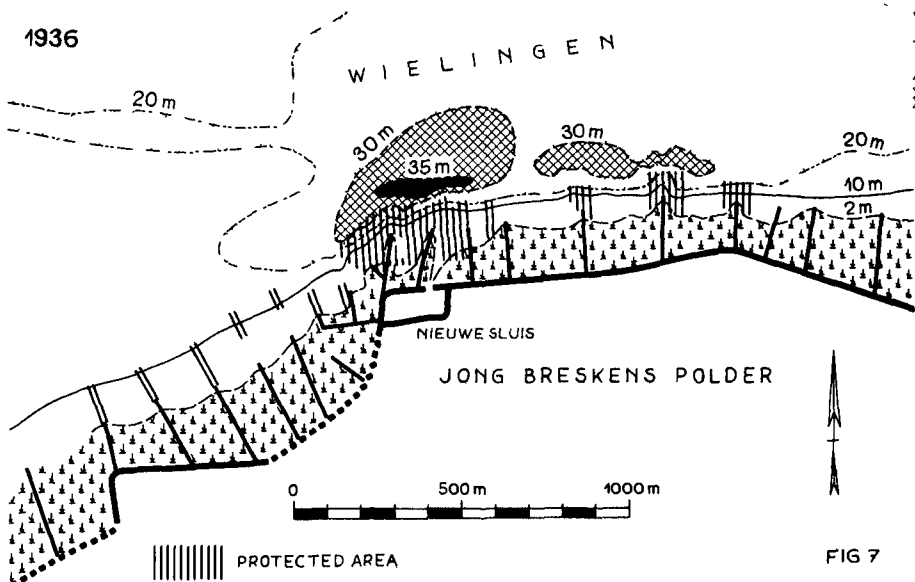
Fig. 7. Scourholes near Nieuwe Sluis caused by badly shaped shore-protection works (1936).

The developments described are due to an imperfect design of the defenceworks. A badly shaped construction causes a strongly turbulent currentpattern, as a result of which powerfull erosive forces come into being. This can be prevented by giving a better design to the defence-works.

A protection made of rip-rap will have to be constructed in such a way that it doesn't show high and irregular elevations.

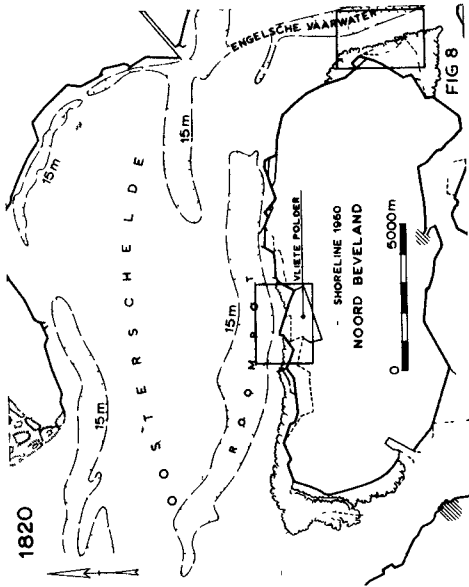
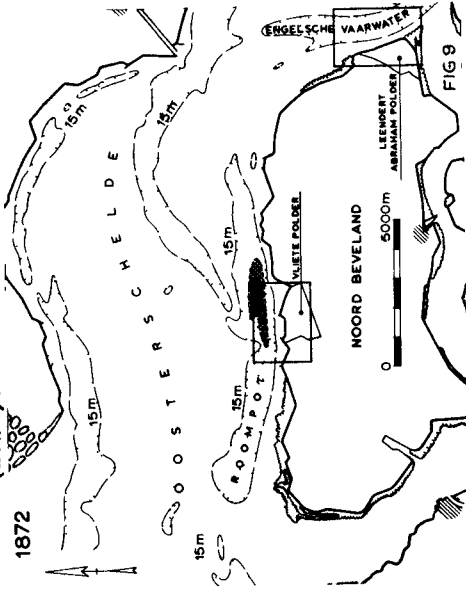
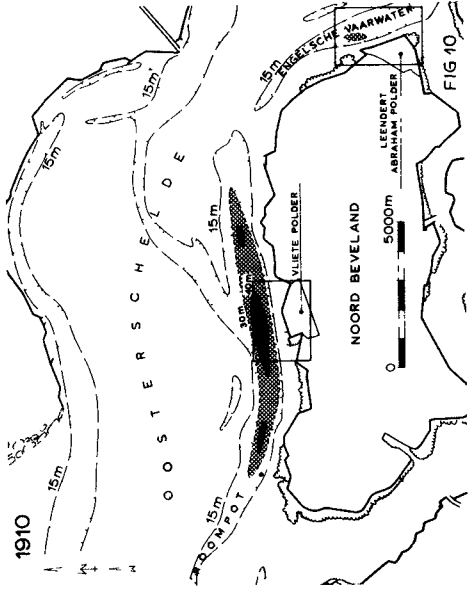
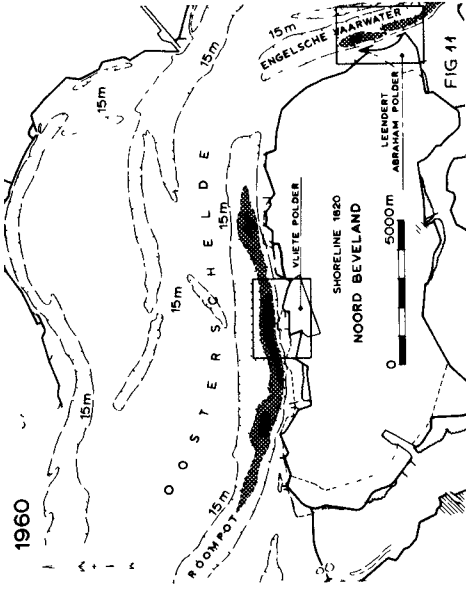
Fig. 10. Depth-contours in the Oosterschelde (1910).

Fig. 11. Depth-contours in the Oosterschelde

Fig. 8. Depth-contours in the Oosterschelde (1820).

Fig. 9. Depth-contours in the Oosterschelde

Early in the 19th century some parts of the northern shore of Noord Beveland were affected partly because of the irregular shore line; see figure no. 8.

The first protection was introduced about 1820 in front of the Vlietepolder, where some attacked places were protected with small mattresses covered with rubble-stone. Later on these constructions were connected to the shore by means of submerged rubble-dams. This way of protecting the shore caused considerable erosion up to N.A.P. - 40 m, where formerly a depth of 15 m was sounded.

The gully in front, the Roompot, moved to the shore, causing local depths of N.A.P. - 45 to 50 m; these pits enlarged in the longitudinal direction of the gully; see the figures nos. 8, 9, 10 and 11 with the situations of 1820, 1872, 1910 and 1960.

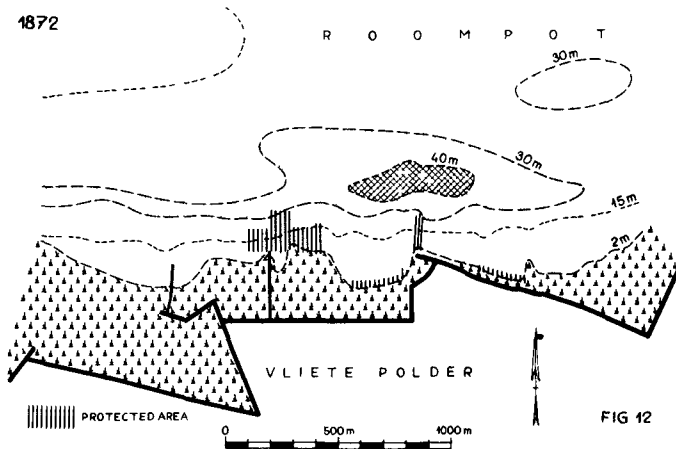
Owing to the southward movement of the gully many falls and slides occurred, through which the shoreline drew back; see the figures nos. 12, 13 and 14.

Fig. 12. Early development near Vliete Polder (1872).

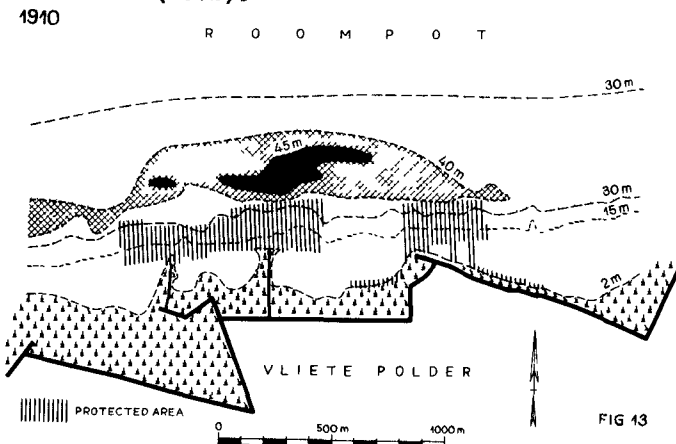
Fig. 13. Protection-works-caused erosion near Vliete Polder (1910).

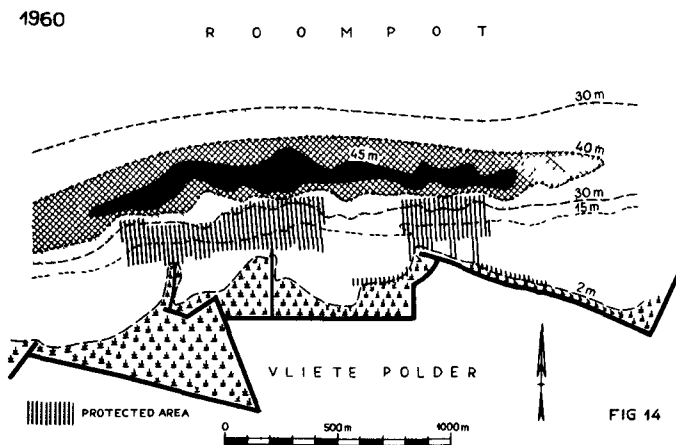
Fig. 14. Further erosion near Vliete Polder (1960)

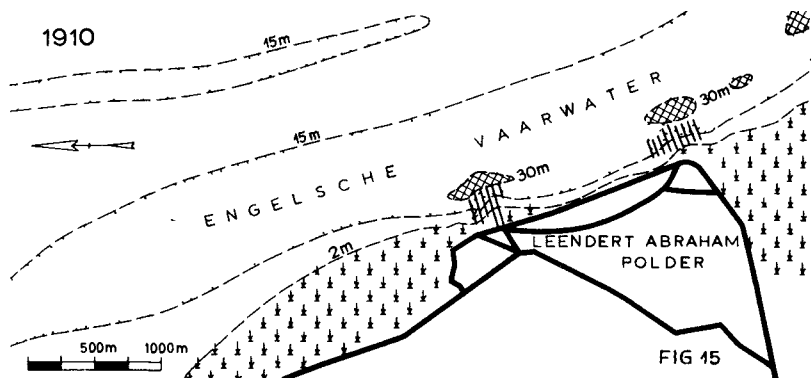
Fig. 15. Early development near Leendert Abraham Polder (1910).

A picture of the development is given by the figures nos. 15, 16 and 17, which also show the retiring of the shoreline, owing to numerous falls and slides, causing the destruction of the initial dike.

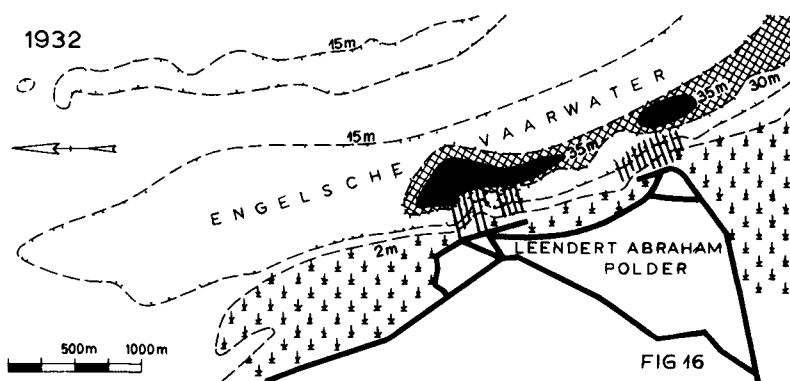
Fig. 16. Protection-works-caused erosion near Leendert Abraham Polder (1932).

Near these works scourholes were formed, necessitating an expansion of the protection: 300.000 m² of the shore were covered with mattresses and with 300.000 tons of rip-rap.

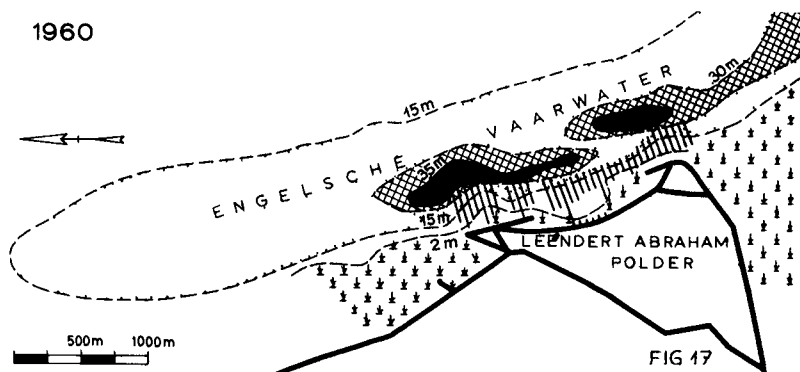
Fig. 17. Further erosion near Leendert Abraham Polder (1960).

After this local scouring up to N.A.P. - 45 m took place. The gully moved to the shore and was held there.

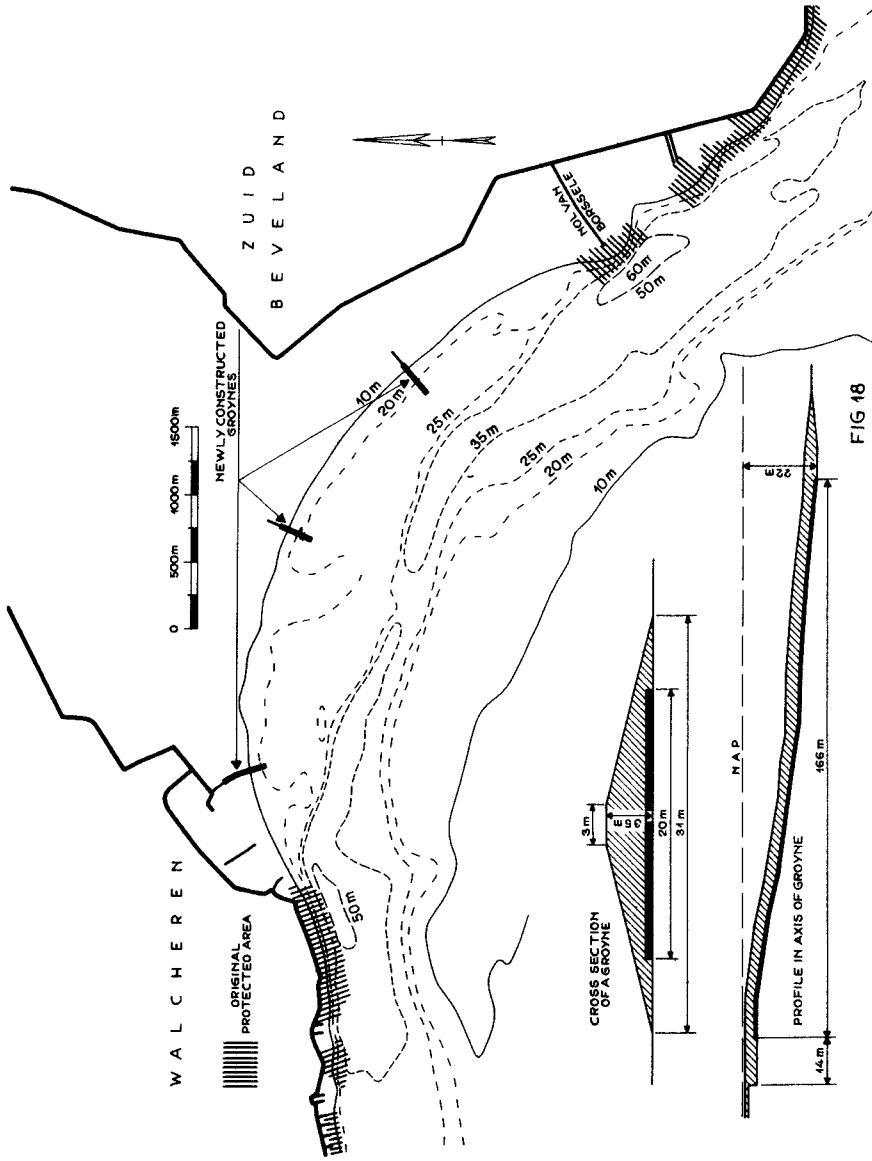
FIG 18

Fig. 18. Protection-works between Walcheren and Zuid-Beveland.

Recently the slightly eroding shore between Walcheren and Zuid-Beveland has been fixed over a length of about 5 km between the existing protective works by means of three groynes, sloping under 1 : 8 from the lowwaterline to a depth of N.A.P. - 20 m; see figure no. 18. The results seem satisfactory.

The bastion to the east of this, called Mol van Borssele (a spur dike, i.e. a remainder of a former dike), has caused a very deep scourhole of more than N.A.P. - 60 m. In the laboratory it was found possible to get a sanding-up of the scour-hole up to a depth of N.A.P. - 40 m by reconstructing the bastion. To this end the originally high bastion was bevelled in the laboratory to 1 : 8 from N.A.P. - 20 m upwards.
