## Chapter 36

### PRAIA DA VITÓRIA HARBOUR (AZORES) DAMAGES IN THE BREAKWATER DUE TO THE STORM OF 26th - 27th DECEMBER, 1962

José Joaquim Reis de Carvalho  
Head, Estuaries and Rivers Division  
Laboratório Nacional de Engenharia Civil, Lisboa, Portugal

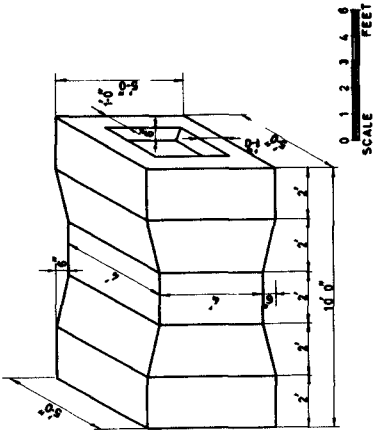
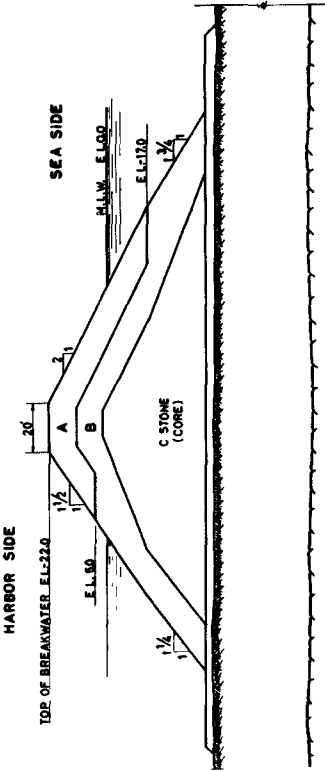
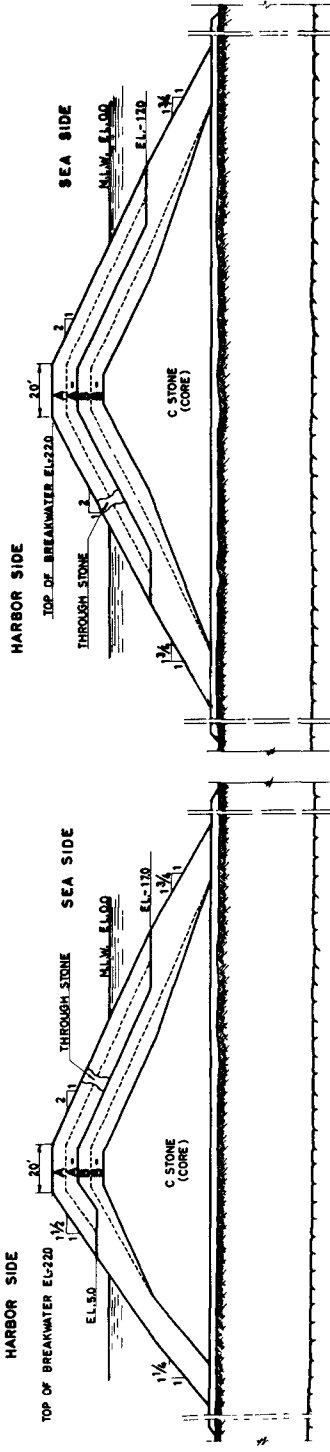
BREAKWATER - STONE SIZES

age of A armour stones, the limits between the different stone types were changed so that 10-13 short ton stones were used in the lower layers and 2-4 short ton stones in the secondary armour of the harbour-side slop (fig.2). The rockfill has a specific gravity of 174.3 lbs/cuf (2.79 ton/m<sup>3</sup>).

Nevertheless the subdivision of armour stone A in two sizes (A, 13-15 and A-10-13 short tons) decreased the safety of the structure as the loss of blocks in the sea-side layer for wave heights above the design values, which is always possible and actually occurred latter on, exposed the lighter layers to the direct action of the waves. For these layers the coefficient K has a value

Therefore, due to the changes in armour stone A, the structure had an insufficient margin of safety and a sufficiently prolonged storm, severer than the storm considered in the design, could give rise to the development of a chain destruction phenomenon with serious results, as each layer successively exposed to the action of the sea would be less stable than the preceding one and consequently would be more easily destroyed. This is what actually happened late in December 1962.

In the harbour side the A armour stone cover extends down to level (+5!0), the B armour stone layer being therefore exposed for all the tide levels save the high water spring tide. This solution is not currently adopted when overtopping is possible.

It was in the head of the breakwater, however, that the structure deviated more considerable from the currently followed rules. In fact it is generally known that the components of the head of a rubble mound breakwater, as that of Praia da Vitória, are subjected to more intense actions, than the components of the profile, due to the additional effect of the jet generated by the wave breaking in this zone. On the other hand, due to the curvature of the head of the breakwater, the components of the internal sector of the head are less stable than

Hence the conclusion that the head of the breakwater of Praia da Vitória harbour had not the same factor of safety as the other sections. Nevertheless, for the reasons indicated below, the head of the breakwater underwent but slight damages in the internal sector. It should be noted, however, that a decreased strength in the head of a breakwater is extremely dangerous, as any damage in that zone can easily extend to the remaining sections even if these by themselves could resist the storm.

In an attempt to obviate the disadvantages of the subdivision of the A armour stone size, it is recommended in the design of the breakwater to use special shaped artificial blocks, cast through stones, placed so as to be included in two armour stone layers. These cast through stones, weighing about 16 short tons, were placed following no special rules, obeying one principle alone, that at least one of every ten A stones placed on the slope in the A stone surface layer must be a through stone.

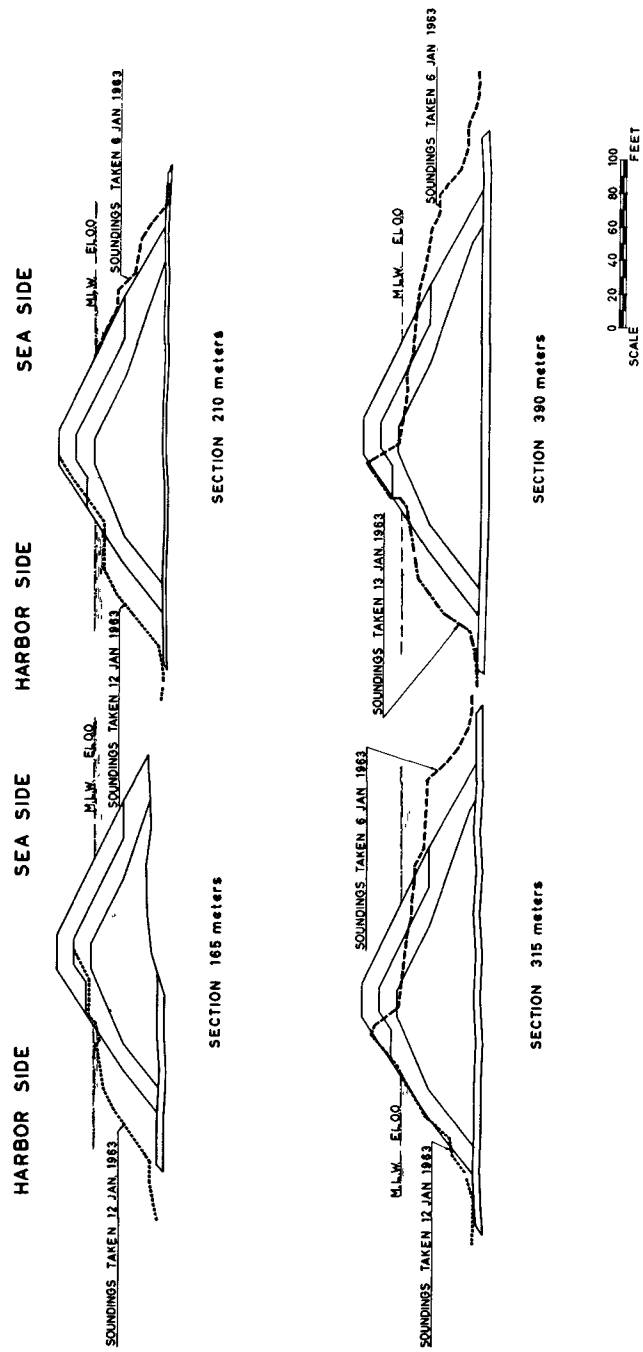
FIG 6 BREAKWATER SECTIONS AFTER STORM

- profiles 0 to 176 metres: this section of the breakwater, completed up to elevation (-12'.0), underwent but slight damages at the surface; on the other hand both the sea-side and the harbour-side slopes were covered by a considerable volume of small stones, removed from the coast north of the breakwater;

- profiles 176 to 291 metres: this section remained in good conditions, as the only damages observed were some A armour stones removed from the sea-side slope and some slight settlements at the top; nevertheless, several B armour stones were displaced from the harbour-side slope below elevation (-5'.00),

which shows that the overtopping waves had harmful effects on this section;

- profiles 291 to 442 metres: this was one of the most severely hit sections, all the A armour stones of the sea-side slope and the top having been removed, rolling over the sea-side slope to the base of the breakwater, together with the B armour stones placed below; nevertheless, some A armour stones and cast through stones remained in place, although in very precarious equilibrium, in the harbour-side slope: if the storm had persisted somewhat longer, these blocks would also have collapsed and this section of the breakwater would have been razed to a level of about (- 0'.00); the type of damage undergone by this section of the breakwater confirms the observations of the preceding sections, showing that the collapse started in the sea-side slope;

- profiles 442 to 530 metres: this section was less damaged than the former as a length of about 45 metres remained almost intact;

- profiles 530 to 565 metres, this was the section where the most severe damages were observed: the breakwater was razed to elevation (- 0.00);

- profiles 565 to 585 metres (head of the breakwater): this section remained in good conditions as only some stones were removed in the harbour-side slope below the water level, thus confirming our present knowledge on collapse phenomena in the heads of breakwaters.
