CHAPTER 38

PATTERN OF WAVE-INDUCED EROSION UNDER CAISSON-TYPE BREAKWATER

P. Donnelly, Head, Marine Structures Section, Department of Public Works, Ottawa, Canada
and

Richard Boivin, Senior Hydraulic Engineer, Lasalle Hydraulic Laboratory Limited, Montreal, Canada

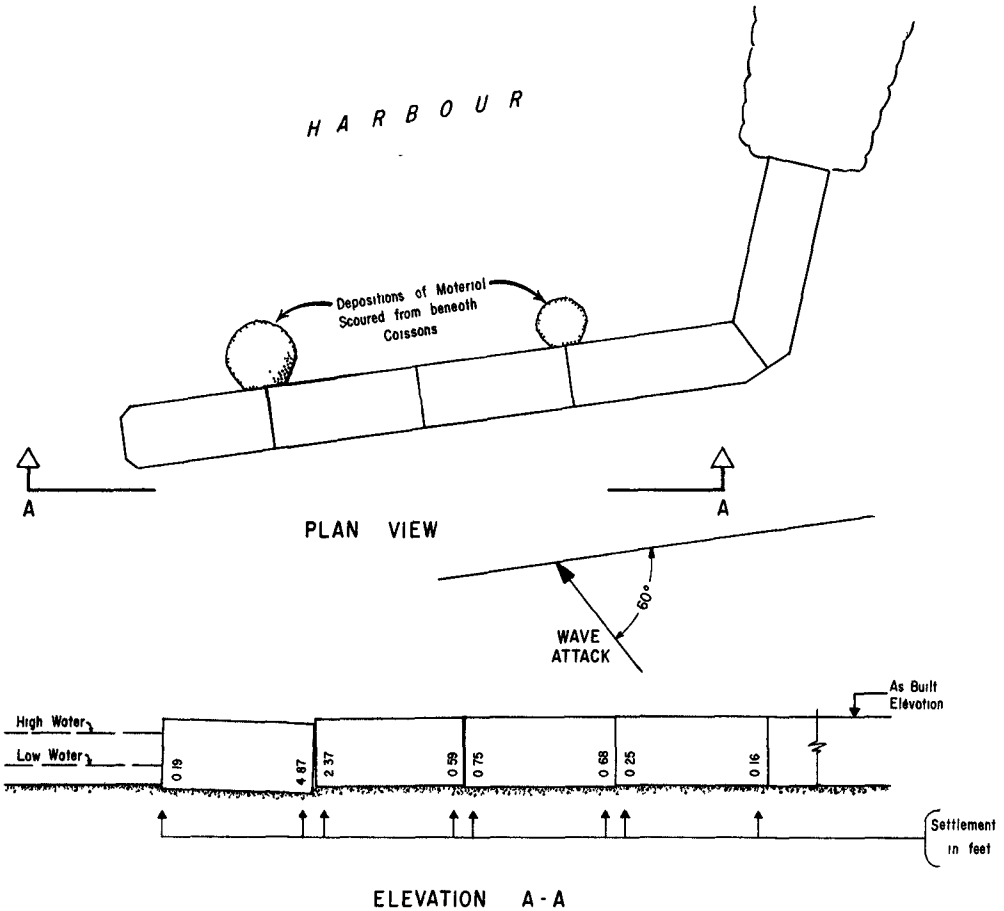
FIG. 1 SETTLEMENT OF PROTOTYPE DURING FIRST YEAR AFTER CONSTRUCTION.

This investigation was initiated to clarify the mechanism by which extensive foundation damage was caused to a recently installed prototype installation. Fig. 1 illustrates the settlement of the prototype which occurred during the first year after complete construction.

It was suspected that the problem was caused by erosion by wave action of the foundations which began at an inadequately closed joint between abutting caissons and extended progressively under the caissons. A laboratory study was undertaken to

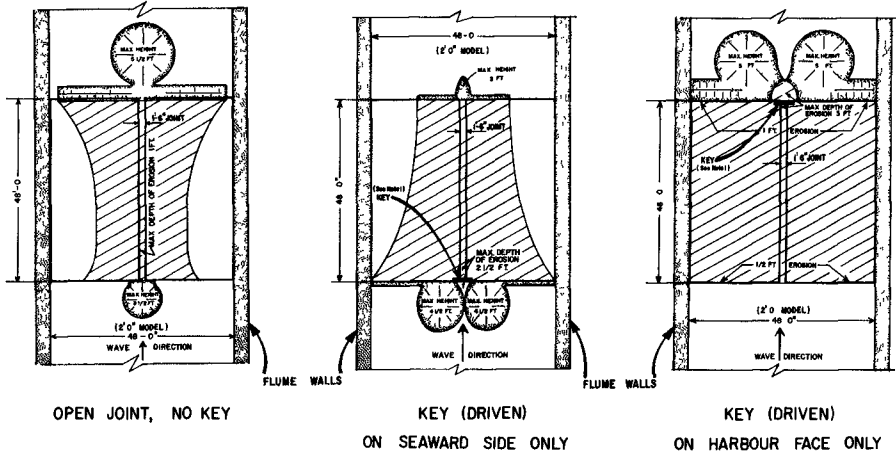
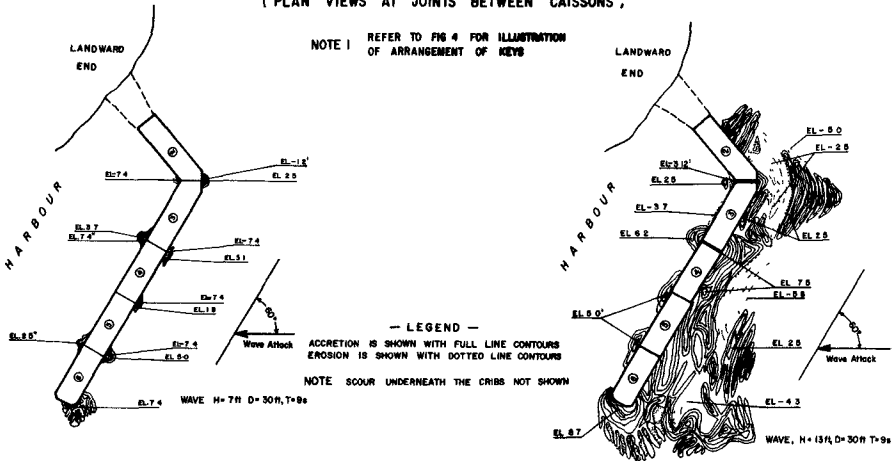
Fig. 2 SAMPLE OF TEST RESULTS SHOWING EROSION PATTERNS

The scour patterns shown in Fig. 2(a) were obtained in the 2 ft flume with 4 foot incident waves acting 2½ hours, the bed material had the same critical speed of erosion as coarse sand (0.5 mm) does in the prototype. Quite similar patterns resulted from tests carried out at a 6¼ foot incident wave height and with a bed material which behaved the same from the point of view of critical speed of erosion as 2 inch gravel in the prototype.

Although the period of time of 2½ hours corresponded in no way to an "equilibrium state" in the erosion process, widespread damage had resulted even from a relatively light wave action. The erosion was not confined to the joint itself, but extended several feet away from it, underneath the caissons.

The tests conducted in the 16 ft wide flume, under oblique wave attack, led to similar scour patterns, as evidenced in Fig. 2 (b).

No success was achieved with tentative methods of sealing the joints, such as a single key placed either at the seaward or at the harbour face of the joint, or a double key arrangement (one at each face of the caisson). Even when the keys were driven into the foundation soils, piping developed around the edge of the keys and led progressively to the erosion patterns shown in Fig. 2.

However, a double key arrangement with fill placed in the space between the keys, as shown in Fig. 4 (insert) performed successfully, both in the 2 ft. and 16 ft. wave flumes. When granular material is employed as fill a minimum height is needed in order to prevent piping. Piping affects are proportional to the effective differential head, ΔZ , at the bottom of the clapotis.

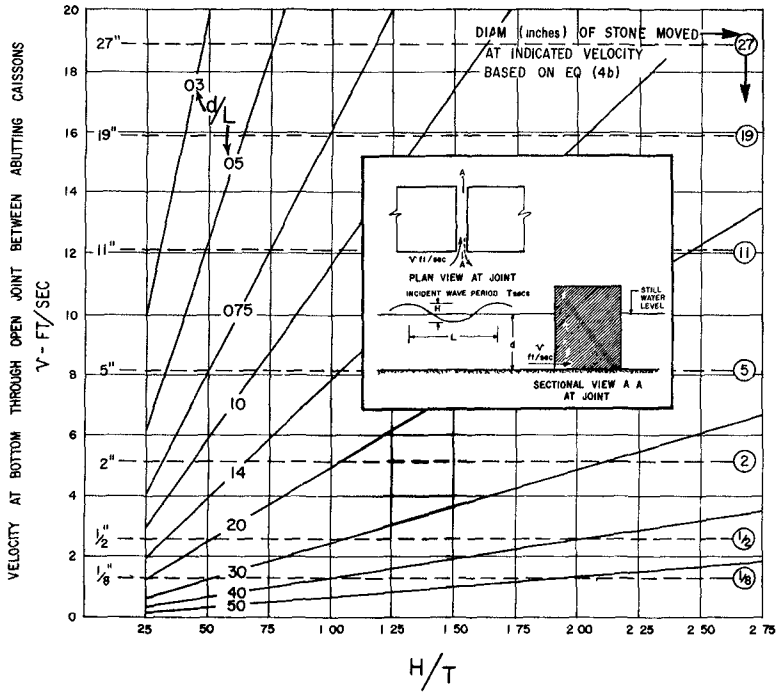
FIG 3 BOTTOM VELOCITY THROUGH OPEN JOINT BETWEEN ABUTTING CAISSONS, AND SIZES OF STONE ERODED, AS A FUNCTION OF WAVE CONDITIONS

Figures 3 and 4 are graphical representations of equations (1) and (3) respectively. Figure 4 also shows the critical speed of erosion of various sizes of foundation materials based on a typical equation (Ref. 1) for critical speed of erosion of particles of diameter, D , larger than the laminar boundary layer

Figure 3 provides a convenient means of making a quick preliminary check to determine if an erosion problem can be anticipated.
