## CHAPTER 81

### BEACH RESTORED BY ARTIFICIAL RENOURISHMENT

Douglas Edward Newman

Hydraulics Research Station, Wallingford, England

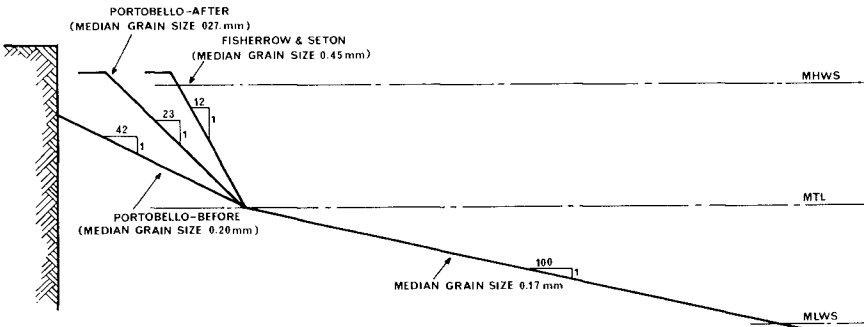
Fig 4. Beach slopes and median grain size.

The beach before renourishment stood at a slope of 1:42 and was composed of a median-sized sand of 0.20 mm. The restored beach was graded to a slope of 1:20, and after 18 months was standing at a slope of 1:23. The mean size of the sand was 0.27 mm (Fig 4).

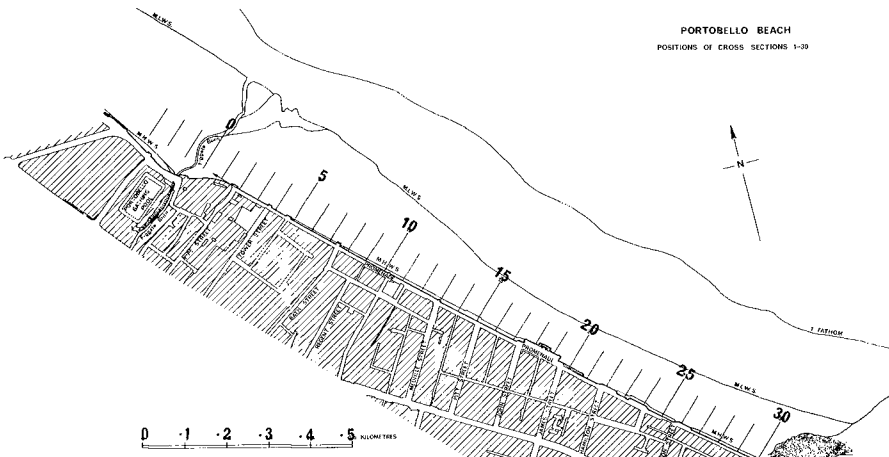
Fig 5. Plan view of beach sections 1-30.

Calculations on the volume of sand remaining in position show that after this period, which included nearly two winters, no loss of sand could be positively identified. The records are based on 30 cross sections throughout the total length of some 1½ kilometres (Fig. 5).

Recent measurements taken at groyne No. 1 (Section 1 Fig 5) show that there is an accumulation of sand on the East side and a difference in level of about 1 m across the groyne. The West side of the terminal groyne will be buttressed with stone to avoid further spillage.

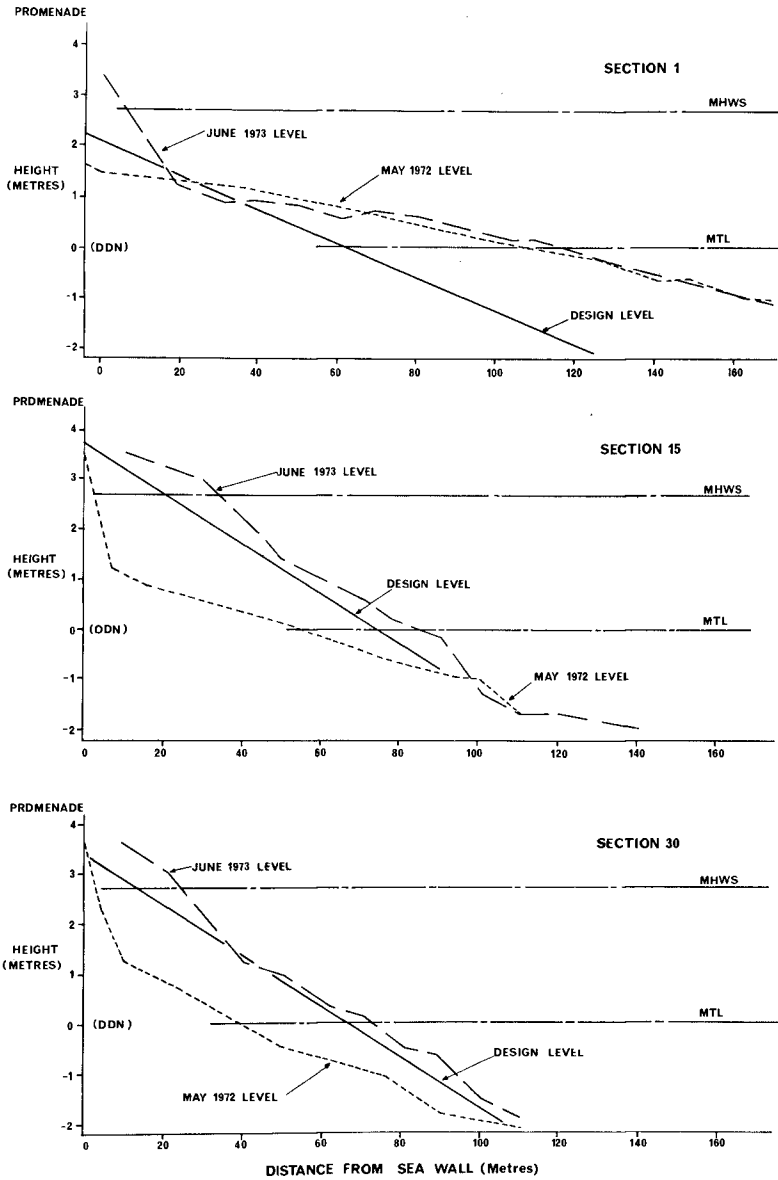
Fig 6. Comparison of three beach sections.

and whereas it is evident that some spilling of the material has occurred at the ends of the restored beach, there is little sign of any appreciable movement offshore. Fig 6 shows the centre section and the terminal sections after 2, and Fig 4 the slopes and sand sizes of the neighbouring beaches compared with Portobello.
