Rosslyn Bay Breakwater, Queensland, Australia

D.N.Foster<sup>(1)</sup>, B.L. McGrath<sup>(2)</sup>, W.Bremner<sup>(3)</sup>

This paper discusses damage to the breakwater from wave and surge action, model studies and repair of the breakwater.

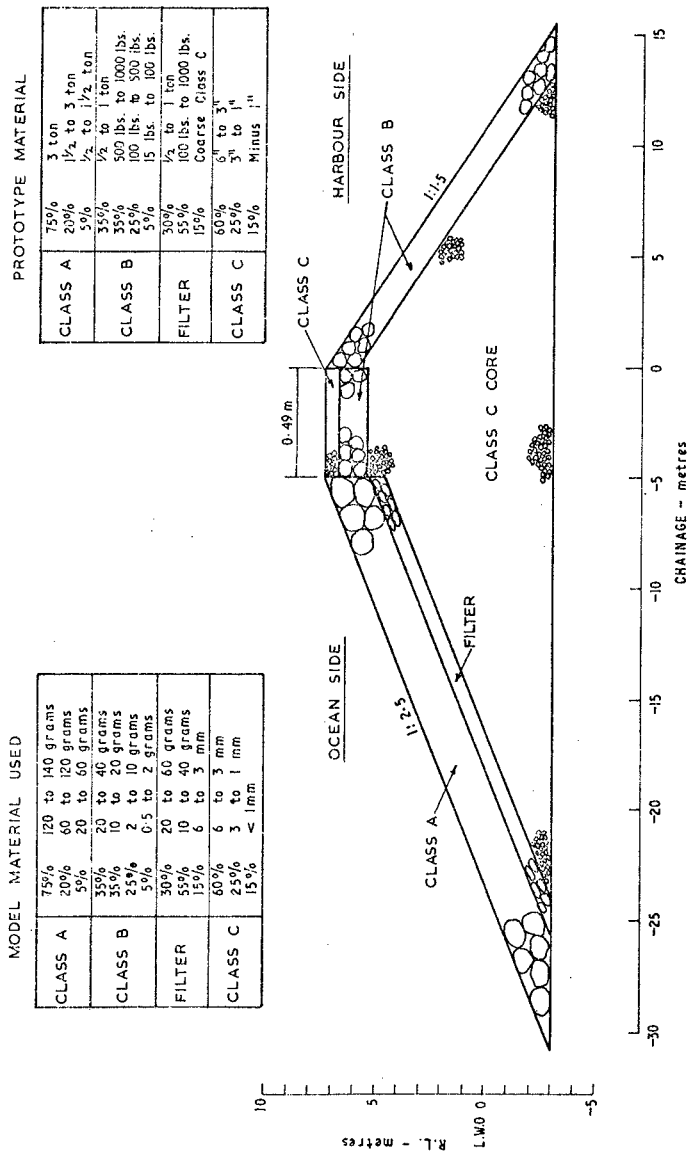
FIGURE 3: TYPICAL CROSS SECTION OF BREAKWATER

A typical section through the breakwater and armour specification is shown in Figure 3. The seaward face was armoured with a nominal 3 ton rock. The crest was armoured with nominal  $\frac{1}{2}$  ton rock blinded with fine material to provide an access road and was not designed to resist overtopping.

As there were no wave records for the area, the design storm surge and wave heights were estimated by hindcasting using available wind records. In Jan. 1967 the Consulting Engineer estimated from the available cyclone records that damage to the breakwater may occur once in every 10 years and such damage was likely to be severe. As it happened, the breakwater was severely damaged by overtopping some 8 years after construction of its first section.

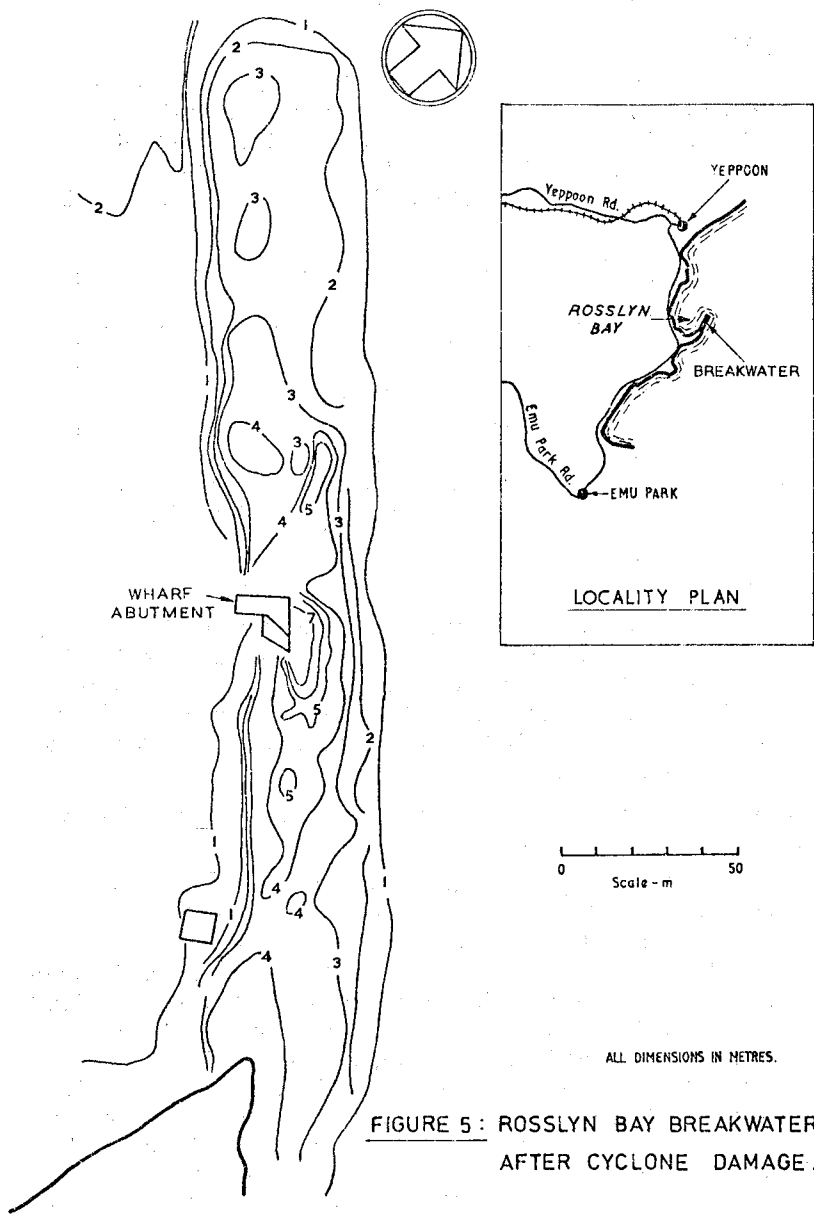
FIGURE 5 : ROSSLYN BAY BREAKWATER  
AFTER CYCLONE DAMAGE .

Major damage to the breakwater occurred at or soon after the evening high tide on 19th. At this time the breakwater failed catastrophically with the crest being destroyed and lowered within a few hours by some 4m over most of its length. The majority of the rock was displaced landwards coming to rest immediately on the harbour side. There was little damage to the seaward face.

A survey of damage to the breakwater was undertaken 20 days following the failure as shown in Figure 5.

Some comments on the damage are worthy of note. The damage resulted from wave overtopping, the majority of the rock being displaced landwards. When damage occurred it was catastrophic, taking place over a few hours. Despite high combinations of wave and storm tide levels and heavy overtopping little damage was noted prior to final collapse. It is difficult to believe that the class C or B material at the crest (Figure 3) would withstand any significant overtopping as was observed to be the case (see section on model simulation of failure). It is possible that as a result of compaction under road traffic the crest acted as an impervious scour blanket giving protection until incipient failure occurred, after which total failure followed quickly. Damage was very uniform over the entire length of the breakwater except at one section where a wharf abutment on the harbour side acted as a buttress. At this location damage was slight. Little damage occurred to the seaward face for deep water wave heights of up to

3.8m and estimated wave heights at the structure of between 3.0 and 3.4m. Equivalent damage coefficients in Hudson's equation are approximately 2.7 to 3.9 and wave conditions varied between breaking at low tide and non-breaking at high tide.

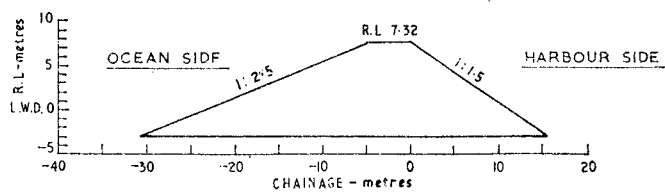
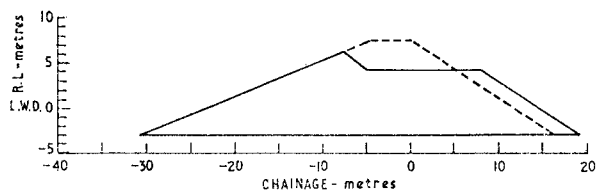
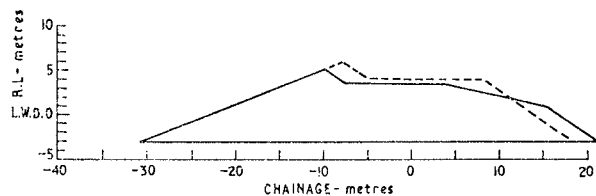
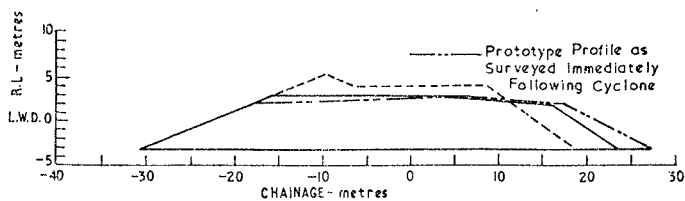
FIGURE 7: MODEL SIMULATION OF FAILURE

As part of the model studies to investigate methods of repairing the breakwater, tests were undertaken to simulate the failure. The test layout for the model is shown in Figure 6. The studies were carried out in a monochromatic wave flume using Froudian scaling. The model scale was 1:27.6. Test conditions reproduced were, offshore significant wave height (approximately  $H_{10}$  at the structure), peak spectral period and storm tide assuming a linear variation between high and low water. Typical test results are shown in Figure 7.

The test began at 2230 hours on 16th (low tide) and was continued until 0700 hours on 20th (low tide). Initial damage to the breakwater occurred at 0900 hours on 17th when the crest was destroyed in a landward direction.

Damage continued during each period of high tide when the crest was overtopped. The main damage was the result of overtopping and only a small proportion of the armour was displaced seaward.

The mechanics of damage in the model and prototype were the same with the majority of damage resulting from rock being displaced from the crest and settling on the immediate harbour side. No significant damage occurred to the seaward face. However, the model differed from the prototype in that initial failure happened much earlier. As soon as the structure was significantly overtopped class C and B material was removed and the crest destroyed. (See comment on prototype damage). Damage in the model continued over five high tide

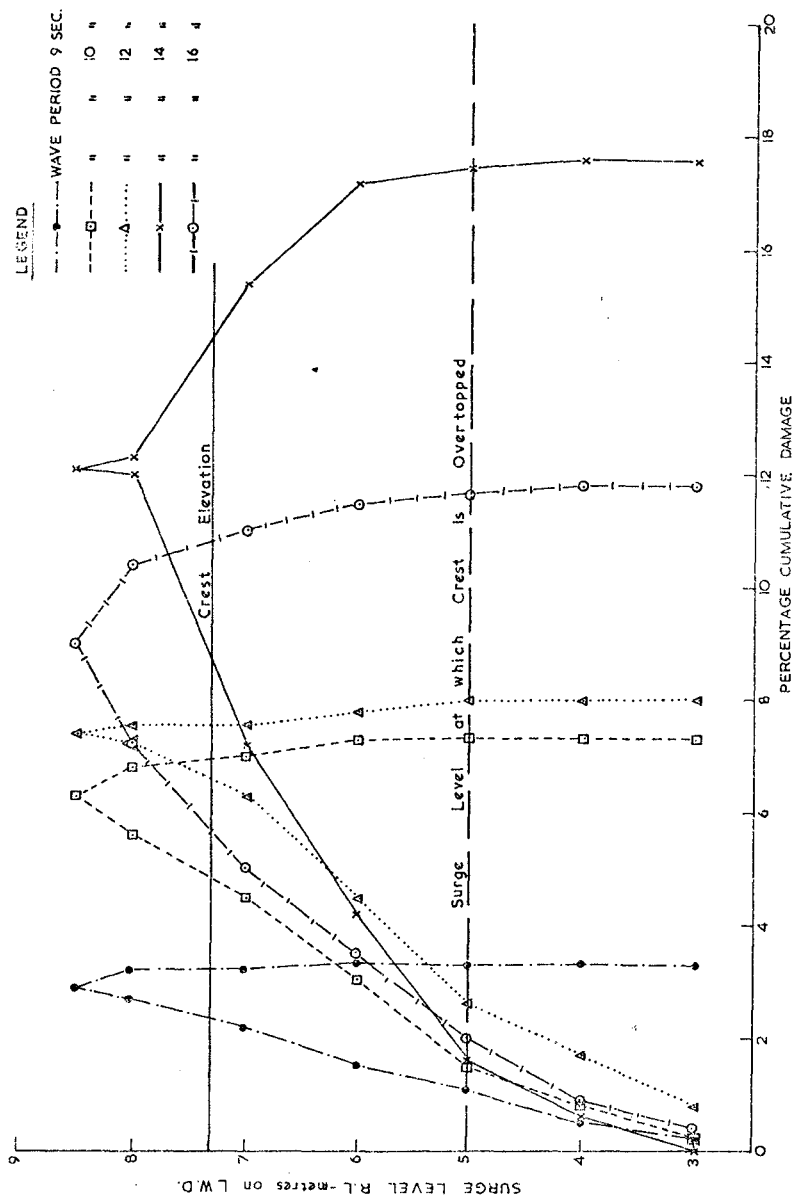
FIGURE 9 : DAMAGE AS A FUNCTION OF SURGE LEVEL FOR WAVE PERIODS FROM 9-16 SECONDS

Model tests indicated that the proposed design would be satisfactory although some damage could be expected, particularly at the crest under critical combination of wave period and storm tide conditions. A typical set of test results is shown in Figure 9. The tests were undertaken in a monochromatic wave flume using the design offshore significant wave height. Storm tide levels were increased in steps of 1m from RL 3m up to the maximum design value of 8.5m and then decreased in a similar manner. At each water level the structure was subjected to waves for an equivalent prototype duration of 82 minutes. The test was repeated over a range of wave periods of between 9 and 16 seconds. Rock displaced was counted as damage and expressed in terms of a percentage of the total number of armour rock. It will be noted that the rate of damage (particularly to the crest) is dependent upon both wave period and storm tide level. Maximum damage to the seaward face occurred for a wave period of 12 seconds and to the crest for a wave period of 14 seconds. At very high surge levels the crest is submerged and wave forces are reduced by a water cushion between the wave and the armour and damage is reduced. For the same reason it may be that a steeper landward face may have been more stable than the 1 in 2 slope used. However, this was not investigated in detail. Test results shown in Figure 9 are for random placed stone. By careful placement of the crest rock a substantial increase in stability could be obtained.
