TIDAL EROSIONAL EFFECTS ON A BULKHEAD SYSTEM

This paper describes an investigation of a bulkhead system supporting a large waterfront development in southern California which was experiencing widespread sinkhole development in the bulkhead's backfill and was on the verge of losing toe material. The objective of this investigation was to determine the extent and cause of ongoing subsurface erosion, to evaluate its effect on the bulkhead stability, and to recommend and design mitigative measures. The cause of the erosion was determined to be piping of fine grained soils due to inadequate backfill drainage. A remedial drainage scheme was designed and field-tested, and several structural repair schemes were suggested for portions of the bulkhead where accumulated damage affected the integrity of the structure.

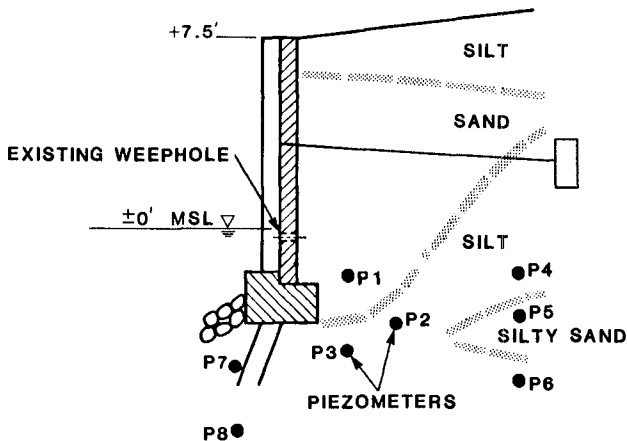
Figure 1. BULKHEAD CROSS SECTION

A typical cross section of the bulkhead is shown on Figure 1. The bulkhead is 9.5 feet high and consists of precast concrete panels, which are supported by precast concrete columns, 11 feet on center. The columns are tied back by anchors to a continuous concrete deadman and rest on a continuous 4-foot-wide by 2.5-foot-high poured-in-place footing which is supported by one row of batter timber piles. Two weepholes per panel, with wire mesh screens, are provided for drainage of the sand backfill.

A typical subsurface profile in the immediate vicinity of the bulkhead is shown on Figure 1. A backfilled wedge of loose fine sand extends down to the footing base, which is underlain by soft natural sandy to clayey silts. The loose sand backfill is generally covered by a stiff silt layer of 3 to 4 feet in thickness. The soils behind the backfill wedge range from loose silty fine sands to dense sandy silts.

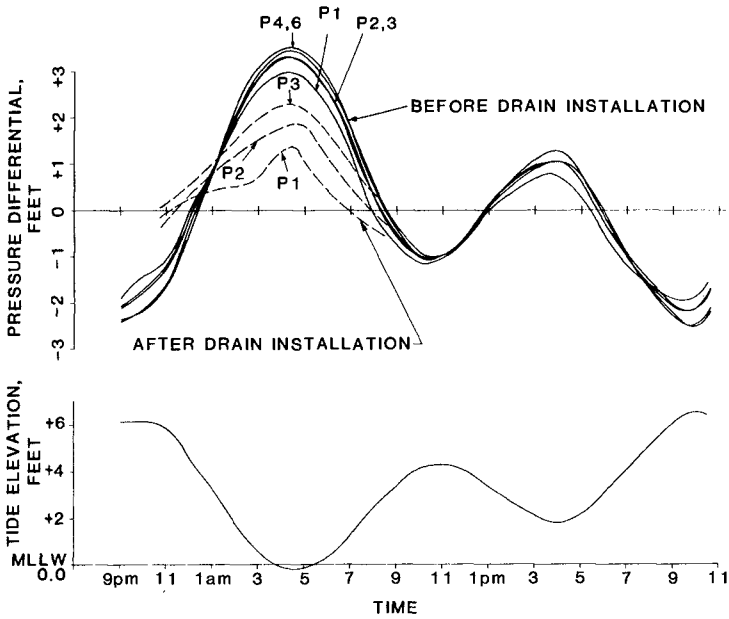
Figure 2. PORE PRESSURE MEASUREMENTS

The general trend of seepage gradients versus time in the backfill is shown graphically on Figure 2. The upper portion of the figure shows the pore pressure differentials, with reference to the free water level in the channel, at the locations of the installed piezometers. For instance, a pore pressure differential of +2 feet at a particular location and time would mean that the ground water in a hypothetical stand pipe installed at this location would rise 2 feet above the water table in the channel. The ground water seepage would thus be directed towards the water channel. From the standpoint of piping, the most severe conditions exist at the peak of positive pore pressure differentials. The lower portion of Figure 2 is a plot of the corresponding tide elevations versus time.

The evaluation of the drains' effectiveness relied on pore pressure measurements in the backfill before and after the installation. Figure 2 shows the pore pressure differential towards the free water level, measured during a critical tidal cycle before the drain installation, and during a similar cycle after the installation. Plotted pressure potentials (after installation) are those of locations P-1 through P-3, represented by the piezometers closest to the wall. Any potential piping which could lead to development of a gap would occur through seepage from the loose backfill at the footing/subsoil interface rather than through deeper zones of the underlying silty soils. The most important piezometer location is P-1 since it represents the conditions in the loose backfill just above the footing base. P-2 and P-3, on the other hand, were expected to record higher pore pressure differentials than P-1, because of the time lag caused by slower drainage of the natural silts in which they are embedded.

Piezometer P-1 shows a rather large reduction, due to the drains, of the maximum pressure potential towards the free water level (from 3 to 1.4 feet). The well points are approximately 1 foot higher than the minimum water level of the tidal cycle under consideration. Therefore, at the time of minimum water level, the ground water behind the wall forms a pool whose water table remains roughly at the well point outlet. Thus, the recorded pressure differential can not be smaller than 1 foot, even under perfect drainage conditions. Hence, the field test with horizontal well points was considered successful and this drainage system was recommended for remedial measure of the entire bulkhead system.

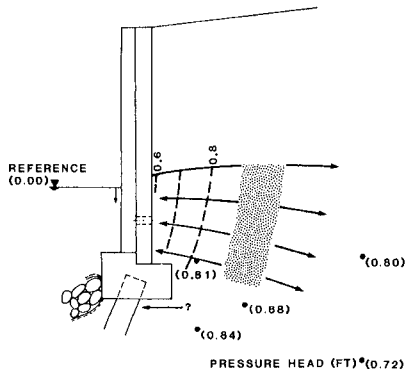
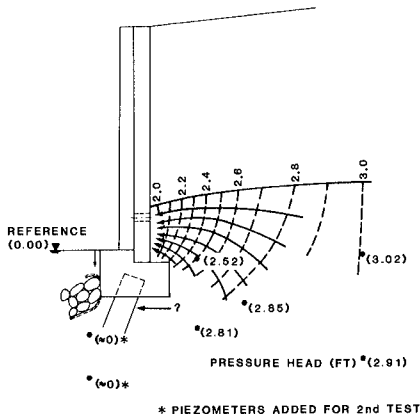
Figure 3. FLOWNETS

Flow nets were constructed at several critical times, making simplified assumptions, such as homogeneous soil conditions and two-dimensional flow conditions. The flow nets shown on Figure 3 represent two "snapshots" of a constantly changing flow pattern in the backfill. The indicated times (1 a.m. and 3 a.m.) for which the flow patterns are depicted correspond to the time scale of the graph on Figure 2.

The flow net at 1:00 a.m. indicates a zone of flow reversal moving away from the wall as the free water level in the channel moves down. The fact that this flow reversal condition, involving very small relative pressure differentials, could consistently be derived from actual pore pressure measurements increased confidence in the piezometer data.

The most critical flow condition in terms of underground erosion (piping) is demonstrated with the flow net at 3:00 a.m. The flow lines in this and subsequent "snapshot" flow nets (not shown here) suggest that the bulk of the seepage water escapes through the vertical panel/column joints above the footing.
