CHAPTER 85

Federal Jetty and Sand Dike at the Entrance to Fire Island Inlet, New York

Cyril Galvin*, M. ASCE, Charles, J. Rooney**
and Gilbert K. Nersesian***, M. ASCE

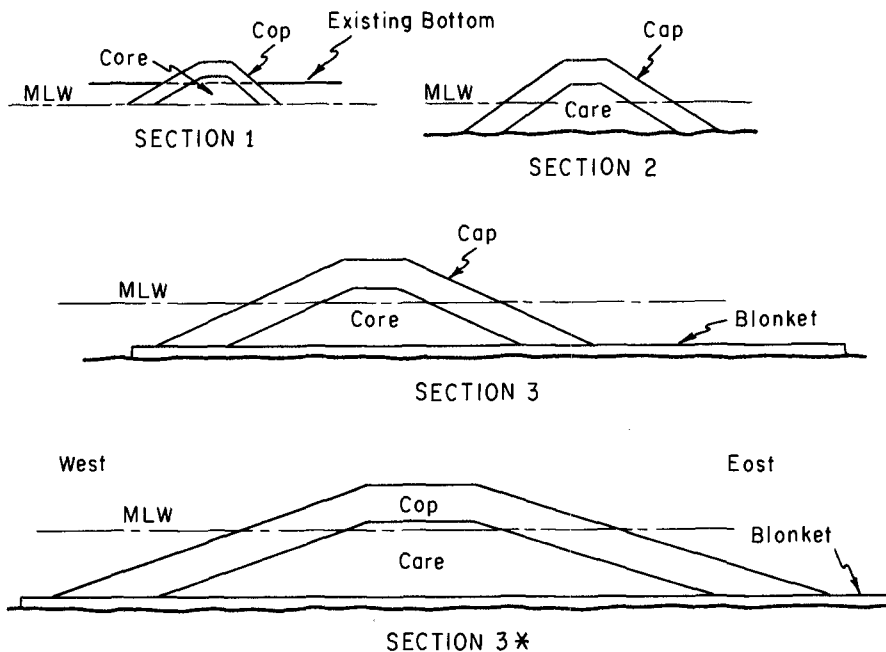
Figure 4. DESIGN CROSS-SECTIONS OF JETTY.

24+00. These locations are in Segment 2, not at the seaward end. No other repairs are known, either from the files or from the memory of knowledgeable persons. The 165 tons is a relatively small amount, occupying, for example, a little more than six feet of the Section 2 shown on Figure 4.

When constructed, Segment 1 was on land (Figure 2), and had a weak cross section (Figure 4 and Table 1). Segment 1 now shows damage both by waves and by tidal currents. Waves have damaged and penetrated behind the jetty for at least 1200 feet, eroding significantly into the dunes east of the jetty (Figure 9). This damage occurs in a relatively sheltered position within the inlet, but the recurved spits, pointing at or terminating at Segment 1, may provide a wave channel which can concentrate ocean waves on the jetty. (During storms, the recurved spits may be submerged, and refraction would concentrate wave energy above the spit, delivering the waves to the jetty.) Recurved spits on the inlet side of the jetty have been a common feature through time. These spits appear across the top of photos in Figures 5, 6, 7, and 8, with shapes and relative positions identical to those observed in recent years. A recurved spit intersecting the damaged length of Segment 1 was especially well developed after the severe northeast storm of 29 March 1984 (Galvin, 1984). Figure 9, based on a June 1984 photo, shows a remnant of this March 1984 spit. However, such a spit was not well developed after Hurricane Gloria (Terchunian, 1986).

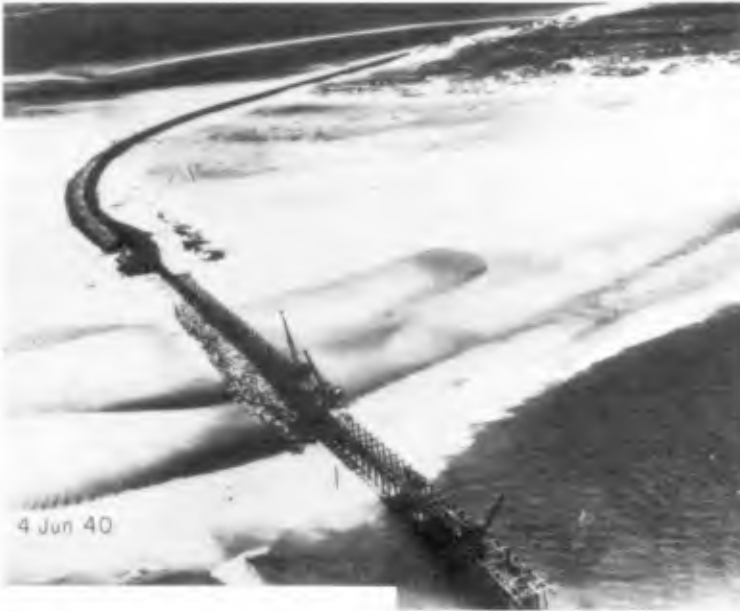
Figure 5. SEGMENT 1 OF JETTY COMPLETE AND TRESTLE CONSTRUCTED FOR SEGMENT 2 ON 4 JUNE 1940.

Figure 5 suggests that Segment 1 of the jetty (Figure 2) was essentially complete by June 1940, approximately a year after the contract was signed. At this time, the trestle was constructed to Station 33+00, which is approximately the seaward end of Segment 2, and core stone had been placed for about half of Segment 2. The trestle bents in Segment 2 are more than double the width of the railroad. The rails are confined to the west half of the bents. It is evident from close inspection of Figures 5 and 7 that temporary timber platforms were laid on the pile caps east of the track to support cranes that placed the cap rock.

The four photos show rapid accretion of the shore east of the jetty and some erosion immediately to the west. By the end of construction, sand freely overtopped the jetty (Figure 8), as it does today. Even at the start of construction, there was a large sand spit west of the jetty, and a recurved sand spit along the inlet which reattaches near Segment 1 (see top of Figure 5). A recurved spit such as shown in Figure 5 is common today after severe storms.

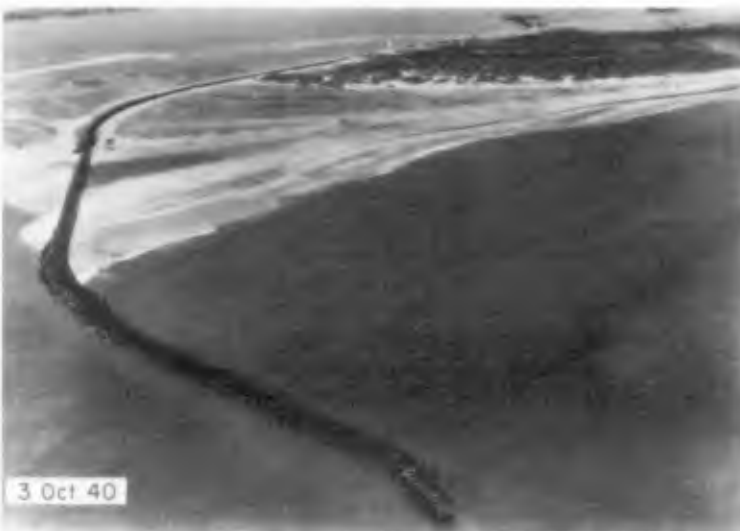
New York Daily News Copyright, with Permission
Figure 6. SEGMENT 3 UNDER CONSTRUCTION ON 3 OCTOBER 1940.

Figures 6 and 7 show the trestle to dogleg to the right at the seaward end, and the track moves from the west side of the trestle to the east side of the trestle after passing the change in direction. Isolated piles in the water along the pre-dogleg line of track suggest that the dogleg replaces a wave-damaged section of trestle.

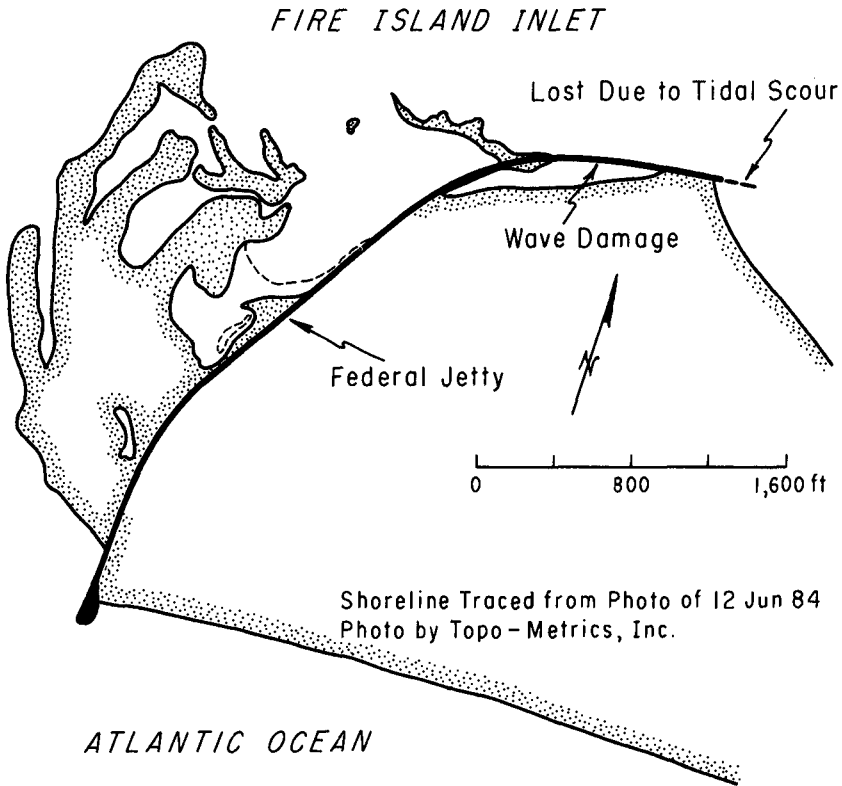
Figure 9. RECENT (1984) SHORELINE IN VICINITY OF FEDERAL JETTY

At the ocean shore east of the jetty, there has been a large accretion of sand since the jetty was constructed. This is made evident by comparing the 1939 shoreline and bathymetry on Figure 2 with the recent shoreline (June 1984) on Figure 9. The present accreted condition was reached rapidly, probably by 1950, according to Saville (1960).

The area of sand in the spit west of the jetty is, surprisingly, relatively unchanged between the 1939 design condition (Figure 2) and the 1984 photo traced on Figure 9. However, this spit has shifted seaward, from a position adjacent to Segment 1 in 1939 to a position adjacent to Segment 3 in 1984 (compare Figures 2 and 9).

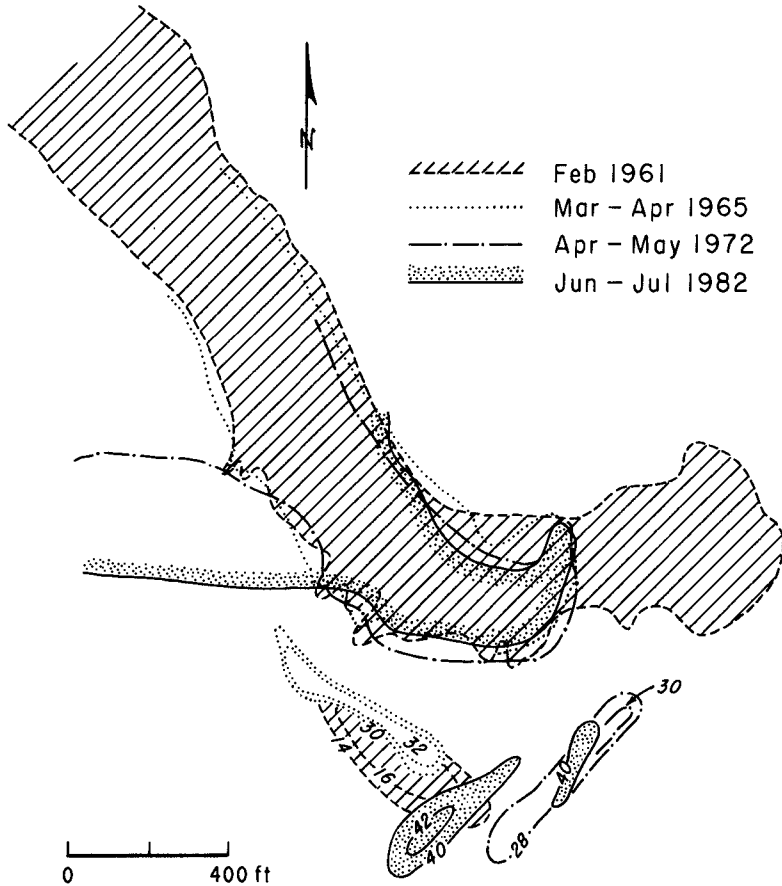
Figure 10. SHORELINE CHANGES AND THE DEEPENING AND REALIGNMENT OF CHANNEL AT THE SAND DIKE.

Subsequent History. The changes to this dike are indicated in part by the shorelines on Figure 10. Shortly after construction, local interests placed stone around the dike to armor it (mentioned in the 2 May 1961 letter, but not directly referred to by Saville, 1960). The dike initially had a boot-like shape, but most of the "foot" to the boot was eroded by 1965. The sequence of shorelines on Figure 10 suggest at least another effort at riprap revetment, after 1961. Since then the dike itself has been relatively stable, and its west side has been subject to much accretion (Galvin, 1985).

The effect of the dike on the channel is indicated by the shape and depth of the deepest part of the channel passing around the end of the dike (Figure 10). For most of the first decade after dike construction, the deepest part of the channel trended to the northwest. Gradually, however, the channel reoriented until now it has a northeast trend, and in the process, the old channel west of the dike was abandoned. The abandoned channel became the site of accretion as the ebb channel, forced eastward by the dike, bypassed a large part of the ebb tidal delta, which then accreted to shore. Analysis of the down-drift accretion is given in detail by Galvin (1985). The general bypassing process under natural conditions is discussed by FitzGerald (1983). The location of the ebb tidal delta and the shifting of the shoals in the inlet are shown in air photos by Barwis, et al. (1977).

Sand Accretion. The Federal Jetty and the sand dike are both aligned perpendicular to shore. Present knowledge would anticipate the large accretion of sand on the ocean shore east of the jetty (Figure 1), but the major accretion west of the sand dike (Figure 10), on the downdrift side, would perhaps still be unanticipated today. The large volume of sand in the ebb tidal delta is the source of this accretion, and the eastward shift of the channel freed this sand to move ashore.
