# DESTRUCTION MECHANISM OF COASTAL LEVEES ON THE SENDAI BAY COAST HIT BY THE 2011 TSUNAMI

Akira Mano<sup>1</sup>, Hitoshi Tanaka<sup>2</sup> and Keiko Udo<sup>3</sup>

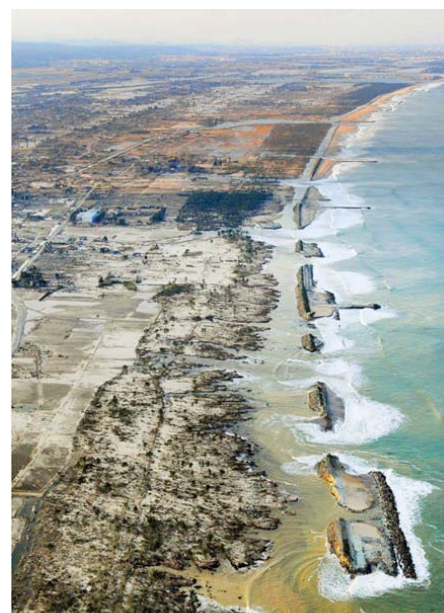
Figure 3 shows a map of the Sendai Bay Area with some names referenced. Here the Yamamoto Coast in the south was most significantly damaged. The photos before and after the tsunami are shown in Photos 1 and 2 respectively. This coast is suffering from severe erosion and T shaped jetties were constructed as the countermeasure. Wave dissipation blocks were placed in front of the levees. The tsunamis breached the levees in many places and a coastal channel was formed behind the levees by the tsunami erosion.

**Photo 2. Yamamoto Coast after the tsunami taken by Kyodo News on March 19, 2011**

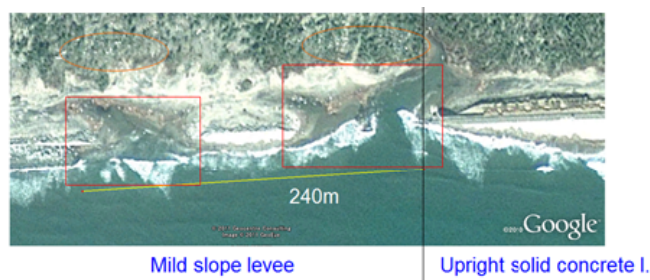
Photo 5 shows the levee breach at Fujitsuka, 2.55 km north of the Natori River mouth. Levee breach occurred at the junction of different type levees: upright solid concrete levee and mild slope levee. Rear side along the concrete levee and junction area are significantly eroded. A maintenance road and then pine tree woods existed behind the levees. The mild slope levee has structure such as soil mound armored by concrete blocks. Wave dissipation blocks had been placed in front of the two kinds of levees. Scatter of the armor and dissipation blocks is found behind the levees and in the woods.

**Photo 5. Breach at Fujitsuka. Google Earth image on March 14, 2011**

- The surging bore of the leading wave overtopped the two types of levees and broke the junction of the mild slope levee. The tsunami carried the armor blocks and wave dissipation blocks landward. Spilled water from the concrete levee fell down to the rear and scoured.
- The return flow along the rear side of the concrete levee accelerated itself by the confluence of the flow through the woods and increased erosion.
- High erosion at the junction removed the footing soil and the end concrete block turned landward.

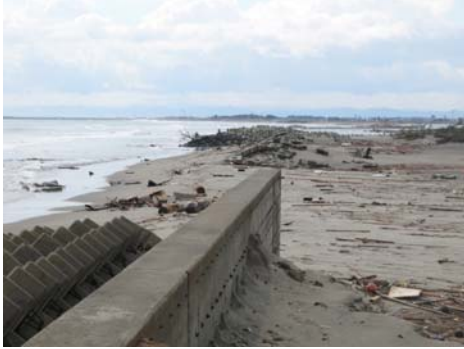
Photo 6 overlooks the breach point from the north. The deep erosion at the breach point was filled back soon. Photo 7 overlooks the concrete levee from the breach point. The levee had been footed with the depth more than 3 m. However because of the significant erosion, the footing of the end concrete block disappeared and the block fell landward. The erosion behind the concrete levee is deeper towards the breach point. This indicates the erosion mainly caused by the return flow. Photo 8 shows scatter of the armor blocks in the pine tree woods. Photo 9 shows scatter of the wave dissipation blocks behind the mild slope levee.

**Photo 6. Overlook the breach point from the north photographed on March 26, 2011**

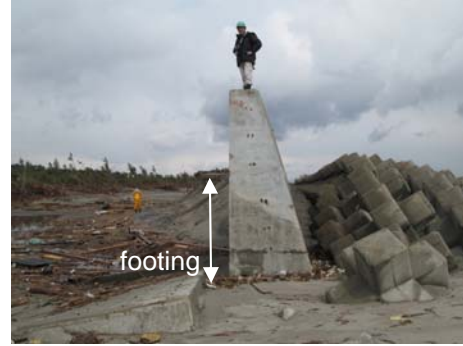
**Photo 7. Overlook the concrete levee from the breach point**

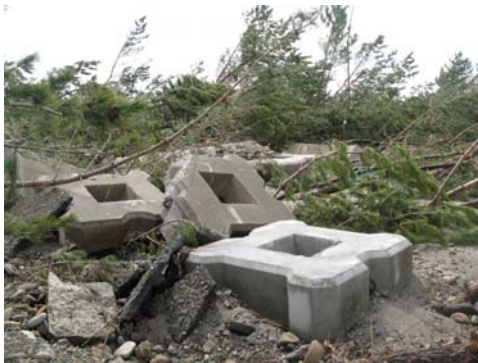
**Photo 8. Scatter of the armor blocks in the woods**

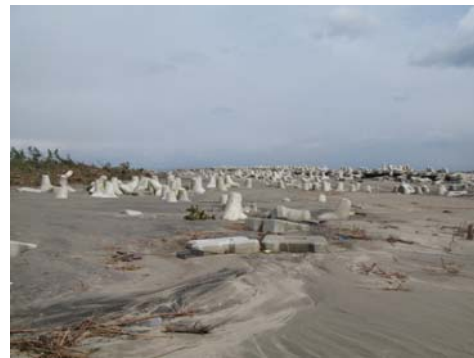
**Photo 9. Scatter of the dissipation blocks behind the levee.**

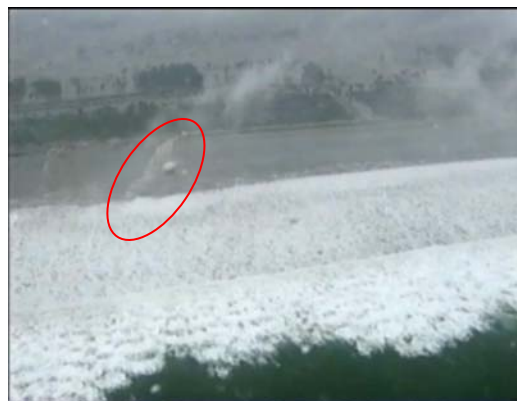
**Photo 10. Return flow from the breach point at Fujitsuka at 16:14 JST, captured from “Michinokugo” video. Return flow from the breach point is circled.**

Photo 10 shows a Fujitsuka point shot from “Michinokugo”. A series of soliton surges approach to the coast while the encircled is the trace of the return flow from the breach point. This means that the junction was broken before this shot, convincingly by the surging bore of the leading wave. Inclination of the trace to the south indicates dominance of the return flow along the concrete levee.

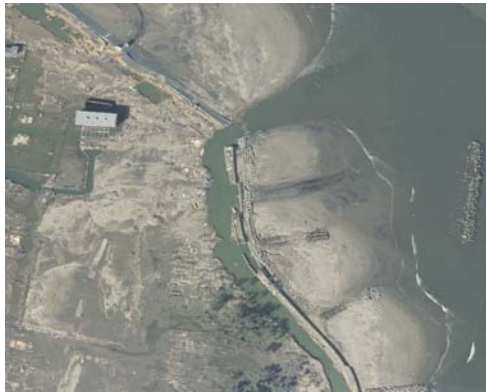
Photo 11 shows the breach point at the Abukuma River mouth. It locates at the junction of the river levee and coastal levee. A newly formed channel behind the coastal levee continues to the breaching point and then to the eroded beach. Photo 12 shows broken coastal levee. The levees have structure that three sided concrete slabs cover the soil mound and the seaside slab is extended to a recurved parapet. The parapet was broken at several points which correspond to erosion streaks on the beach in Photo 11. Photo 13 shows the back side of the end block of the river levee. One block of the coastal levee was separated at the joints and completely lost. Photo 14 shows three sides of the river levee in which the river side covered by concrete blocks was not damaged at all for the overflow of the tsunami. Upright parapet at the top was blown away landward by the overtop. The land side covered by the grass was eroded deeply by the overflow and return flow.

**Photo 11. Right bank of the Abukuma River mouth, photographed on March 12, 2011 by GSI.**

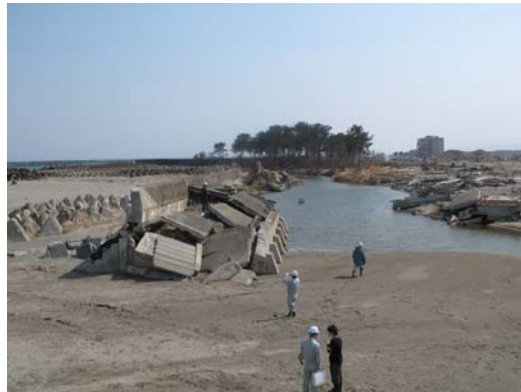
**Photo 12. Broken coastal levee and newly formed channel**

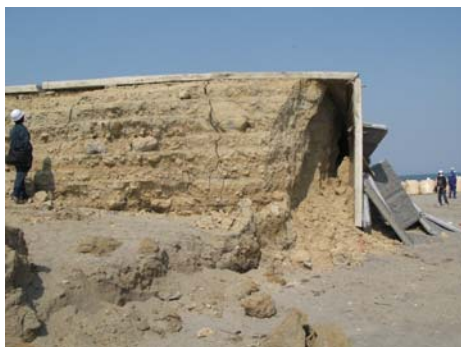
**Photo 13. End section of the river levee.**

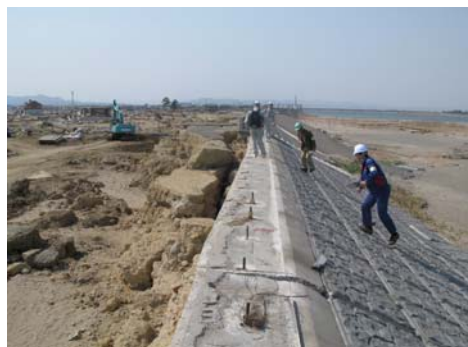
**Photo 14. Three sides of the river levee.**

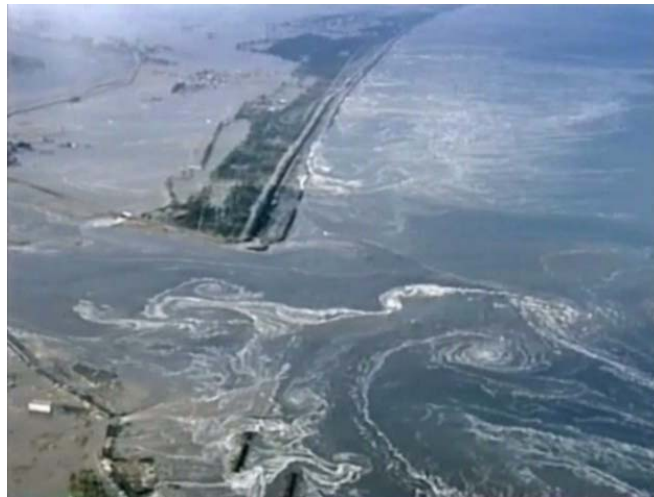
Photo 15 shows the return flow at the Abukuma River mouth taken from "Michinokugo". We can see intense return flow issued from the breach point and large eddies of turbid water which extends wide and far from the levee. Narrow streaks of the return flow issue also from the break points of the recurved parapet as mentioned for Photo 11. Judging from the extension of the turbid water, the break of the parapet occurred fairly before the shot of "Michinokugo", again convincingly by the surging bore of the leading wave.

**Photo 15. Return flow in the sea issued from the breach point, the right bank of the Abukuma River mouth, at 16:33 JST, captured from "Michinokugo" video.**

- The surging bore of the leading wave run-up the riverside slope of the river levee, blew the upright parapet away and eroded the land side of the levee. The bore also hit the recurved parapet of the coastal levee, broke it at several points and intruded into the land.
- Huge amount of seawater on land delivered by the overflow soon started to return back to the sea through the gaps of the broken parapet of the coastal levee. The junction block of the coastal levee was easily moved by the water pressure due to the joints.
- Because the lower structure of the coastal levee remained at the other part, the return flow along the rear side of the levee headed to the breach point by accelerating itself and eroding the bottom. This is the cause of the turbid water and channel formation.

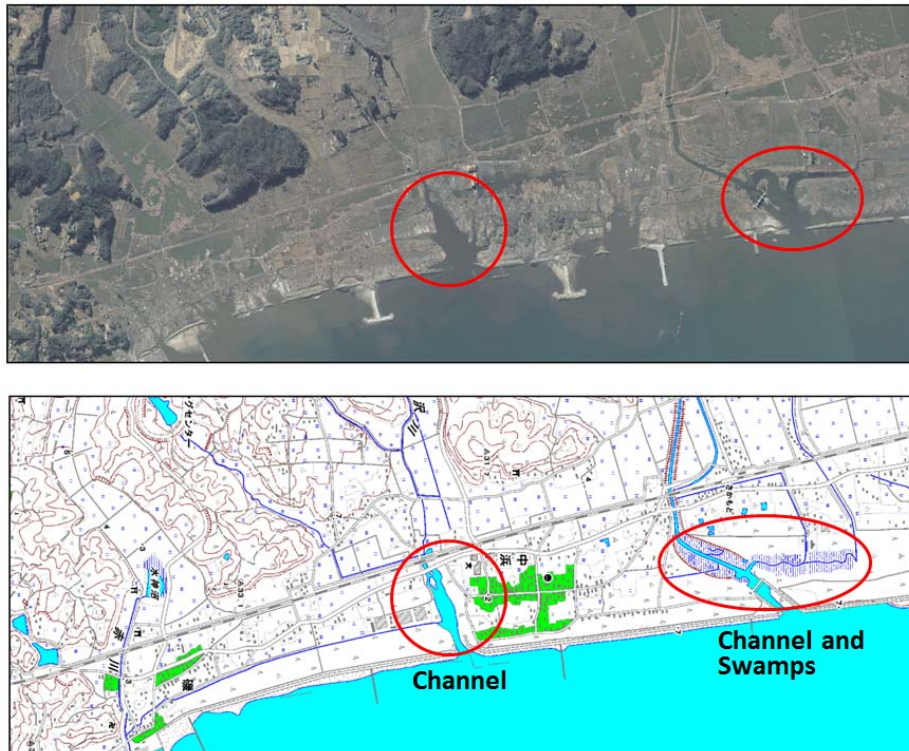
As mentioned on Photos 1 and 2, the Yamamoto Coast was most violently destructed. Photo 16 shows the aerial photo of the southern Yamamoto Coast on March 12, 2011. Encircled places on the photo indicate massive erosion. The places agree with the channels shown in Fig. 7 of the topographic map. This indicates that the huge amount of sea water delivered by the tsunami returned to the sea by concentrating to the channels and eroding the sides and bottom.

Photo 16 (top). Aerial photo of the southern Yamamoto Coast on March 12, 2011 taken by GSI.  
Figure 7 (bottom). Topographic map of the same region measured in 2009 by GSI.

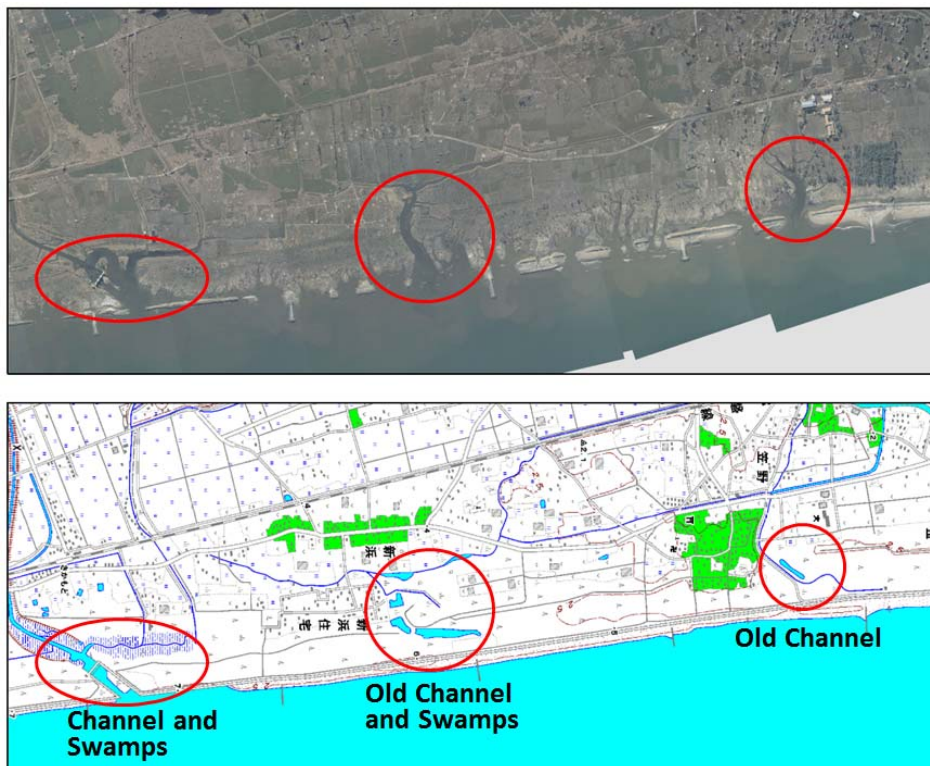
Photo 17 and Fig. 8 show similar conditions of the middle Yamamoto Coast. Swamps and old channels which had dead ends before the tsunami were also the targets of the return flow concentration. The flow extended the dead ends by the erosion while breaking the levee and further extending to the sea. After the tsunami, wide and long inlets were formed.

Photo 17 (top). Aerial photo of the middle Yamamoto Coast on March 12, 2011 taken by GSI.  
Figure 8 (bottom). Topographic map of the same region measured in 2009 by GSI.

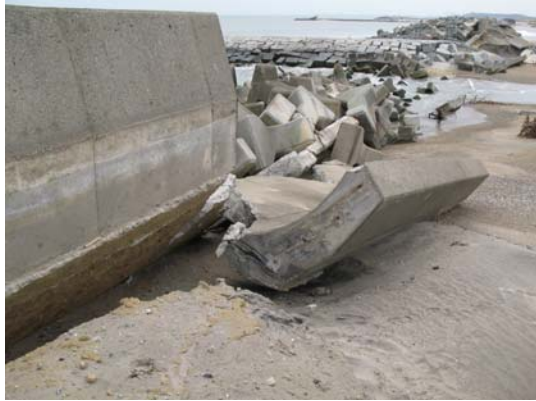
Photo 18 shows breaking of the recurved parapet on the southern Yamamoto Coast. These parapets are much thicker than these of the coastal levees at the Abukuma River mouth and were protected by the wave dissipater blocks. However, they could not keep the shape against the tsunami impact.

Photo 18. Breaking of recurved parapet, southern Yamamoto Coast.

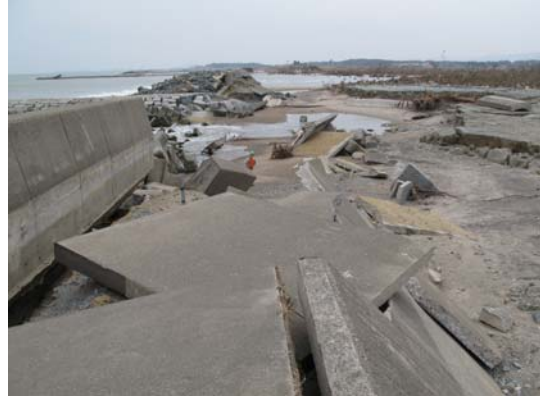
Photo 19 shows the backside of the levee. The top and landward concrete slabs were broken and scattered.

Photo 19. Breaking of the top and landside concrete slabs, southern Yamamoto Coast.

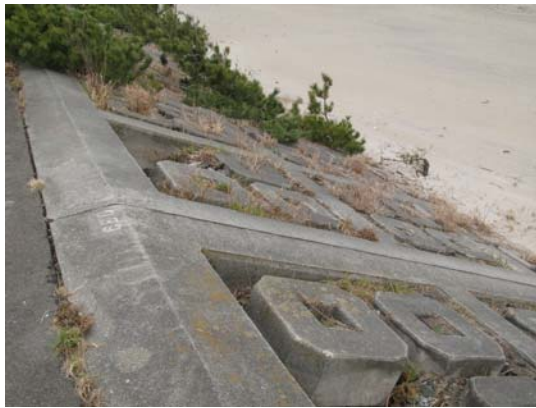
Photo 20 shows the seaside of the levee on the northern Yamamoto Coast. Most of the concrete blocks embedded in the lattices remained, however, in the rear side most of the blocks especially in the lower parts were sucked out and scattered landward. The lattices were also deformed and broken in some places. It is deduced that the structures to block the tsunami impact were broken in most cases and sloped structures on which the tsunami passed through were less broken.

Photo 20. Seaside armor blocks of the levee, northern Yamamoto coast.

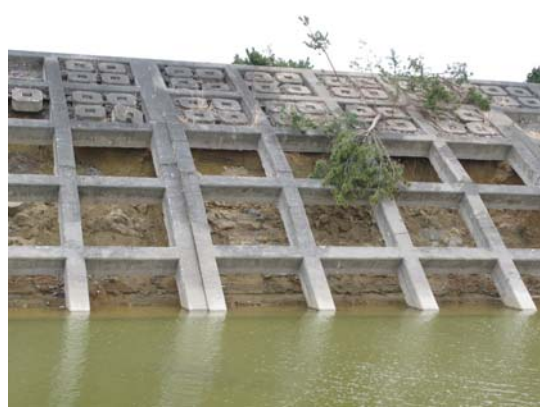
Photo 21. Landside armor blocks of the levee, and a created channel, northern Yamamoto Coast.

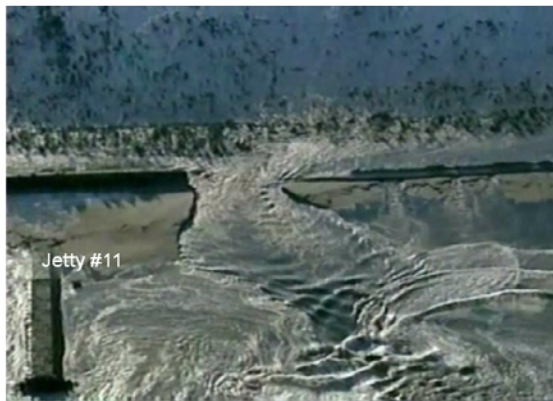
Photo 22. Return flow from the break point at 16:35 JST, March 11, shot from "Michinokugo"

Photo 22 shows return flows along the rear side of the levees and the flows are merged at the break point with the flow through the pine tree woods. The flow concentration causes high erosion to wash the levees from the basement away as shown in Photo 23.

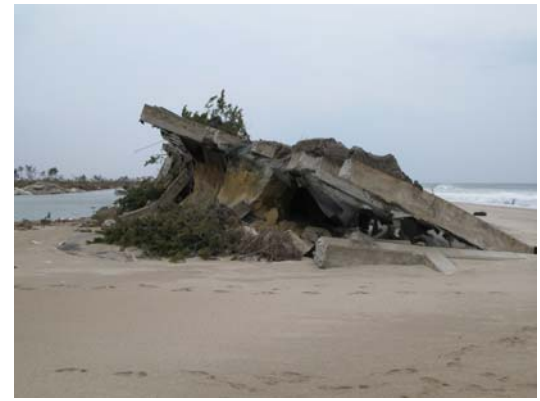
Photo 23. Destructive erosion of the levee at the break pint.

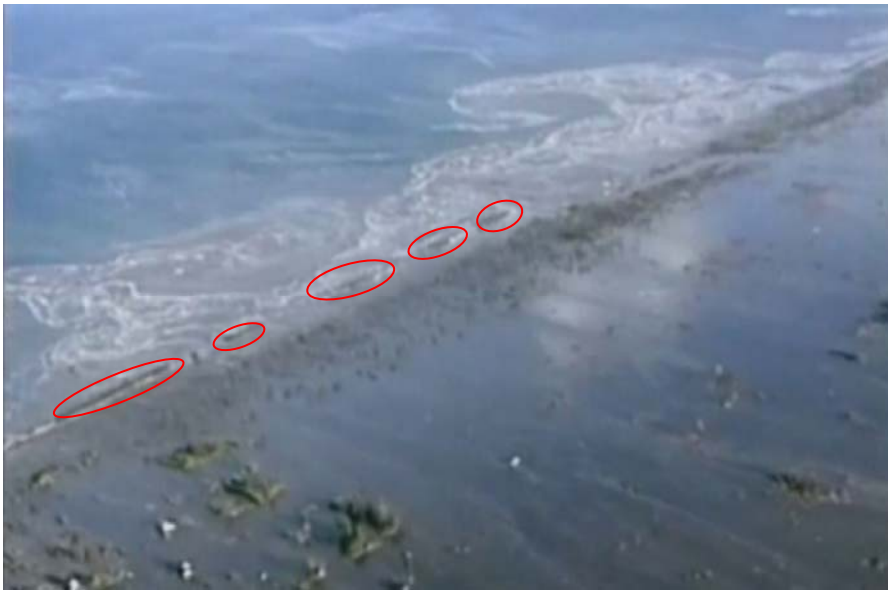
Photo 24 shows the southern Yamamoto Coast shot from "Michinokugo" at 16:39 JST. We can see several segments of the levee above the sea surface. The other part of the levee is submerged. This indicates that the other part of the levee was broken and corresponds to the broken parapet. Widely spread large eddies of turbid water issue from the submerged levee and this suggests again that the parapet was broken by the impact of the surging bore of the leading wave.

Photo 23. Return flows from the break points on southern Yamamoto Coast, at 16:39 JST, March 11, shot from "Michinokugo". Upper left of the photo is the sea. Encircled objects are levees above the sea surface.
