# FAILURE MECHANISM OF KAMAISHI BREAKWATERS DUE TO THE GREAT EAST JAPAN EARTHQUAKE TSUNAMI

*Keywords: Kamaishi breakwater; tsunami overflow; stability of breakwaters*

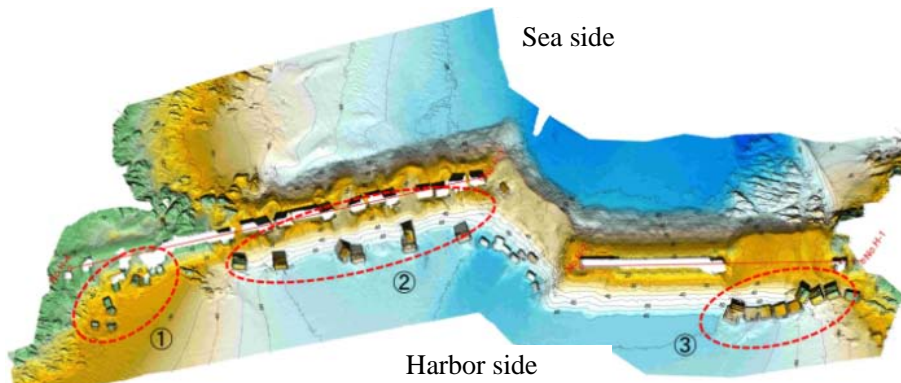
Figure 3. State of damage of breakwater

Fig. 3. shows the state of damage to all the breakwaters, Photo 2. shows the state of damage to caissons near the crest of the North Breakwater, and Fig. 4. shows the detailed state of sliding of the caissons in the deep part of the North Breakwater. This shows that in the deep part at the North Breakwater, many of them slid without leaning after sliding. And Fig. 5. shows the difference between the sections before and after the disaster. On the North Breakwater, the mound was scoured from 5m to 10m.

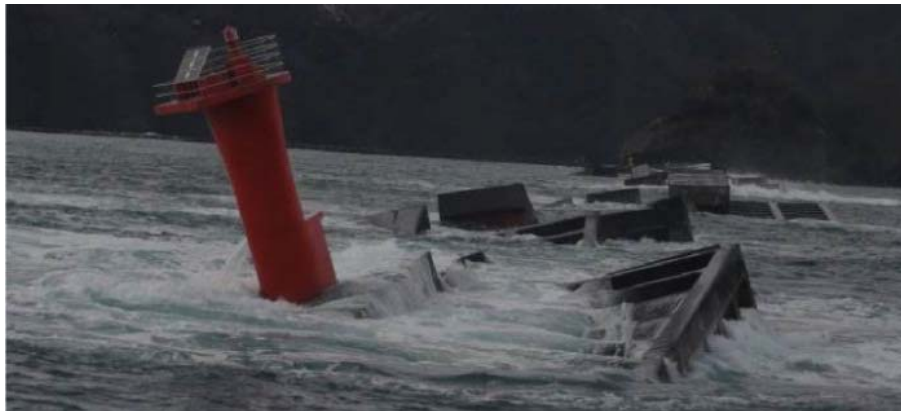
Photo 2. State of damage of North Breakwater

It shows that on both the North Breakwater and South Breakwater, the toe of the slope of the mound on the inside of the bay was not seriously deformed and the caissons slid on the mound. These facts suggest that the caissons could have been gently pulled back inside the bay

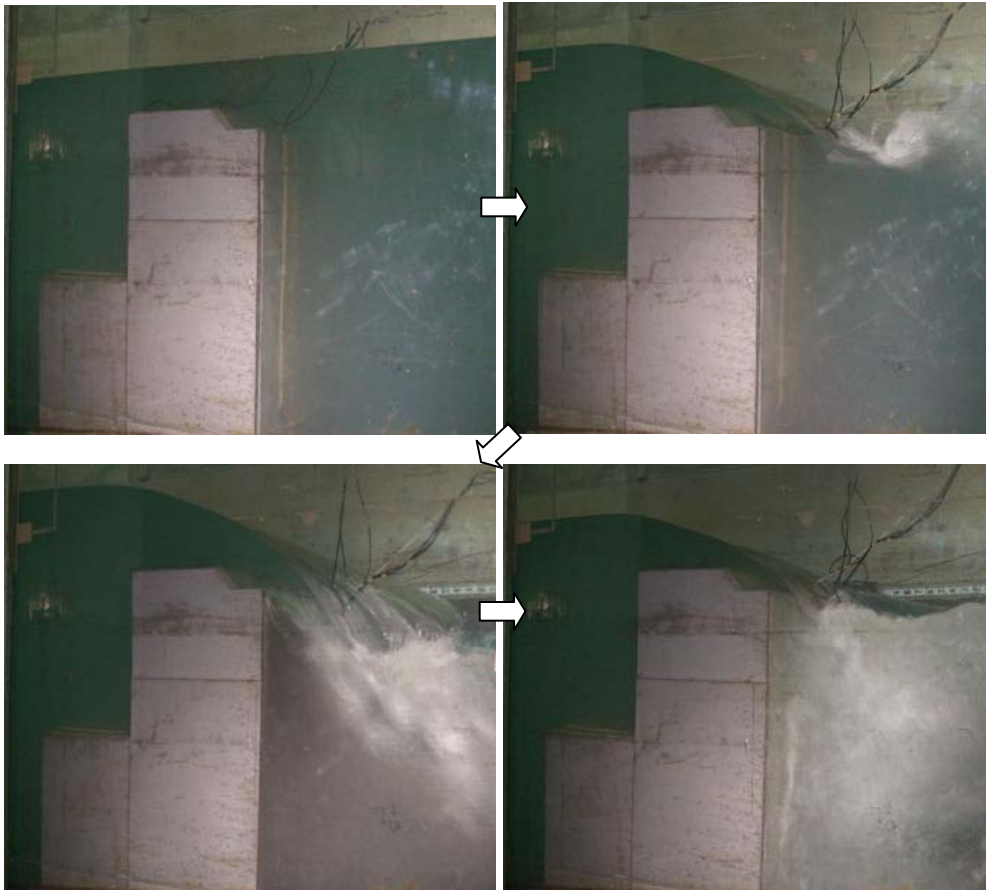
Photo 3. State of experiments (case 1 trial 3)

Photo 3. shows views of the third experiment in Case 1. It shows that as the water level difference was gradually increased from the initial water level, the impact of the overflow in the rear increased, the final state is the state after the caissons are pulled out, and when they were pulled out, the water level difference began its recovery. The caisson which can be observed from the window is the dummy caisson, so its weight is about 10% heavier and it did not slide.

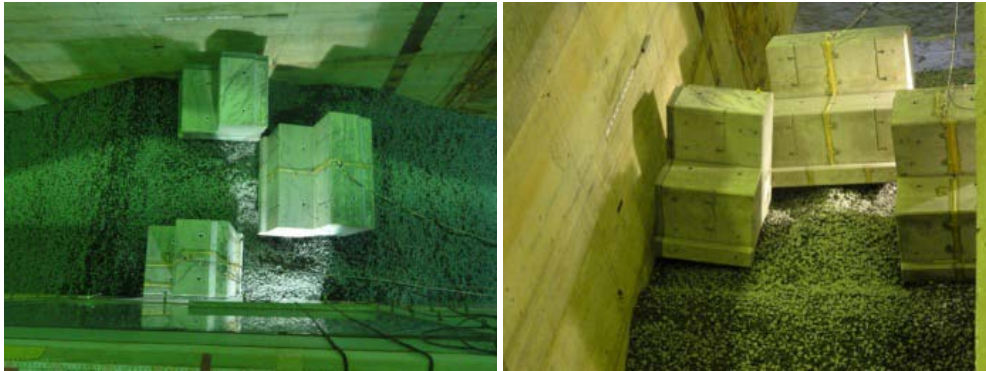
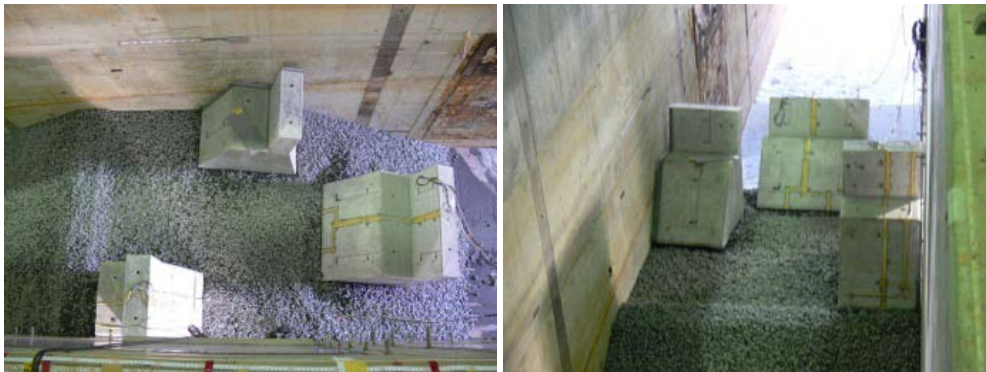
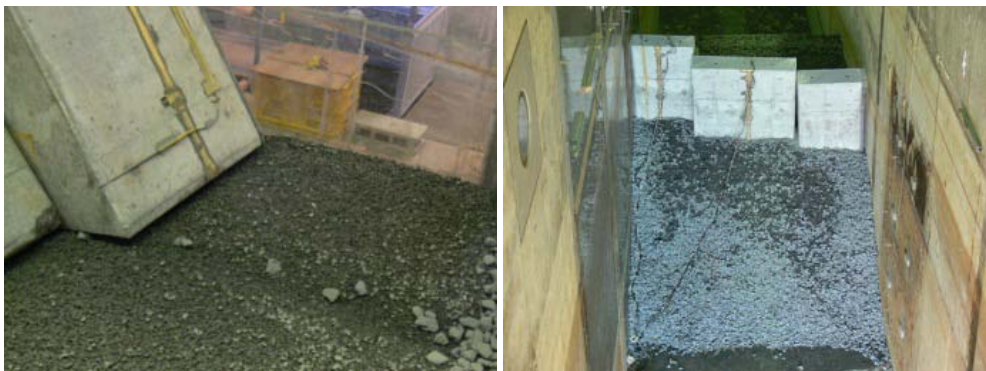
Photo 4 to Photo 6 shows views before and after the third experiment in all cases. Because the water level difference is reduced by the pulling out of the main caissons, the distance it is displaced is shortened, and as shown by Arikawa et al., (2012), it did not slide to the bottom of the mound. The results of an in-site survey show that because the caisson slid to the bottom of the mound, it is possible that force sufficient to move the caisson for a long period of time acted. And even in case 3 where the mound was a small quantity of riprap, no traces of scouring of joints were seen. Observations during the experiments failed to show that the overflowing water mass caused scouring severe enough to reach the back toe of the caissons.
