# DESTRUCTION MECHANISM OF COASTAL STRUCTURES DUE TO THE 2011 TOHOKU TSUNAMI IN THE SOUTH OF FUKUSHIMA

Shinji Sato<sup>1</sup> and Shohei Ohkuma<sup>1</sup>

Destruction mechanisms of coastal structures due to the 2011 Tohoku Tsunami were investigated on the basis of intensive field surveys in the southern part of Fukushima Prefecture. Numerical tsunami simulation was utilized to estimate the tsunami force exerted to the structure. The large difference in water pressure due to overflowing tsunami is found to be the essential mechanism of overturning destruction of coastal structures. The destruction was enhanced by the generation of large impulsive force due to a turbulent bore and the local scour of the foundation. The seaside slope of the seawalls was found to be essential as more significant damage was observed for upright seawalls than gentle slope ones. Inland topography also exerted dominant influences on the destruction of seawalls due to receding tsunami. The joint between the parapet and the seawall basement was considered to be a weak point unless it was appropriately reinforced by steel bars.

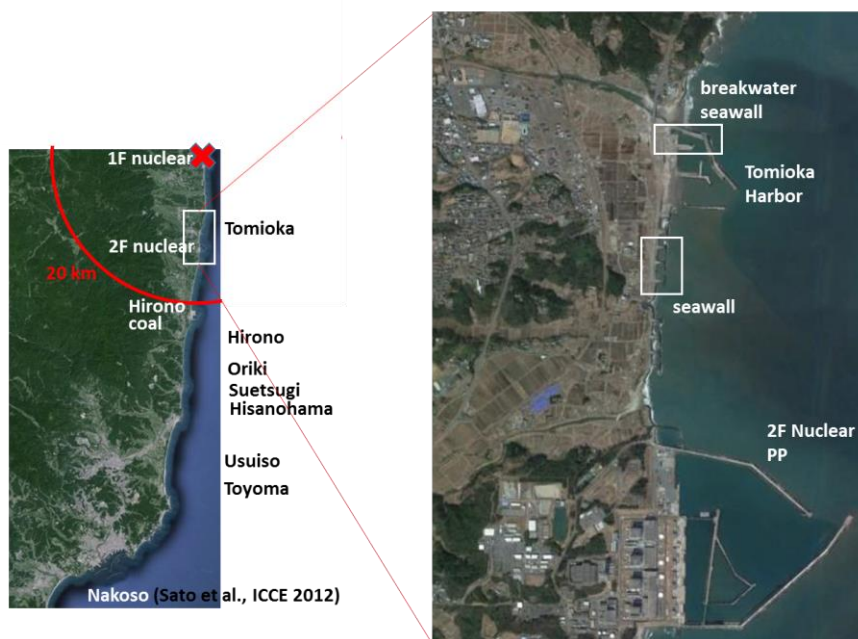
**Figure 2** shows the damage of structures in Tomioka located 7 km south of the Fukushima Dai-ichi Power Plant and 3 km north of the Fukushima Dai-ni Power Plant. Damage of breakwater caissons and seawalls was observed at the Tomioka Harbor. Damage of seawalls was also found 1 km south of the harbor. In the Tomioka Harbor, several caissons of the breakwater were overturned to the harbor side and seawalls were broken at the entrance to the harbor where a gate was installed at the seawall gap as shown in **Figure 3**. The gate was completely destroyed by the tsunami. The entrance road to the harbor was connected to an underpass running through the shore-parallel road embankment.

Figure 2. Damage of seawalls and breakwaters in Tomioka. The Tomioka Harbor is located 7 km south of the Fukushima Dai-ich NPP and 3 km north of the Fukushima Dai-ni NPP.

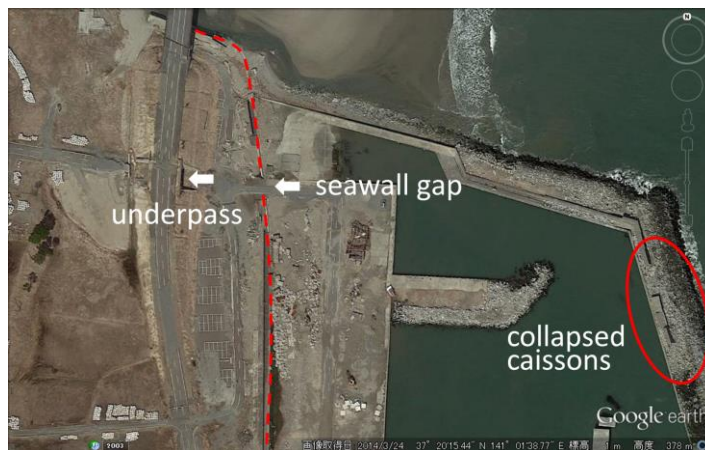
Figure 3. Damage of breakwater caissons in the Tomioka Harbor. Damage of seawalls was significant near the seawall gap connected with an underpass of a shore-parallel road embankment. The embankment appeared to be effective in reducing the tsunami force.

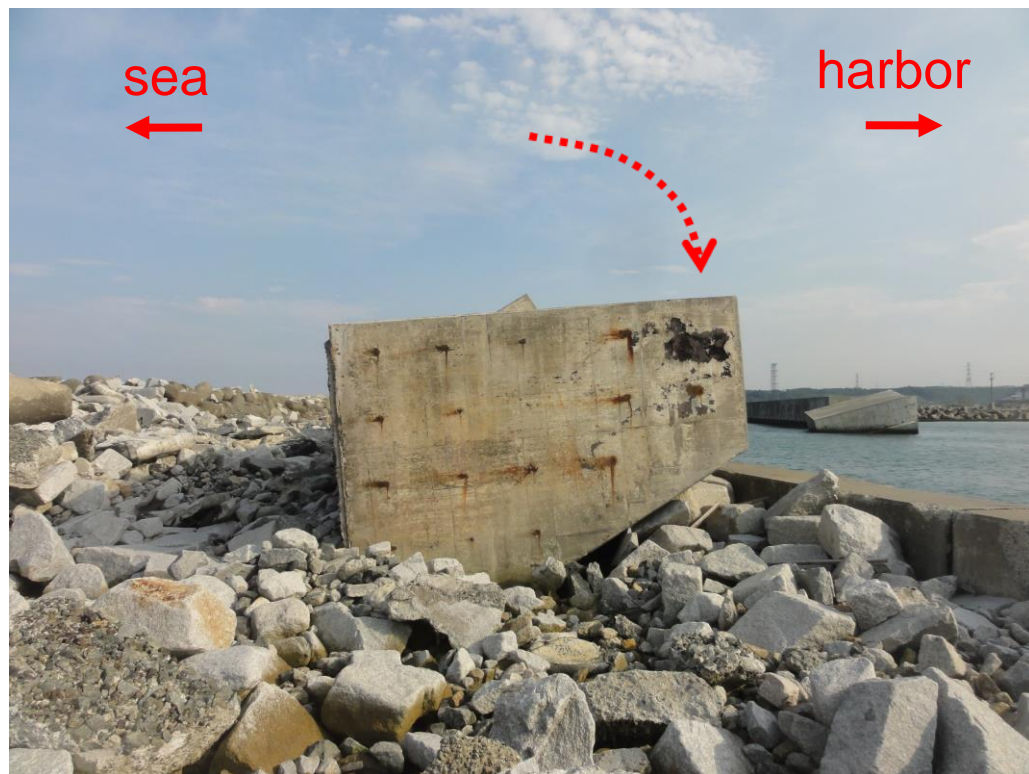
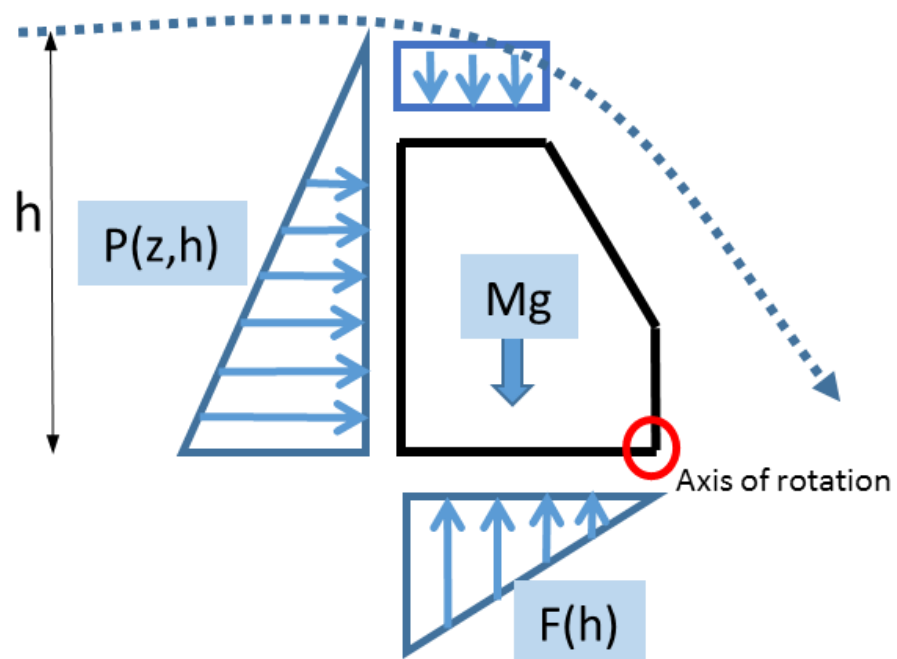
**Figure 4** illustrates collapse of the breakwater caissons at Tomioka Fishery Harbor. The breakwater caissons, 5 m tall and 4 m wide, were considered to be overturned to the harbor side by water pressure

difference due to large tsunami. Assuming the axis of rotation is at the bottom corner of the harbor side, the critical tsunami height for the overturning was calculated as 7.1 m. The water pressure due to tsunami was assumed to be static on the sea side while the water pressure on the harbor side was assumed to be zero since the vertically downward acceleration was large for the flow on the harbor side. The maximum tsunami height computed in the numerical model was 10.4 m. It is therefore confirmed that the difference in water pressure due to overflowing tsunami was large enough to overturn the caissons.

Figure 4. Collapse of a breakwater caisson in the Tomioka Harbor. Several 5 m tall caissons were overturned to the harbor side. The large static water pressure due to large tsunami appeared to rotate the caisson body.

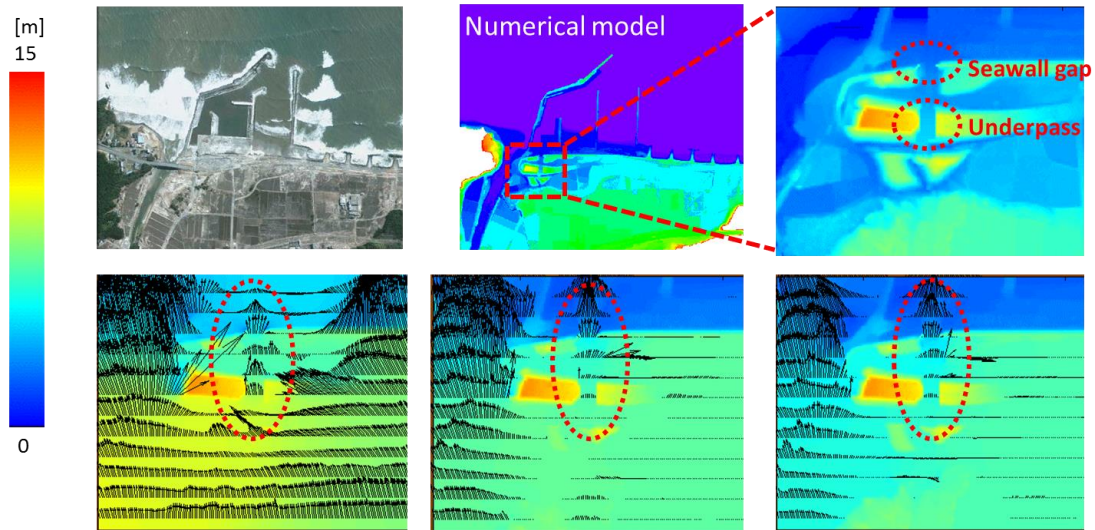
The seawalls located behind the Tomioka Harbor were destroyed by the scour on the landside slope. **Figure 5** illustrates the concentration of tsunami flow near the seawall gap and the underpass. The concentration of tsunami flow is especially significant for receding tsunami. Strong current velocity due to receding tsunami is considered to be the reason for the scour of the landside slope of the seawall. Most of the seawalls located further south from the seawall gap were found intact. A road embankment in parallel to the seawall located 30 m landside appeared to be efficient in weakening the overflowed tsunami as a two-line embankment.

Figure 5. Concentration of tsunami to the seawall gap and the underpass simulated near the Tomioka Harbor. The figures on the bottom display the concentration of receding tsunami flow at the gap/underpass location.

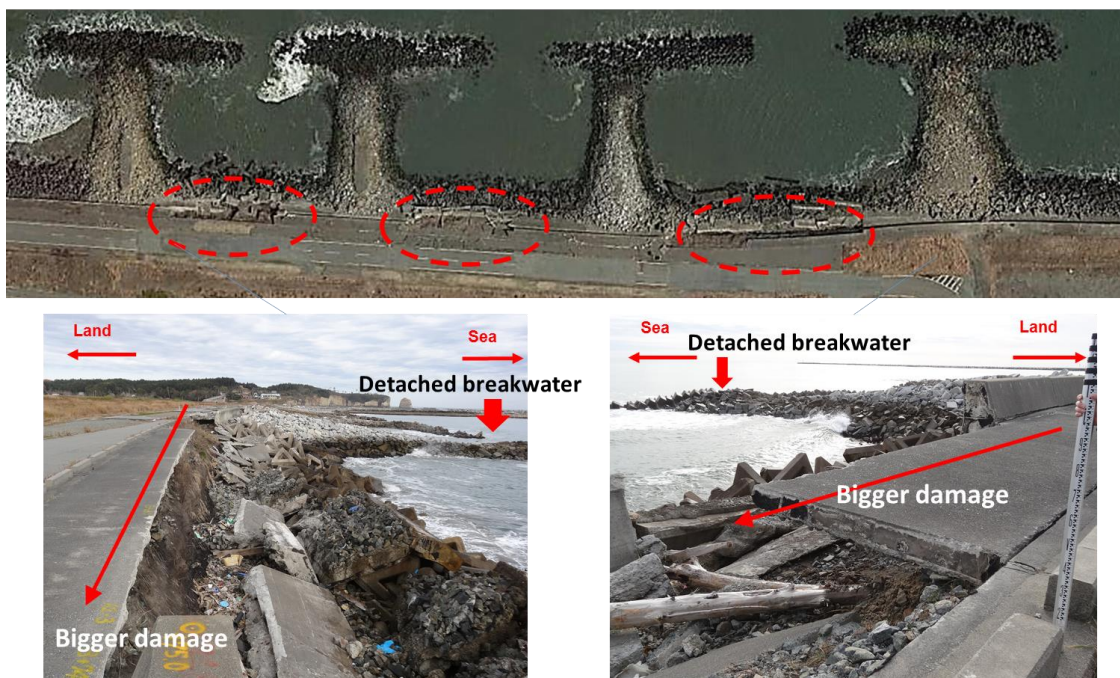
The coast located 1 km south of the Tomioka Harbor was protected by a series of detached breakwaters and seawalls. Most of the detached breakwaters appeared to be intact while seawalls were partially destroyed by the tsunami. **Figure 6** illustrates the damage of seawalls. The damage appeared to be significant at the gap of detached breakwaters. The computed tsunami demonstrated the concentration of incoming tsunami to the gap location in a similar way to **Figure 5**. These examples showed that the gap of structures must be considered as a weak point for the tsunami.

Figure 6. Damage of seawalls south of the Tomioka Harbor. The damage was significant at the gap of detached breakwaters.

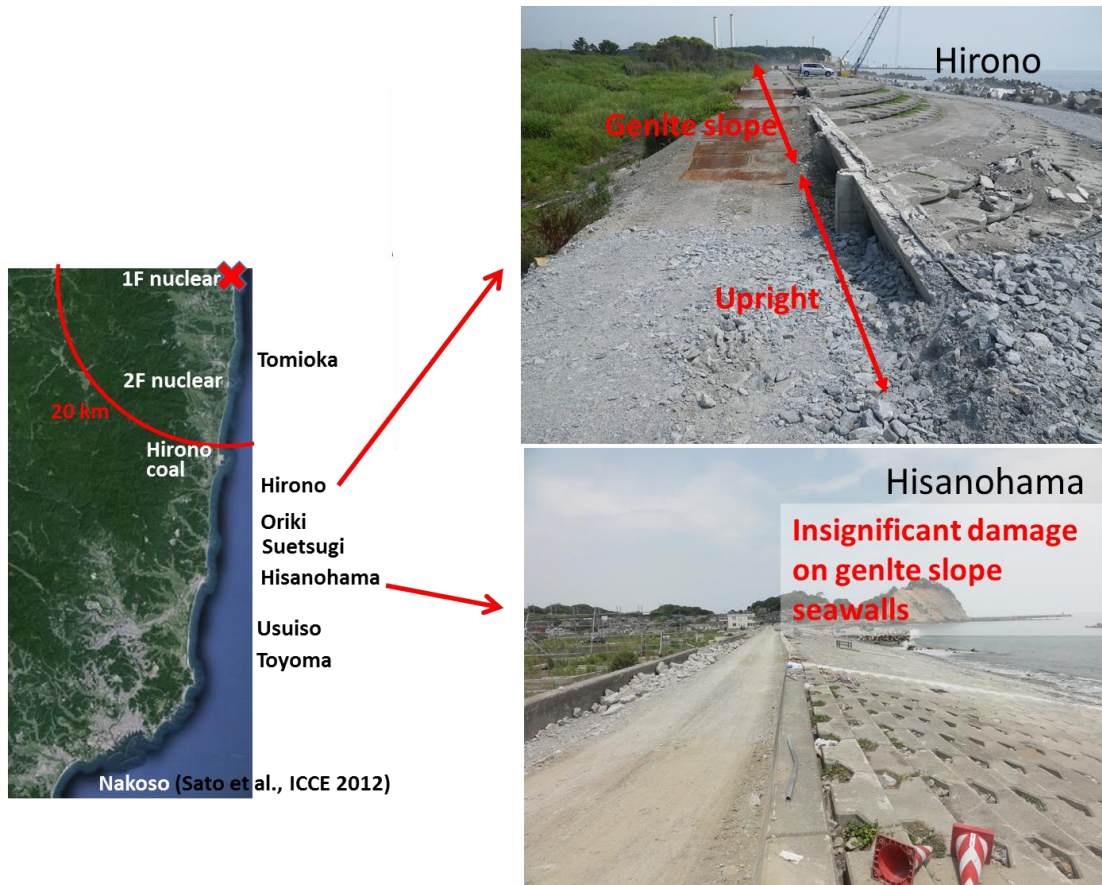
The seaside slope of seawalls were found to be essential in the destruction mechanism. Seawalls in Hirono are composed of upright dikes in the north part and gentle slope seawalls in the south part. **Figure 7** shows the damage of seawalls in Hirono and Hisanohama. In Hirono, gentle slope seawalls were connected to upright seawalls. **Figure 7** demonstrates that the damage of the upright seawalls was serious while the damage of the gentle slope seawalls was very small. Gentle slope seawalls were also found mostly intact in Hisanohama. This is considered to be due to the larger wave force exerted to upright seawalls than to gentle slope seawalls. Although many upright seawalls were broken in this area, some of upright seawalls in Hirono and Naraha were found survived in case they were supported by inner partition walls. The partition walls were placed every 10 m section. Seawalls without partition walls were mostly collapsed after the scour of filled sand as explained in the Tomioka Harbor. Seawalls with inner partition walls are therefore considered to be one of tenacious structures for overflowing tsunami.

**Figure 7.** Damage of seawalls in Hirono and Hisanohama. The damage of seawall was smaller for gentle slope seawalls.

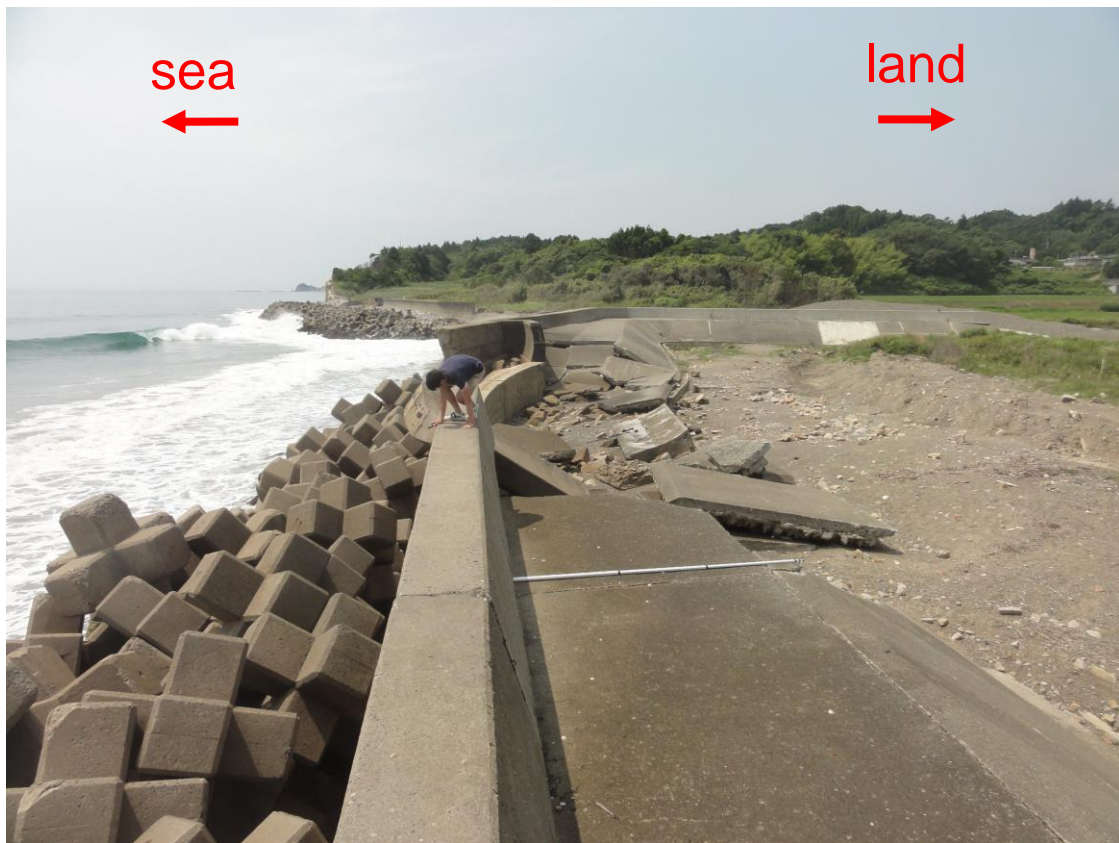
**Figure 8. Damage of seawall in Oriki. The parapets with 1.5 m height were broken and transported about 50 m inland. A large scour hole is observed behind the seawall.**

Collapsed seawalls in Oriki and Suetsugi, Iwaki City, displayed another contrast in terms of destruction mechanisms. The upright seawalls in Oriki were found to be collapsed at the joint between the parapet and the basement although they were connected with steel bars with 19 mm diameter (**Figure 8**). The height of the parapet was about 1.5 m. The broken parapet was transported inland with maximum distance of about 50 m. On the other hand, sloping seawalls in Suetsugi were found to be overturned to seaside (**Figure 9**). The destruction mechanisms of these two seawalls were investigated by using computed tsunami properties.

In Oriki, the seawall parapet was found to be destroyed when the tsunami was larger than 11.4 m. The maximum tsunami height at Oriki computed by the numerical model was 8.2 m. Therefore, the static water pressure alone was insufficient to cause the destruction. Asakura *et al.* (2000) demonstrated by hydraulic experiments that the maximum impulsive pressure due to broken bores was three times as large as the pressure due to unbroken bores with the same height. If the incoming tsunami formed a broken bore at Oriki, the wave force due to the broken bore with height of 8.2 m must have been large enough to destroy the structure. It is noted that the tsunami attacked in the form of a broken bore in Naraha, 3 km north of Hirono (Sanuki *et al.*, 2013). In Suetsugi, on the other hand, the maximum tsunami height was computed as 5.9 m and the sloping seawalls were found stable to the onshore force due to the incoming tsunami even in case the impulsive force of broken bores was applied. However, it could be turned over to seaside if the water level of the receding tsunami at the land side was higher than 5.9 m. It was considered that the receding tsunami flow concentrated to the damaged section of seawalls since they were found near the mouth of a small stream.

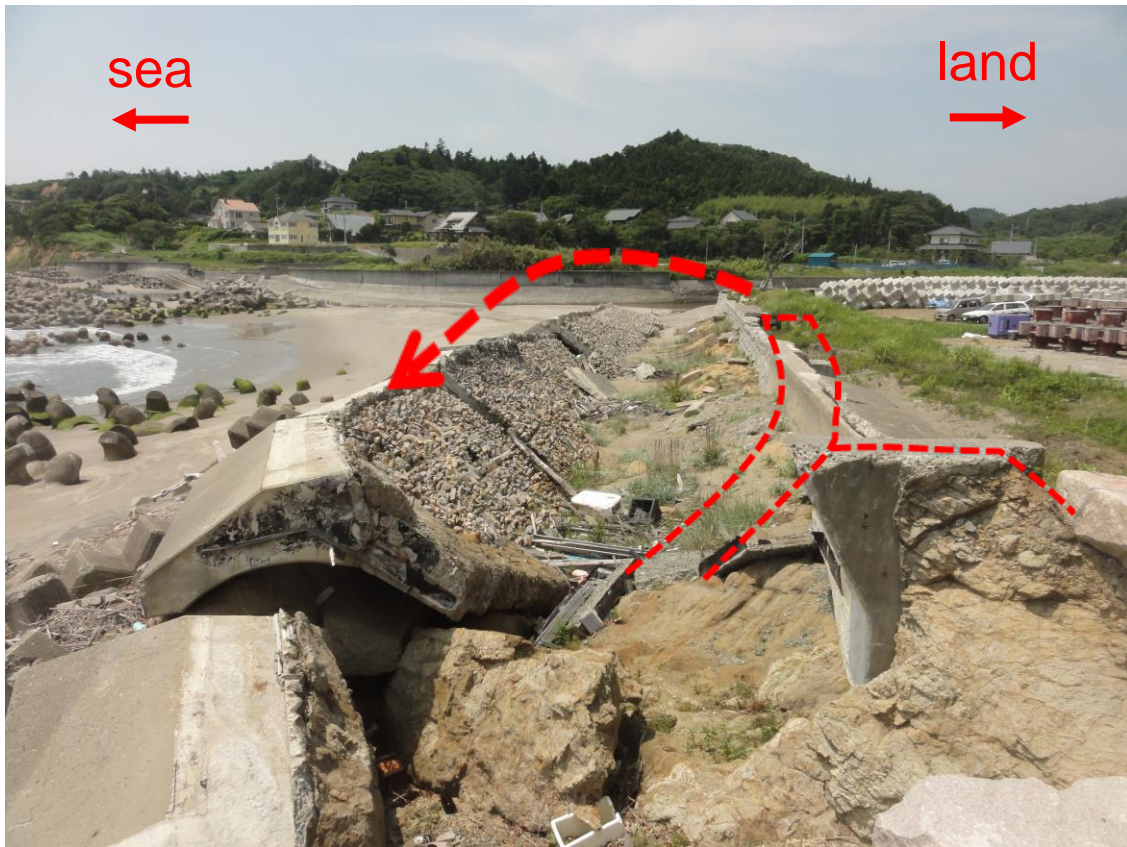
Figure 9. Damage of seawall in Suetsugi. The concrete plate on the seaside slope with parapet was overturned to the sea side. The original location of the concrete plate is illustrated by the red dashed line.

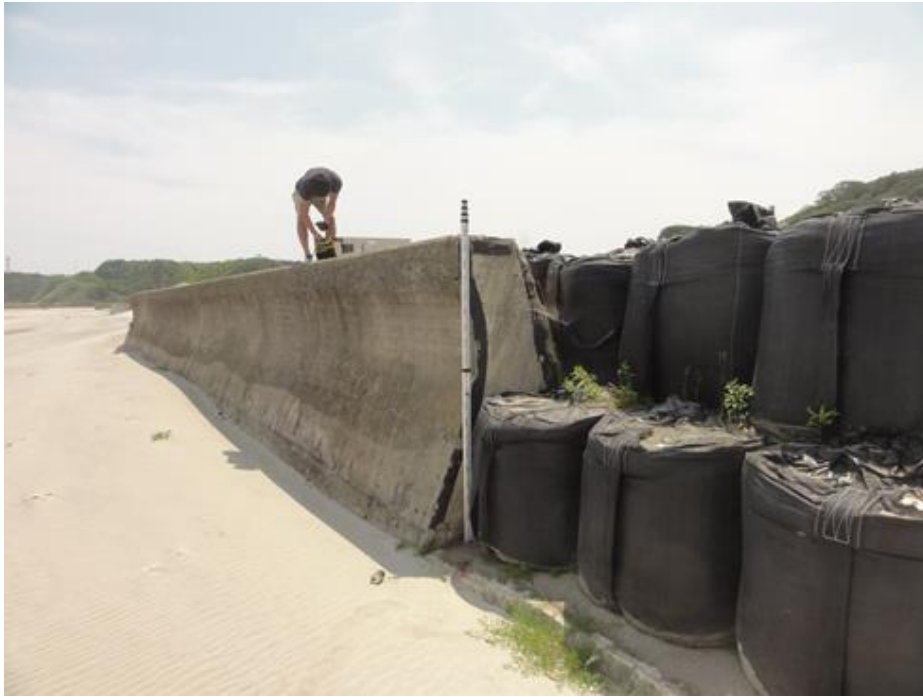
In the southern part of the study sites, Usuiso, Toyoma and Nakoso, damage of seawalls was concentrated to the parapet. **Figure 10** shows broken parapets in Usuiso and **Figure 11** shows those in Toyoma. Although the seawalls in Toyoma were broken in the middle of the parapet as shown in **Figure 11**, most of the seawalls were broken at the joint between the parapet and the basement. The location of the failure appeared to be dependent on the ground level on the land side. The collapse of seawalls at the joint is also reported in Nakoso by Sato *et al.* (2012). The enforcement of the joint is considered to be another key point in strengthening the structure.

Figure 10. Damage of seawall parapet in Usuiso. The height of the parapet is about 2 m. The seawall was broken at the joint between the parapet and the basement. Black sand bags were placed as temporal recovery.

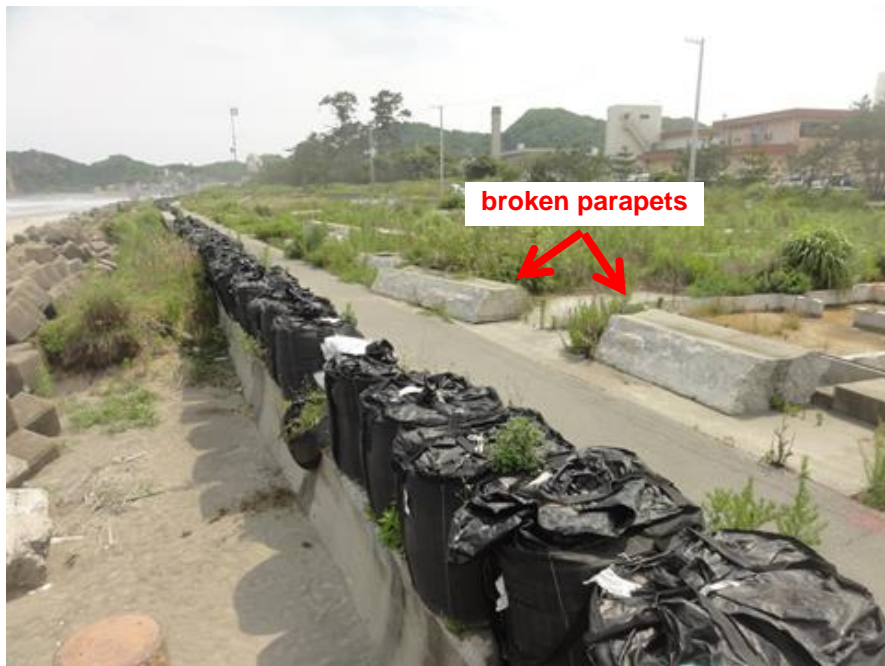
Figure 11. Damage of seawall parapet in Toyoma. The seawall was broken in the middle of the parapet. Broken parapets were transported inland. Black sand bags were placed for temporal recovery.
