SMALL BUILDING PERFORMANCE IN HURRICANE IKE ON THE BOLIVAR PENINSULA

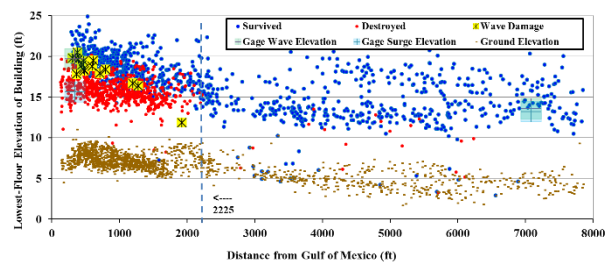
Analysis will include a comparison of the storm surge and wave modeling ability to predict building damage. Pre- and post-storm Flood Insurance Rate Maps will be compared to survival or failure of the buildings on an individual and community scale. Preliminary results are shown in Figure 1. Depth damage curves will be developed and the uncertainty evaluated.

Figure 1 - Building damage distribution by floor elevation and distance from the Gulf of Mexico (Rogers, 2015).
