SMALL BUILDING PERFORMANCE IN HURRICANE IKE ON THE BOLIVAR PENINSULA

Spencer Rogers

This study: H. Ike Three phases

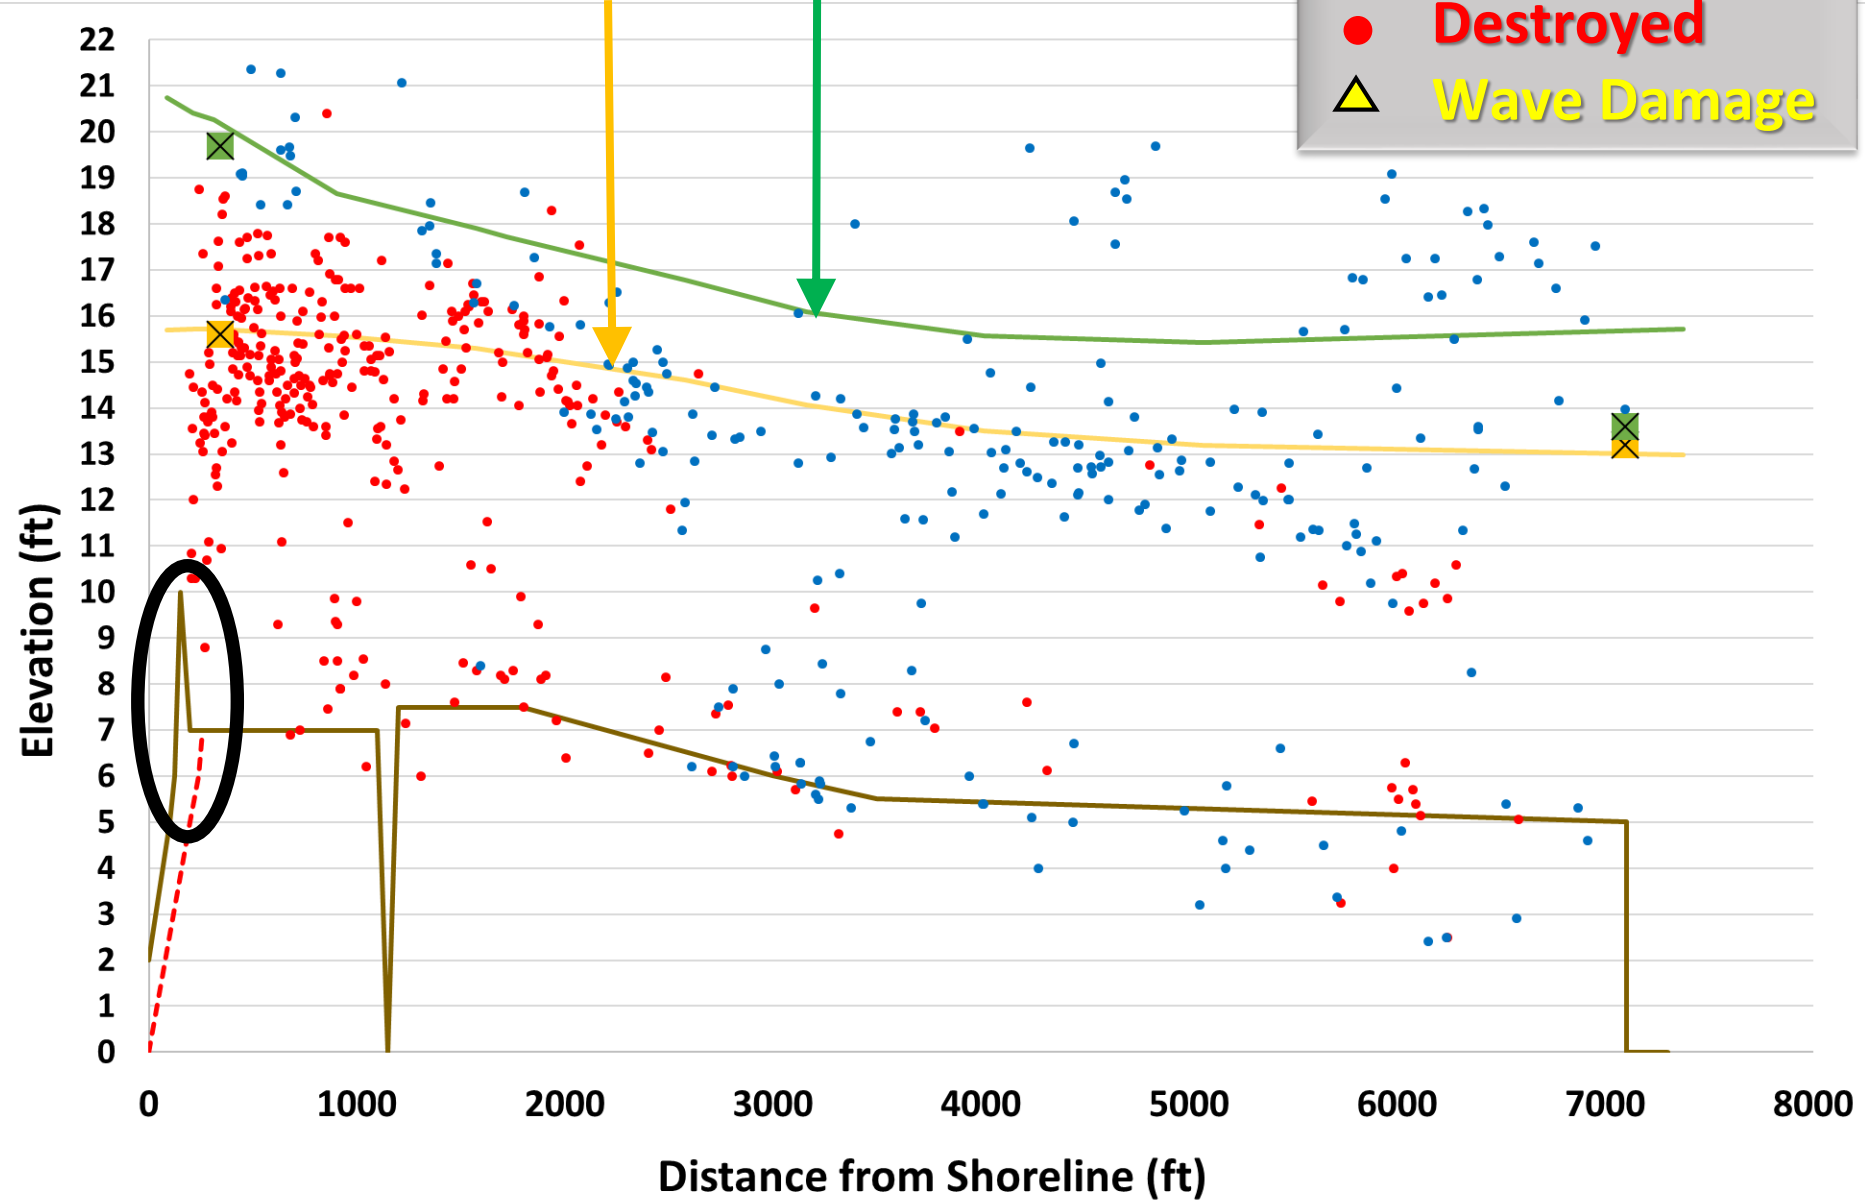
Cross-Shore Lowest Floor Elevation Relative to ADCIRC Wave Elevation

STRUCTURES = 4337

● Survived = 1505

● Destroyed = 2813

▲ Wave Damage = 19

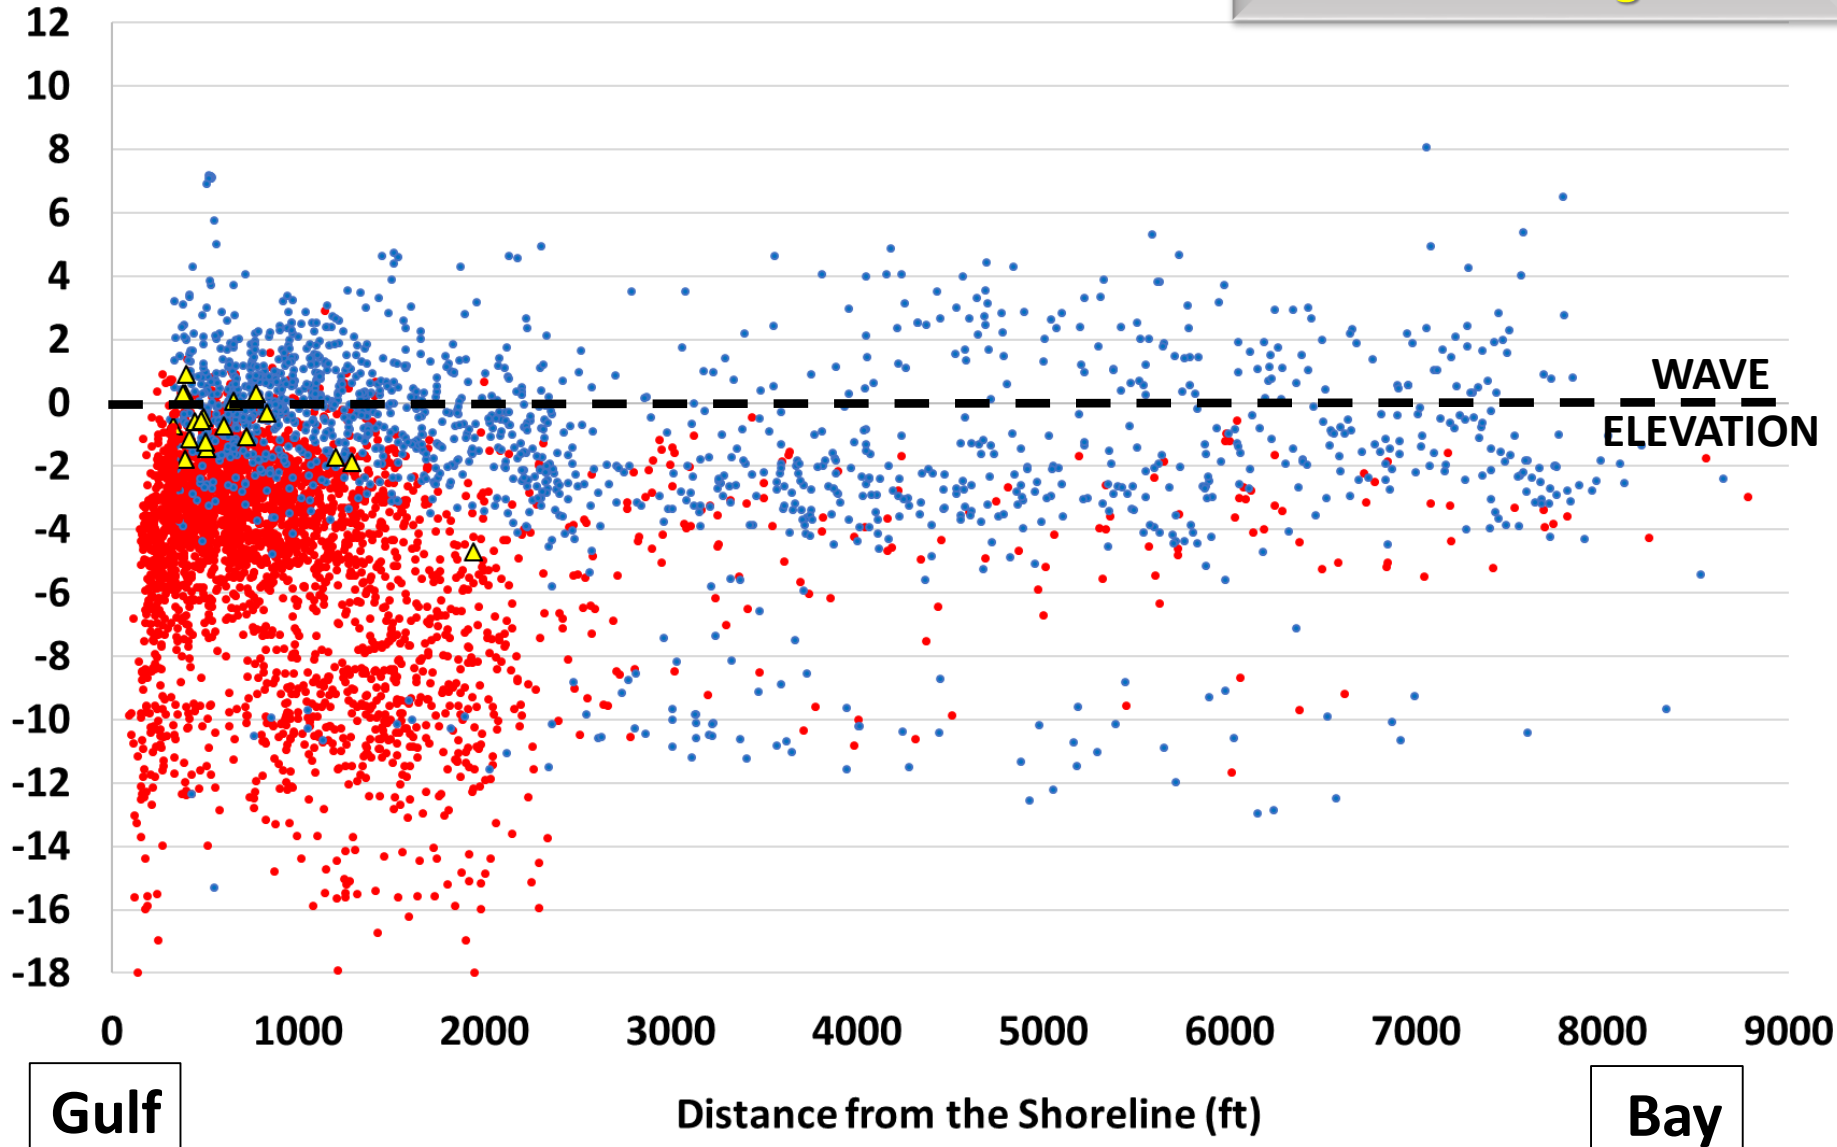
Potential Erosion Failures

Cross-Shore
Lowest Floor Elevation Relative to
ADCIRC Wave Elevation

- Survived
- Destroyed
- ▲ Wave Damage
- Erosion Failure? = 303

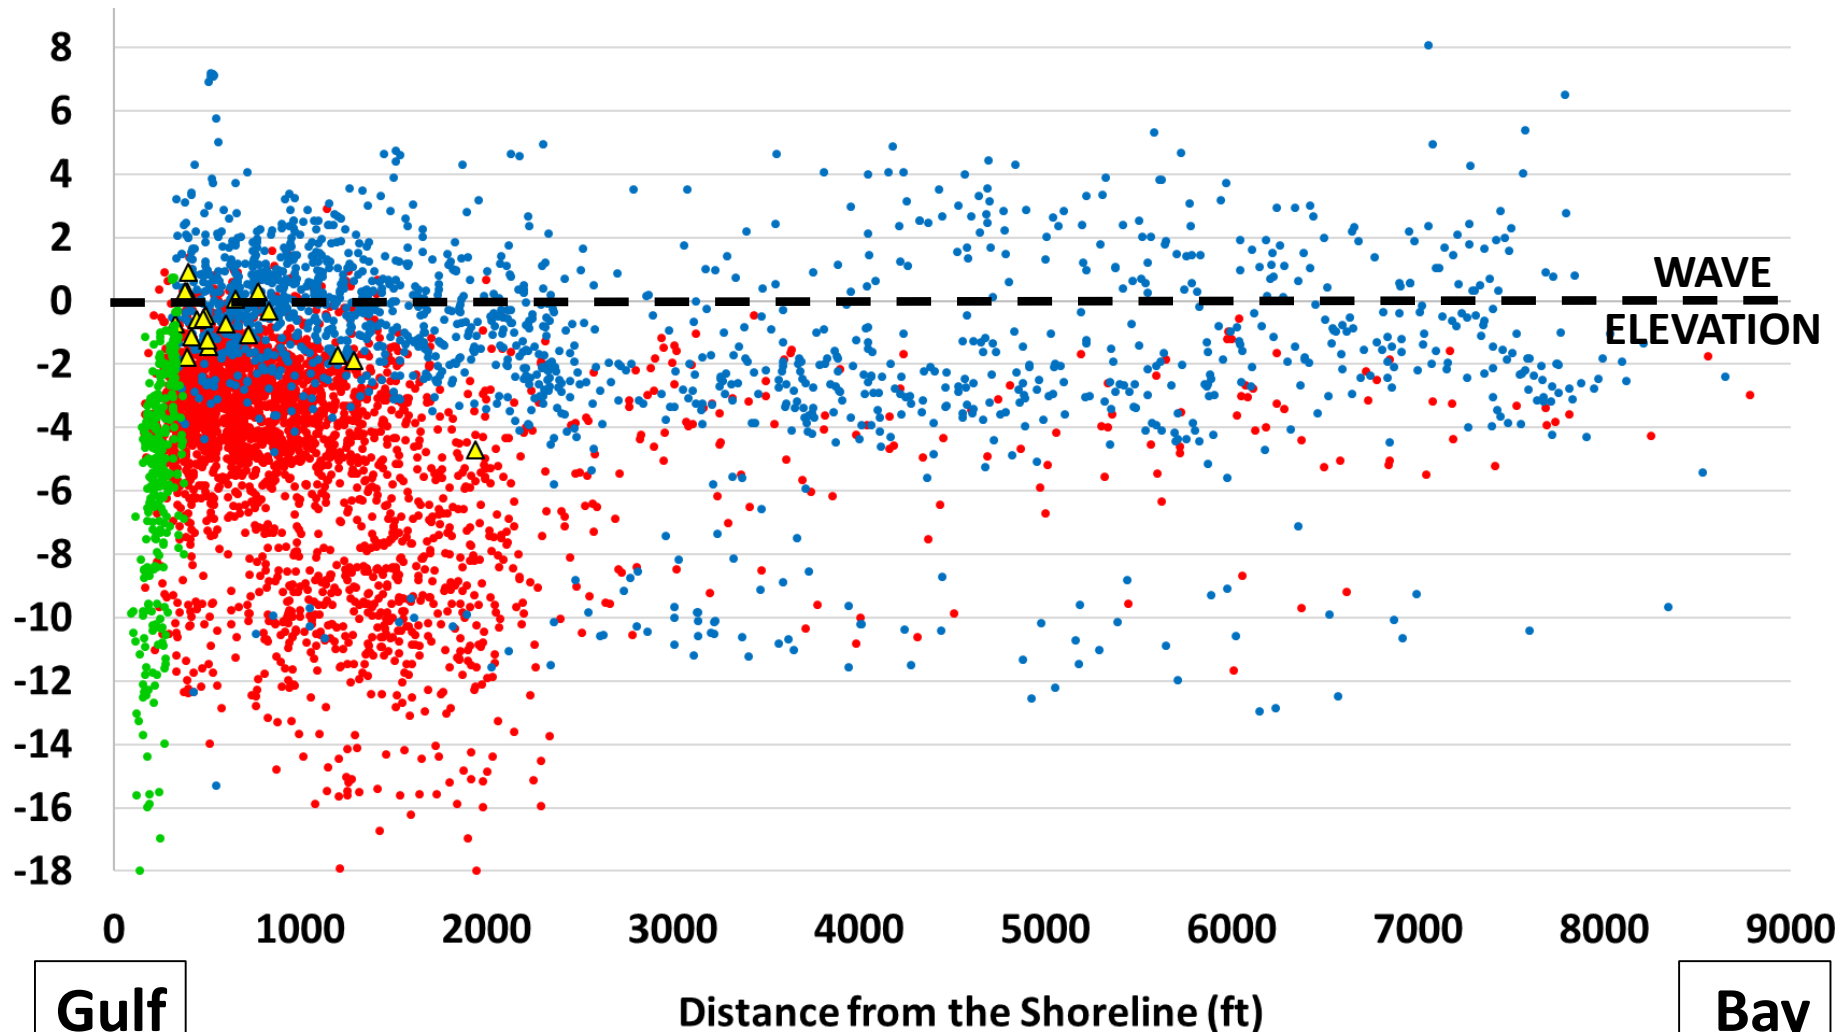
Wave Failures

Cross-Shore
Lowest Floor Elevation Relative to
ADCIRC Wave Elevation

STRUCTURES = 4337

● Survived = 1505

● Destroyed = 2510

▲ Wave Damage = 19

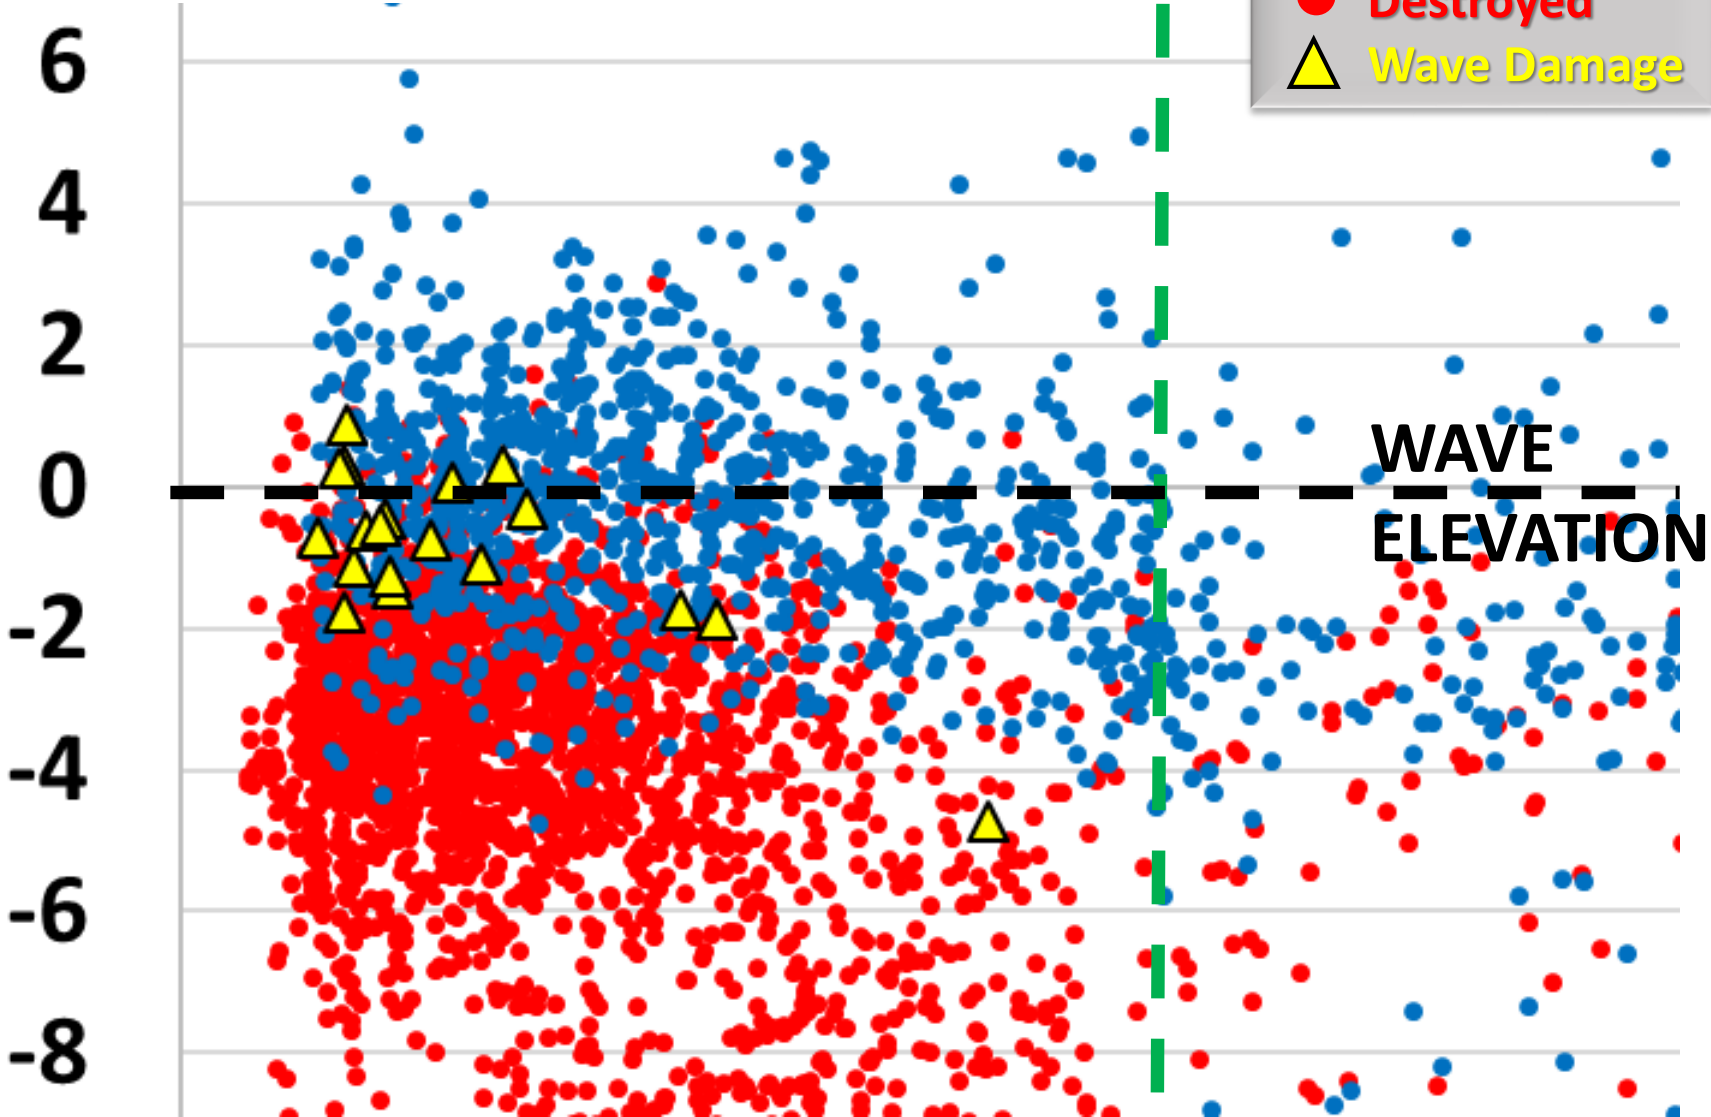
Breakaway Walls

WALLS DESIGNED
FOR 125 MPH WINDS

FAILED in

~1.5-ft WAVES

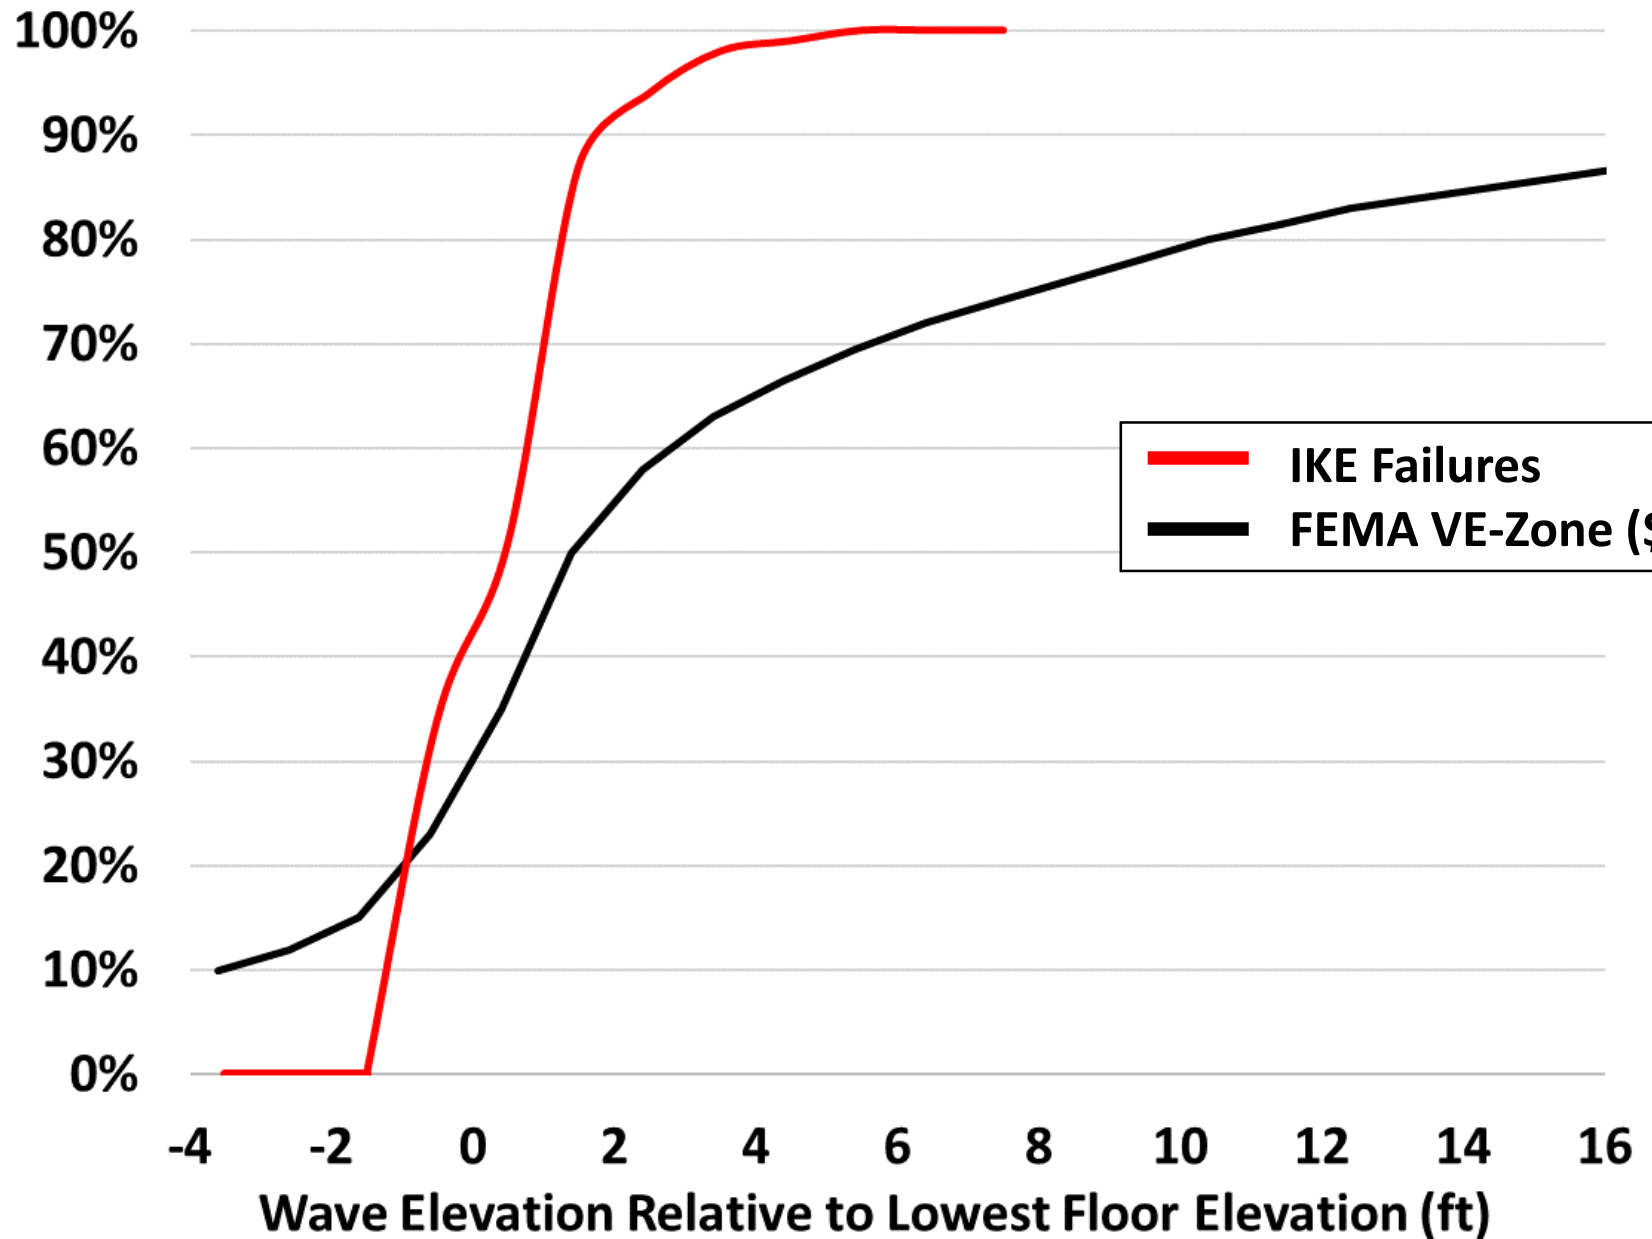
Building Damage Variability with Flood Depth

**Risk of Failure Relative to Peak Wave Elevation above
Lowest Floor Elevation (LFE): $\leq 500'$ from Shoreline for ADCIRC**

- **Depth/damage begins at bottom of floor joists**
- **Failure ~100% at 5' higher**
