BATTLING THE BERING SEA: ST. GEORGE ISLAND'S BERM BREAKWATER

Philip J. Blackmar¹ and Ronald L. McPherson²

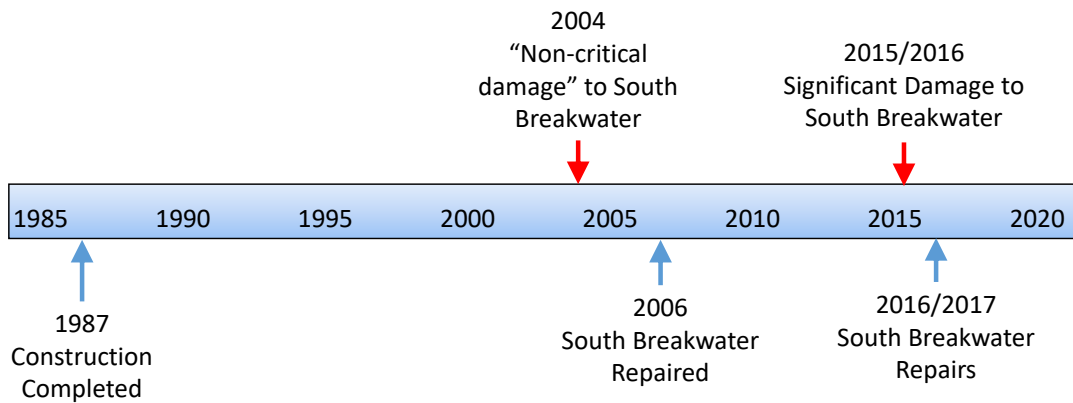
A strong indication of the success of the berm breakwaters at St. George is the minimal maintenance and repair work performed in the approximately 30 years since construction. Figure 3 shows a timeline of the documented damage occurrences and the associated repairs. The first documented damage to the breakwaters occurred in 2004, approximately 17 years after construction (PND, 2008). This damage event displaced stone from the breakwater cross-section, but review of survey drawings from the repairs design shows minimal to no loss of the breakwater crest elevation, therefore leaving the harbor functioning (PND, 2007). Repairs for the 2004 damage were constructed in 2006 and consisted of placing 18,000 tons of 6 to 12 ton armor stone on the south breakwater. The next, and most recent, documented damage occurred during the winter of 2015 and 2016 when the crest of the south breakwater arm was displaced. This event was approximately 27 years after construction and displaced approximately 29,300 tons of armor stone on the south breakwater (HDR, 2017).

Figure 3. Timeline showing St. George breakwater damage and associated repairs.

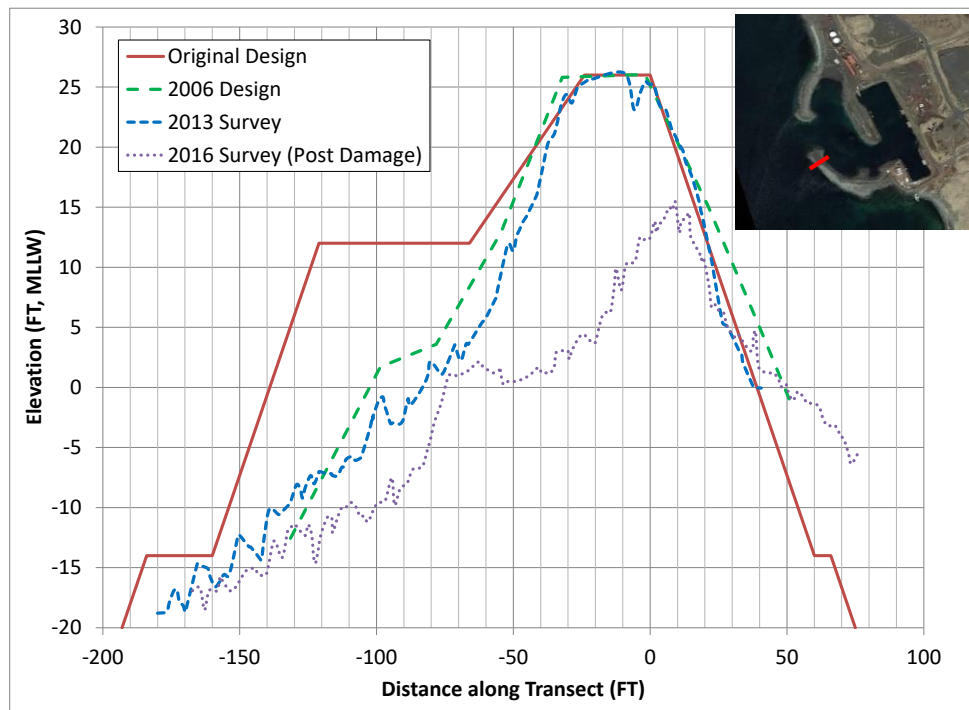
Figure 4. Breakwater cross-section comparison of original design (digitized from PND, 1984), 2006 survey data (data digitized from PND, 2007), 2013 survey data (HDR, 2013), and 2016 data (HDR, 2017). Inset on right shows the location of the survey cross-sections.

Numerous conclusions can be deduced from Figure 4. Of most significance is that the berm portion of the breakwater only appears in the design template, but not in any of the subsequent surveys. It is important to note that the first post-construction survey section is from 2006, almost 20 years after construction. One potential explanation for loss of the berm armor stone is longshore transport of the stone. Movement of the berm stone over the project life was expected as the project was designed to be dynamically stable (or "reshaping"). It is expected that the basalt armor stone degraded over time with constant wave forcing and undergoing freeze and thaw cycles. Reduction in size of the stone by degradation would have increased potential for armor stone movement. Therefore berm material may

have been pushed southward during large wave events due to the oblique orientation of the south breakwater arm. Armor stone accumulation was apparent on some southern portions of the south breakwater in the 2013 survey and analysis (HDR, 2013) and in aerial photographs. Armor stone movement may also have resulted in displacement of stone further offshore. Another possible explanation for the loss of berm material is settlement into the sand bottom. As the armor stones were continuously impacted by waves, movement of some of the stone may have gradually caused them to settle deeper and deeper into the seafloor. In reality it is likely a combination of these damage mechanisms that occurred.

Additional armor stone from the central portion of the breakwater section appears to have been lost between the 2006 and 2013 cross-sections, and then ultimately the 2016 survey cross-section shows loss of the breakwater crest. The intended design function of the berm breakwater requires the presence of the berm to allow for some reshaping of the breakwater and to dissipate wave energy prior to waves impacting the remainder of the structure. From the information available it is unclear how quickly the berm portion of the breakwater was lost, but based on the lack of documented damage prior to 2004 it is expected that the berm was present to some degree for over a decade after construction.

One additional and noteworthy observation from Figure 4 is that the crest elevation of the breakwater remained relatively stable until the 2016 storm event. The crest elevation of the breakwater is imperative to prevent significant wave energy from overtopping into the harbor and creating hazardous conditions. The stability of the breakwater crest for approximately 27 years is a significant achievement for the project and lends to the success of the design.

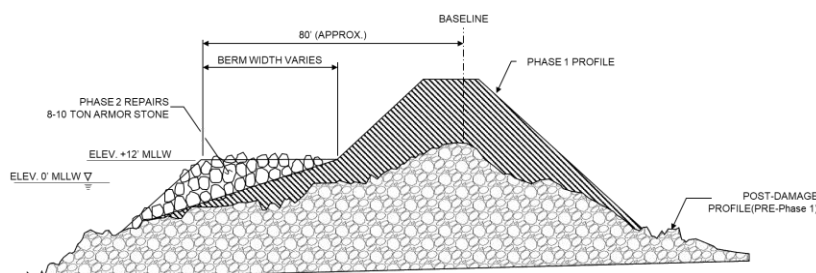
The design analysis for Phase 1 identified that the remaining stone in the breakwater cross-section was focused on the leeward side of the original structure. This was attributed to the damage mechanics and larger wave forces on the seaward slope. To reduce volumes necessary to complete the Phase 1 repairs, the centerline of the breakwater crest was shifted landward to center over the remaining armor stone.

Figure 5. Comprehensive cross-section of Phase 1 and Phase 2 repairs to the south breakwater at St. George Harbor.

Phase 1 repairs applied a composite breakwater slope on the seaward side with a 4H:1V slope in the lower portion of the breakwater below the +12 ft MLLW contour and a 1.5H:1V slope on the upper section. The composite slope allowed for greater stability in the lower portion of the breakwater cross-section while still meeting the elevation requirement for the crest. Figure 5 shows a cross-section of the Phase 1 and Phase 2 repair design.

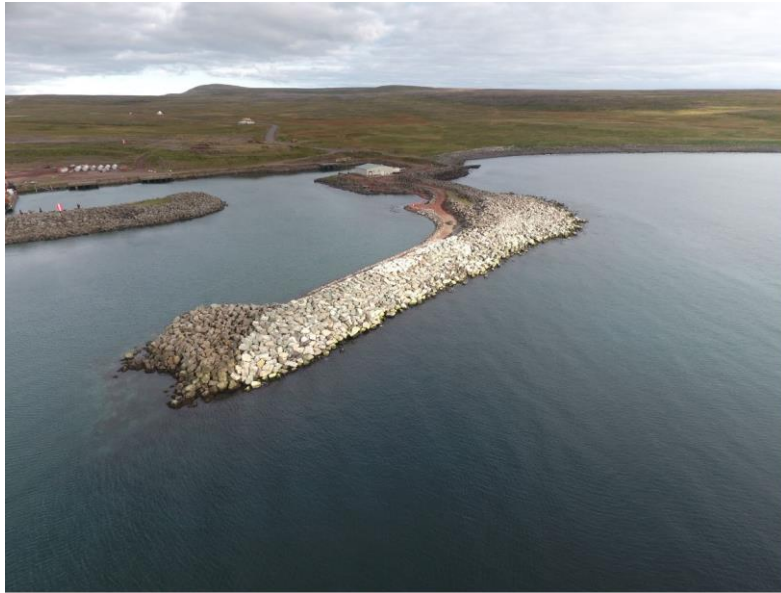
Figure 6. Aerial photograph of completed Phase 1 repairs. (Photo courtesy of Brice Construction).

The repairs placed 6 to 10 ton armor stone partially sourced from a local quarry on the island and also imported from Kodiak Island, AK and Rainier, WA. Construction of Phase 1 was completed in September 2016. An aerial photograph of the completed repairs is shown in Figure 6.

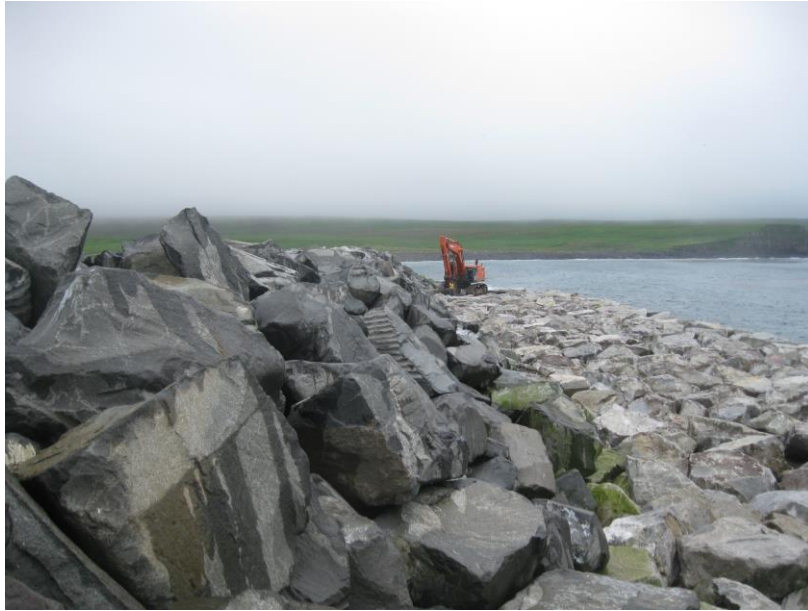
Figure 7. Ground level photograph of completed Phase 2 repairs (Photo courtesy of Brice Construction).

The Phase 2 repairs focused on increasing the overall stability of the breakwater rather than just restoring the crest elevation. Design alternatives for both a composite slope and a berm breakwater were considered and ultimately a berm breakwater was chosen, largely based on the success of the concept from the original construction. The berm would be constructed on the seaward side of the damaged breakwater section and serve to dissipate wave energy in its porous section before the energy impacts the remainder of the structure.

The original design of the St. George breakwaters used a dynamic berm concept in which the berm would be reshape in the wave conditions at the site. Although the berm was intended to ultimately be stable despite the reshaping, the repair work was able to utilize larger stone to create a more stable berm. In the stable berm concept, large enough stone is used so that it is not intended to reshape. This approach is expected to provide a more robust breakwater system. The construction of the stable berm was only possible by importing larger armor stone, whereas the original breakwater construction utilized local-quarried armor stone from St. George Island. For Phase 2 armor stone was imported from Shackmanoff Quarry on Kodiak Island, AK. Figure 5 shows a comprehensive cross-section of the Phase 1 and Phase 2 repairs. Construction of the Phase 2 repairs was completed in July 2017. A ground-level photograph of the constructed berm is shown in Figure 7. Approximately 32,000 tons of armor stone were placed in total between Phase 1 and Phase 2 for a total construction cost of approximately \$17M.
