Battling the Bering Sea:

St. George Island's Berm
Breakwater

Philip Blackmar, P.E.
Ronny McPherson, P.E.

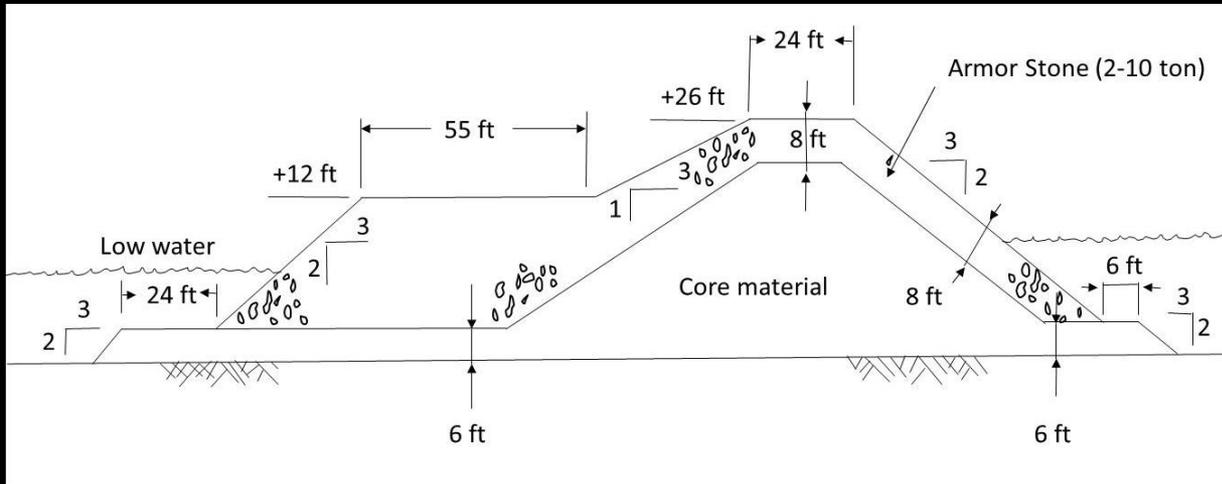
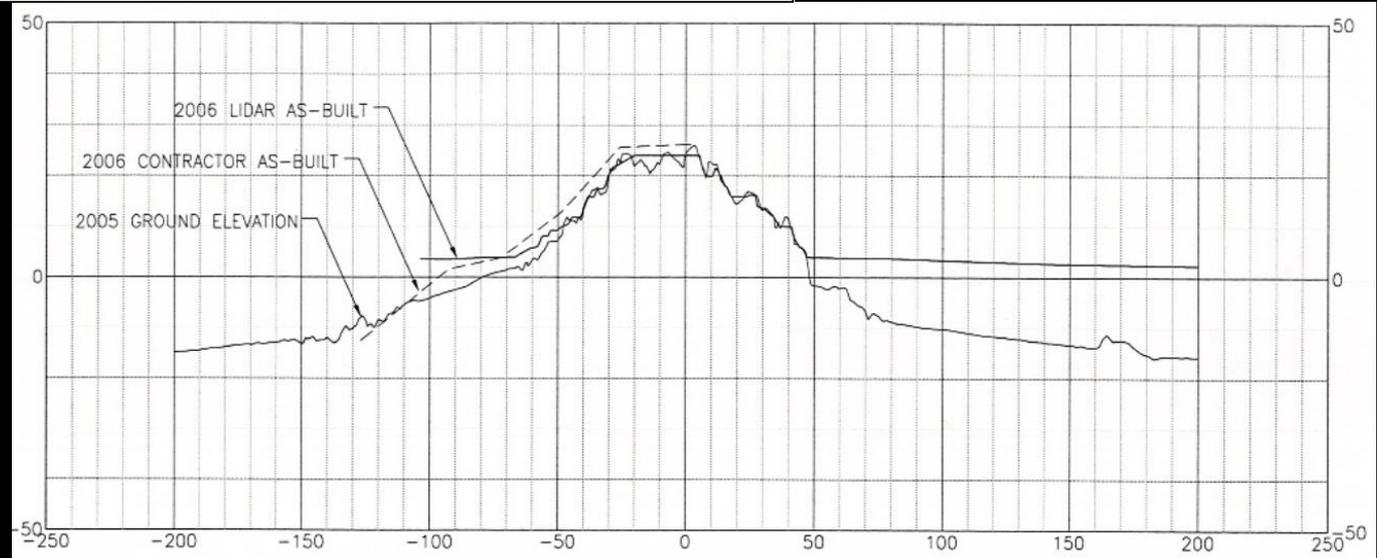
Original Design*

2005/2006

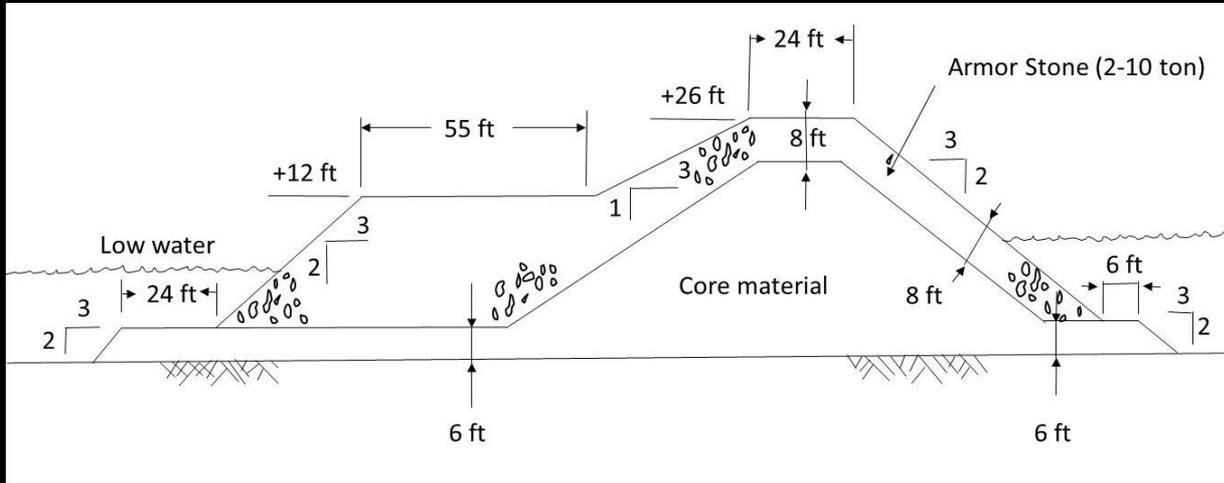
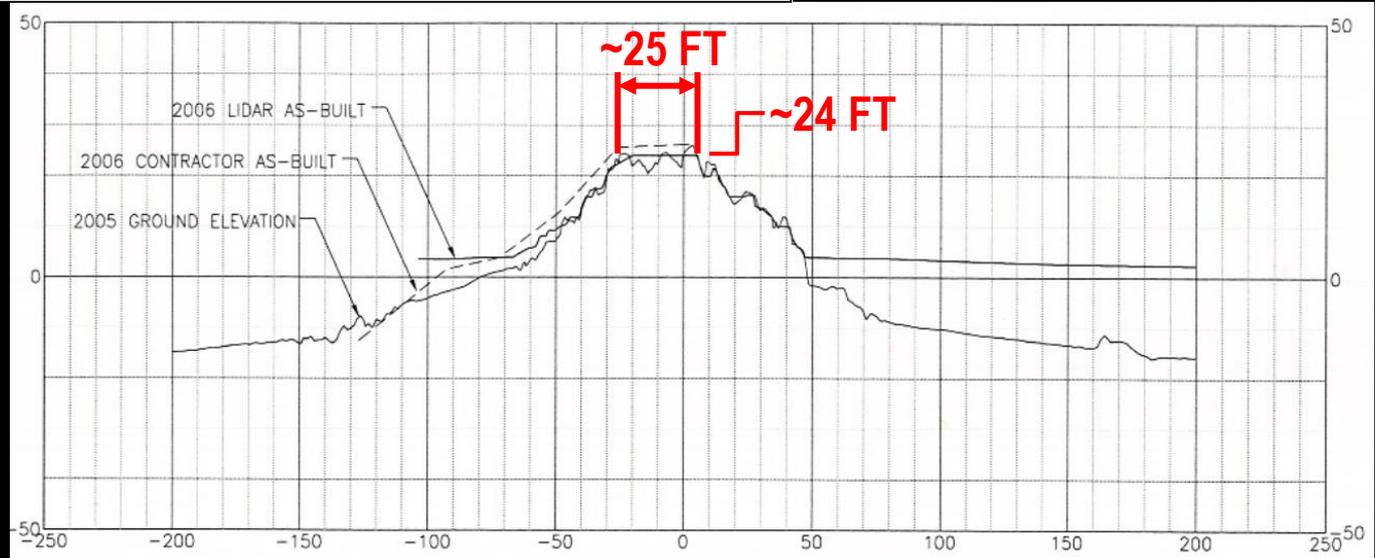
Original Design*

2005/2006

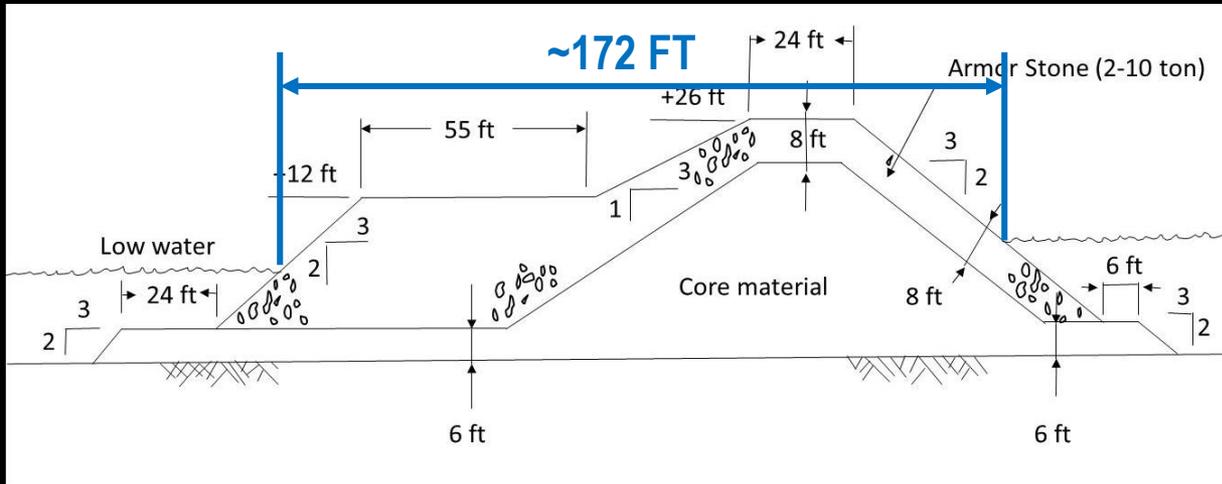
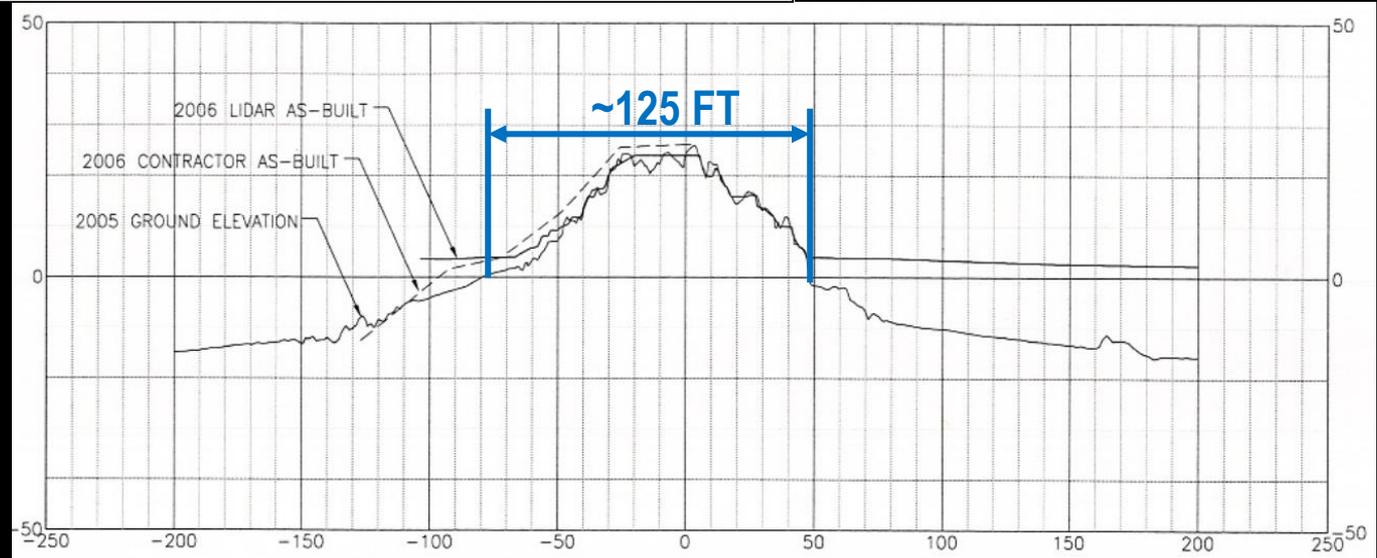
Original Design*

2005/2006

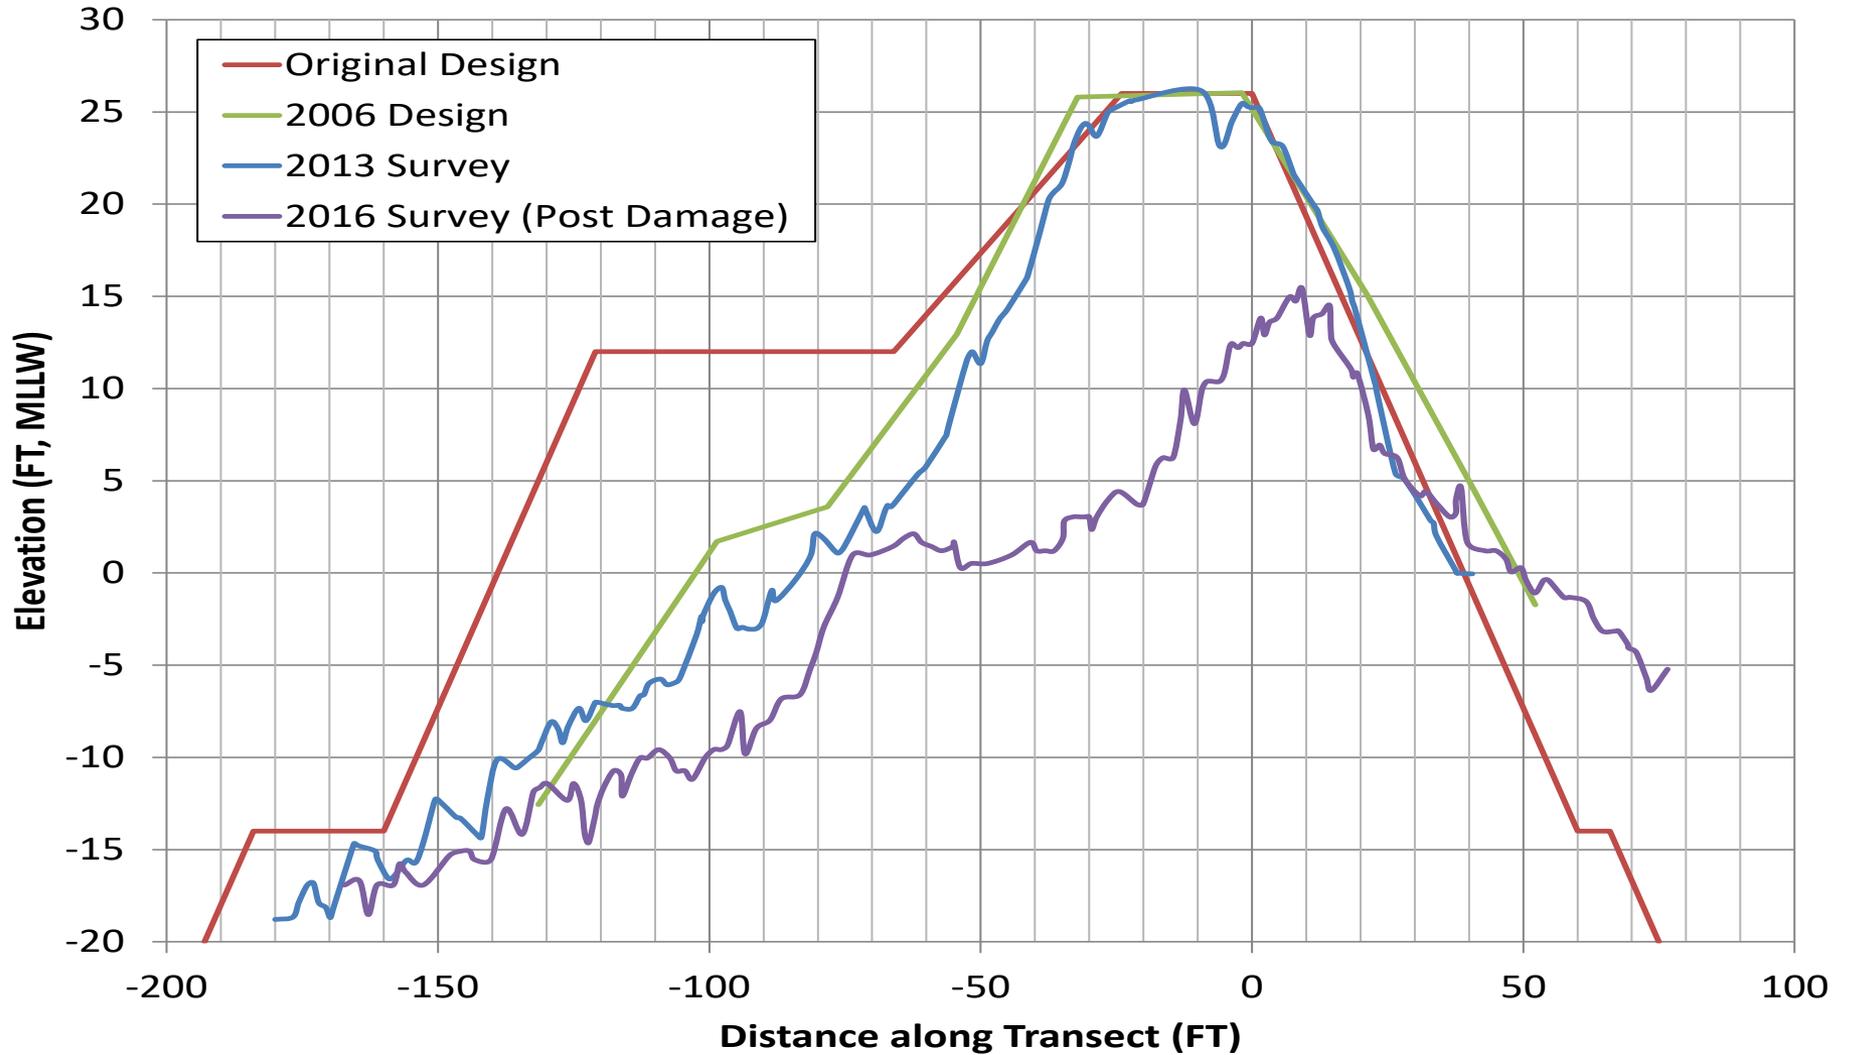
- Loss of berm material apparent in available survey data
 - Original design was considered dynamically stable
 - Armor stone used in original project was basalt rock with low durability
 - Potential lateral transport of berm stone
