# COMPARISONS OF STORM SURGE DISASTERS IN ASIA ----CASES OF CYCLONES SIDR IN 2007 AND NARGIS IN 2008----

Field surveys were performed in the southwest of Bangladesh after cyclone Sidr in 2007 and in Yangon River Basin after Cyclone Nargis in Myanmar in 2008 in order to learn lessons out of severe disasters due to storm surges. Spatial distributions of inundation heights were measured around the most damaged areas. Both Bangladesh and Myanmar were severely damaged, but the preparedness against storm surge and the experiences were different. The resultant total losses in these two countries were significantly different. In Bangladesh, many people witnessed that storm surges inundated with bore-like waves. Counter measured against storm surges should account for the physical mechanisms for the development of such bore-like waves and possible damages due to such waves. Embankment showed significant roles to minimize the damage. Development of riverbanks especially around the river mouth is one of most essential counter-measures to be carried out in Bangladesh. Shelter functioned well to save significant number of lives in Bangladesh. But in Myanmar, there were few experiences on storm

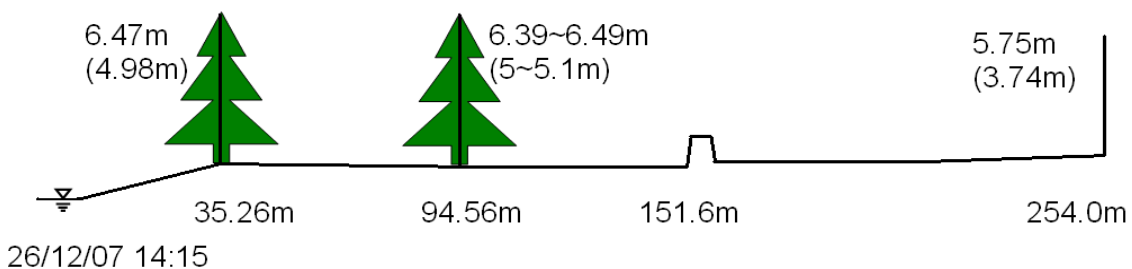
The measurement result of a cross section is shown in Fig. 2. River banks were built around thirty

Figure 2. Measurement result of a cross section in Southkhali. Distances are from the river shore and inundation height from the river water level (numbers in parenthesis is from the ground level). (Shibayama et al., 2009a)

years ago but they were broken due to erosion before Sidr attacked them. Though newer banks had been built recently about 150 m inside from these older banks, the high tide due to Sidr flowed over their tops of about 2.5 m over the river water at the measurement time. These newer banks are shown in Fig. 2 around  $x = 151.6$  m and their photo in Fig. 3. The river depth decreases every year due to erosion, resulting in wider width of the river.

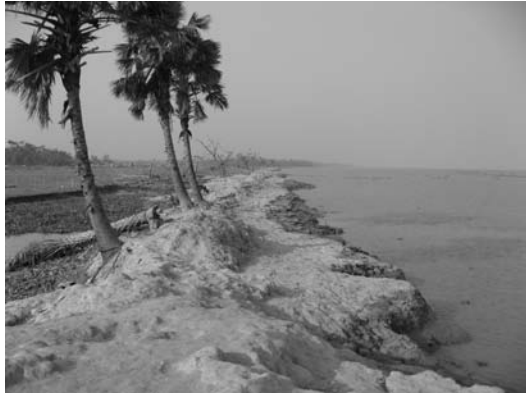
Figure 3: River bank erosion in Southkhari.

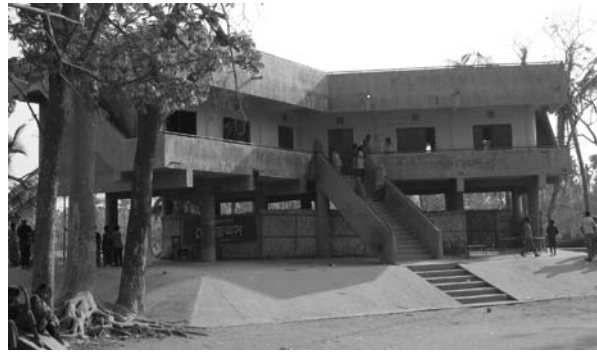
Figure 4: Cyclone shelter in Southkhari.

According to our hearing, the first wave of the high tide came to the newer bank at  $x$  is about 150 m, after which the second wave flowed over the newer bank. The third wave of the high tide advanced on the shelter (Fig. 4). The wave period of these bores was around one minute. The high tide continued about fifteen minutes. Women and children took mainly refuge in the second level of the shelter, where the inundation depth was 0.59 m over the floor, whose height was 2.99 m over the basement surface of the shelter. Some water entered through windows, the lower edges of which were of 3.8 m height over the basement surface of the shelter. When the water came into the second level, the refugees were frightened and wanted to go outside but they could not open doors because of strong winds. Some traces were left when they forced themselves to open the doors. Around one thousand people evacuated on the shelter top, where they felt the space was not enough.

Many people were flowed before they reached this shelter, including a child flowed about 3 km. Several children caught trees to be spared. In this area about 300 people were died. In regard to evacuation, the following points are important: 1) education of residents on disaster prevention, 2) certain communication channel of evacuation information (e.g. speaker for Alcoran), 3) construction of shelters considering adequate evacuation distance and enough capacity.

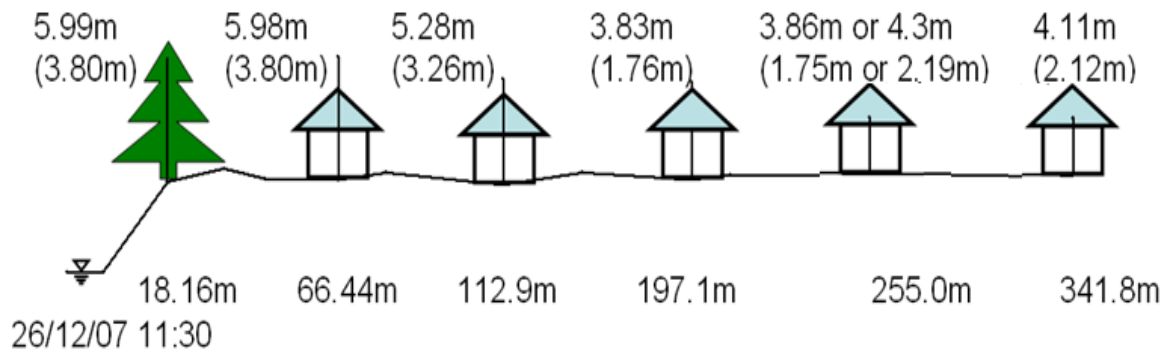
In a bank of the Baleshwar River in Royenda Bazar, the measurement of inundation were performed. The traverse line was extended upward, where a lot of collaborative people gave us in-depth information. The measurement result of a cross section is shown in Fig. 5. Inundation at a depth of 2.5 - 3.0 m over the ground surface was shown in several places.

Figure 5: Measurement result of a cross section in Royenda Bazar. (Shibayama et al., 2009a)

In Fig. 5, the inundation level at  $x = 18.16$  m was shown on a palm tree. Several people, who climbed upcountry palm trees during the high tide, watched the riverside trees having a soak of water. Eight people were died at  $x = 66.44$  m. At  $x = 255.0$  m, one person said the inundation depth was 1.75 m over the ground surface, while another person said the water depth was 2.19 m covering the top of a house door. At  $x = 341.8$  m, the inundation depth was 2.12 m inside a house. Outside this house, three different values of inundated water depth were shown by three persons of a family, one of which was 1.54 m; these three values possess lower reliability.

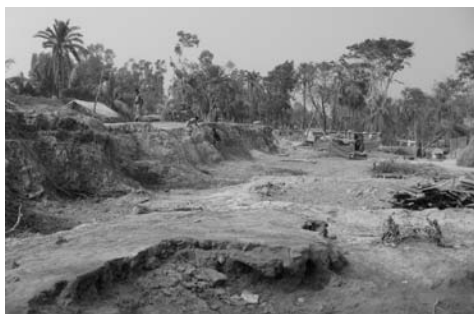
The survey on water level of storm surge was started from the surface water of Burishwar River, where riverbank had eroded into 50m in shape of a semicircle (Fig. 6 and Fig. 7). The old location of riverbank before storm surge was 500m forward. The erosion area was all over a few kilometer of river line.

Figure 6: River shore erosion in Sombonia.

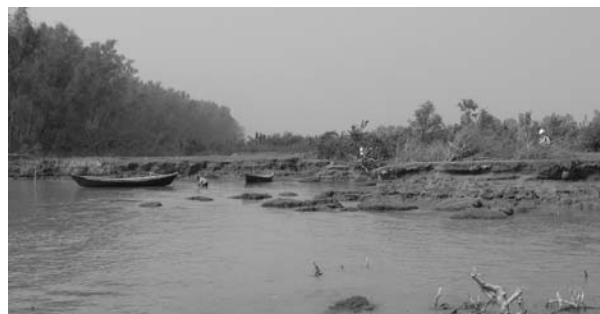
Figure 7: Erosion behind bank in Sombonia.

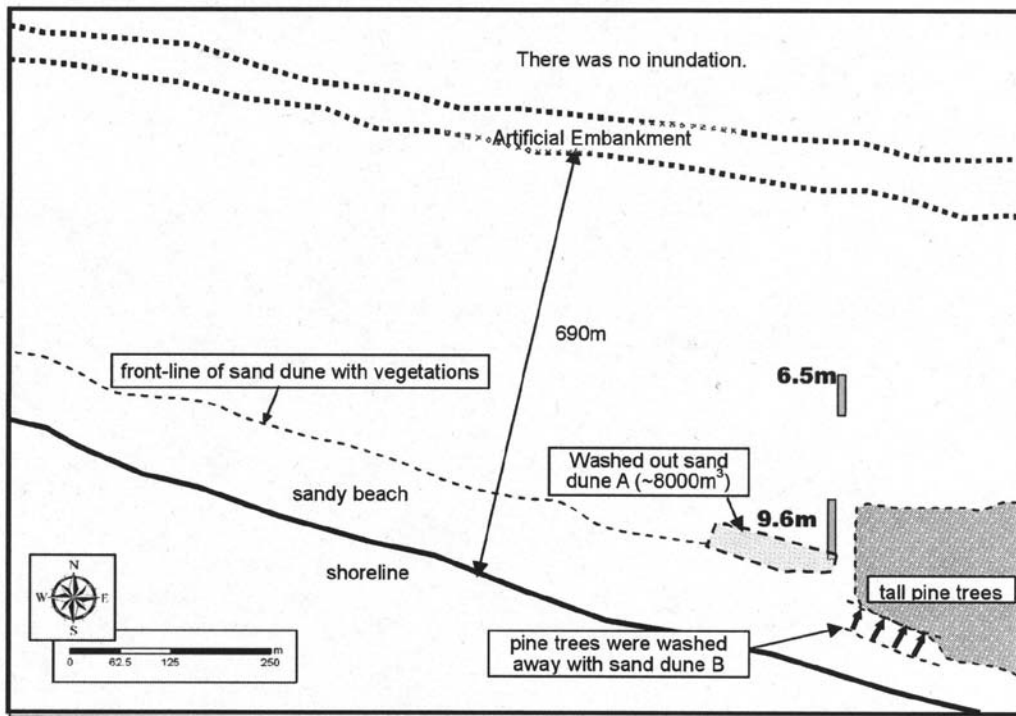
Characteristic features observed in Kuakata are outlined as follows. Fig. 8 overviews observed features in Kuakata. Since the distance from the shoreline to the embankment was relatively long,  $L=690$ m, and various plants were vegetated on the mild slope to the embankment, storm surge did not overtop the embankment. Before the storm, 1.5m-high sand dune was developed (dune A in Fig. 8) and restaurant house was built on the dune. Storm surge completely washed both the house and the sand dune although the surface of the dune was fully vegetated. Estimated volume of the washed sand dune is about  $8000\text{m}^3$ . A part of sand dunes (dune B in Fig. 8) was also washed away. The width and height of

Figure 8. Overview of observed damages around Kuakata. (Shibayama et al., 2009a)

the washed sand dune were about 30m and 1m, respectively.

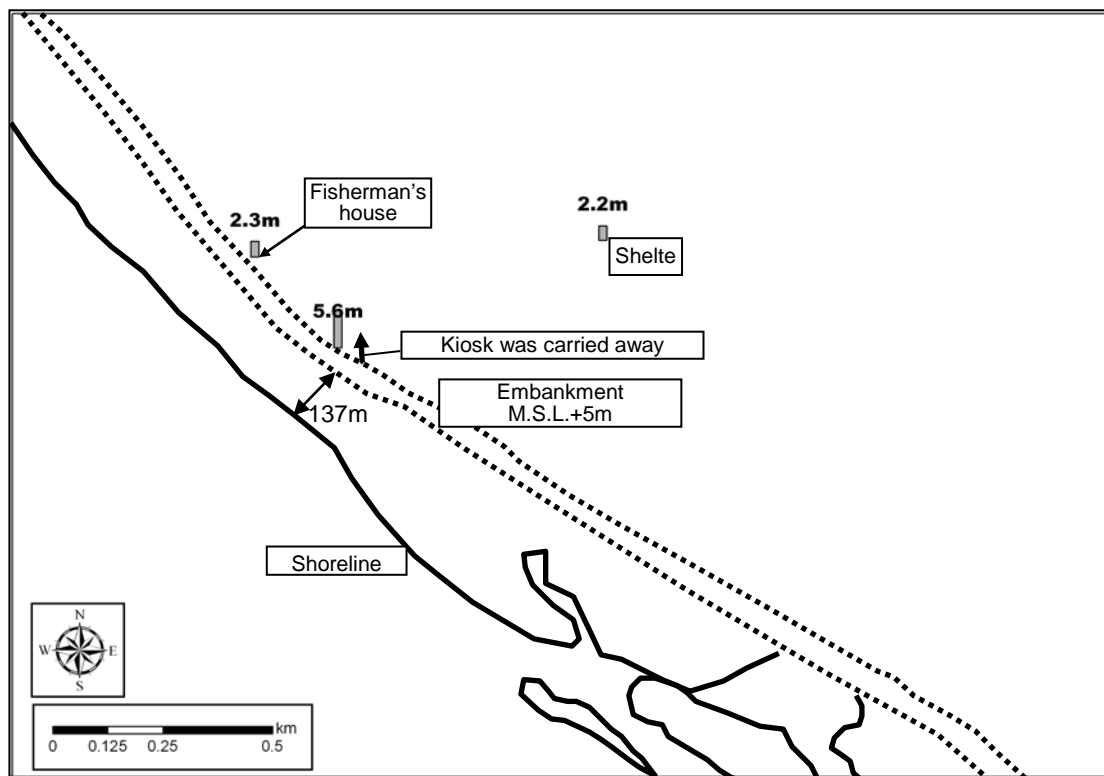
Figure 9: Overview of observed features in West Kuakata. (Shibayama et al., 2009a)

Figure 9 shows overview of West Kuakata. Characteristics features observed in West Kuakata are as follows. Height and width of the embankment were 5m above the mean water level and 12m, respectively. Depth of the flooding water on the embankment was about 60cm. Kiosk built on the embankment was washed in the northward and reached around 55m behind the embankment (Figure 9). The storm surge overtopped the embankment for 10 to 15 minutes. Front slope of the embankment was about 1:2. Sandbags were placed where the front surface was severely eroded due to stormy waves. Many houses, built on the seaside of the embankment before the storm, were all washed away. Backside slope of the embankment is 3:10. Several scours were observed behind the crest of embankment. Inundation depth at fisherman's house just behind the embankment was 72cm. This house was not settled on the foundation and was washed around 1m without suffering structural damages. Stormy waves were witnessed although their heights and periods were unknown. Most of residents took a shelter while some survived by tie themselves to a tree. Inundation depth around the shelter was about 1m. The shelter was built beside school since the school provided the land for the shelter.

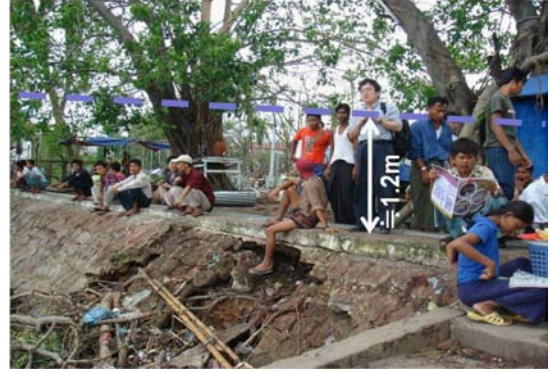
Fig. 12: Yangon Ferry Terminal

Figure 12 shows one example of flooded height in Yangon area. The storm surge height was around 1.2 m above the bank. The water flooded over port area and many boats are damaged to sink. The high water continued for around four days.

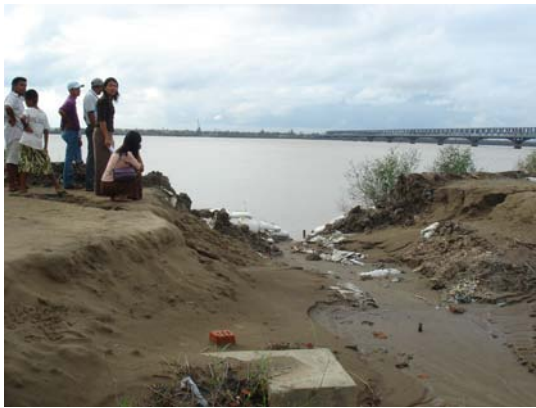
Fig. 13: Left bank of Bago River

Large numbers of boats were moved and were left in land after the storm. A large scale local scour

due to return flow of flooded water was observed as shown in the Figure 13.

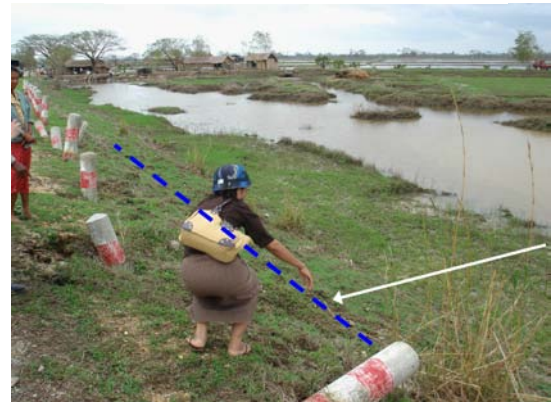
Fig. 14: Flood at Rakhine Chaing Village.

Storm surge came to paddy area with height of around 1.5 m through irrigational channels (see Fig. 14). According to interviews with the local residents, it appears that significant flooding took place at inland areas as a result of the upsurge through the tributaries or channels from the main river.
