**COMPARISONS OF STORM SURGE DISASTERS IN ASIA
----CASES OF CYCLONES SIDR IN 2007 AND NARGIS IN 2008----**

Tomoya Shibayama¹

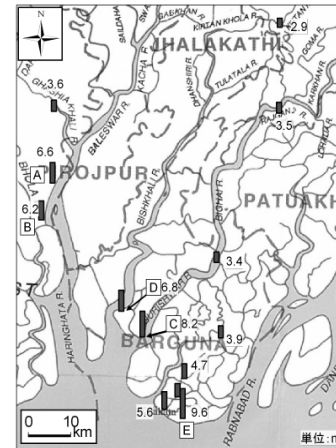
The basic method of survey was to detect flood height and to measure distances by using laser distance meters and to measure locations by using GPS. Fig. 1 shows the survey route and distribution of measured storm surge heights in meters.

Figure 1. Survey route and measured storm surge height. (Shibayama et al., 2009a)

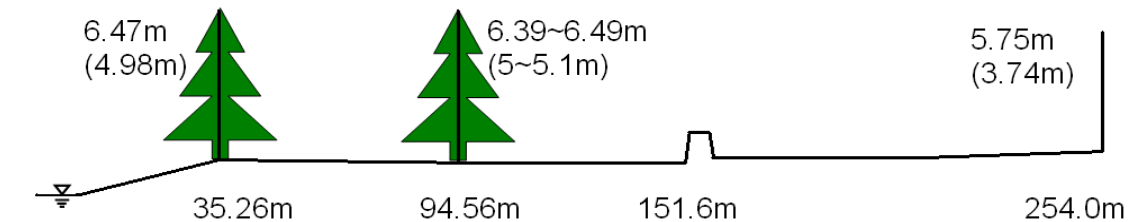
The measurement result of a cross section is shown in Fig. 2. River banks were built around thirty

Figure 2. Measurement result of a cross section in Southkhali. Distances are from the river shore and inundation height from the river water level (numbers in parenthesis is from the ground level). (Shibayama et al., 2009a)

years ago but they were broken due to erosion before Sidr attacked them. Though newer banks had been built recently about 150 m inside from these older banks, the high tide due to Sidr flowed over their tops of about 2.5 m over the river water at the measurement time. These newer banks are shown in Fig. 2 around $x = 151.6$ m and their photo in Fig. 3. The river depth decreases every year due to erosion, resulting in wider width of the river.

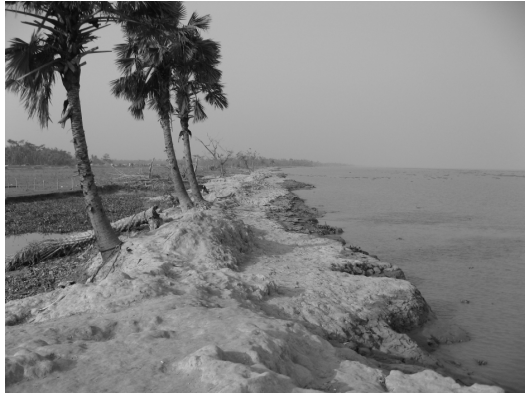
Figure 3: River bank erosion in Southkhari.

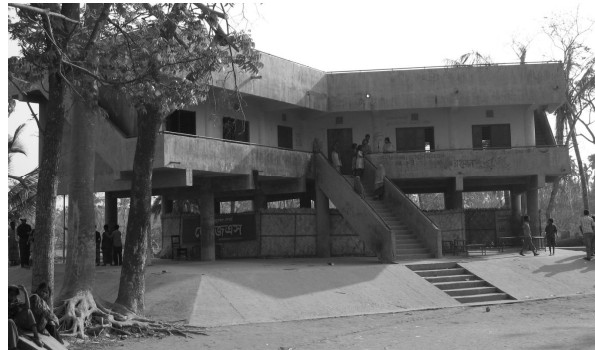
Figure 4: Cyclone shelter in Southkhari.

According to our hearing, the first wave of the high tide came to the newer bank at x is about 150 m, after which the second wave flowed over the newer bank. The third wave of the high tide advanced on the shelter (Fig. 4). The wave period of these bores was around one minute. The high tide continued about fifteen minutes. Women and children took mainly refuge in the second level of the shelter, where the inundation depth was 0.59 m over the floor, whose height was 2.99 m over the basement surface of the shelter. Some water entered through windows, the lower edges of which were of 3.8 m height over the basement surface of the shelter. When the water came into the second level, the refugees were frightened and wanted to go outside but they could not open doors because of strong winds. Some traces were left when they forced themselves to open the doors. Around one thousand people evacuated on the shelter top, where they felt the space was not enough.

Many people were flowed before they reached this shelter, including a child flowed about 3 km. Several children caught trees to be spared. In this area about 300 people were died. In regard to evacuation, the following points are important: 1) education of residents on disaster prevention, 2) certain communication channel of evacuation information (e.g. speaker for Alcoran), 3) construction of shelters considering adequate evacuation distance and enough capacity.

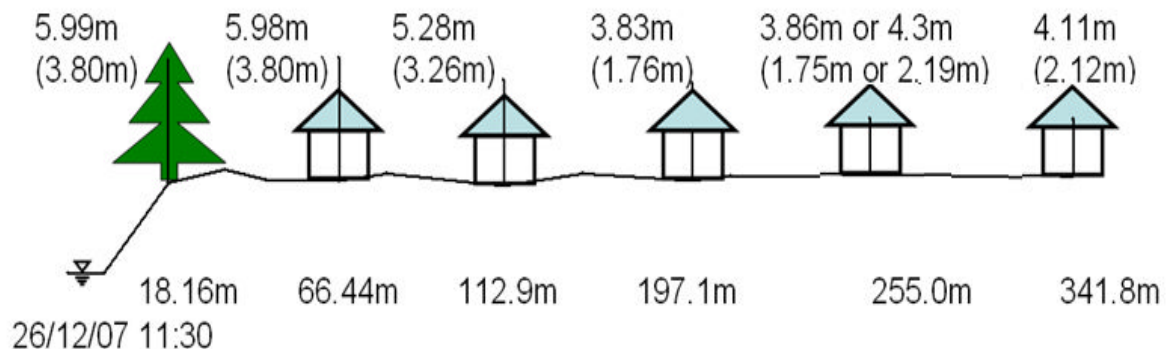
In a bank of the Baleshwar River in Royenda Bazar, the measurement of inundation were performed. The traverse line was extended upward, where a lot of collaborative people gave us in-depth information. The measurement result of a cross section is shown in Fig. 5. Inundation at a depth of 2.5 - 3.0 m over the ground surface was shown in several places.

Figure 5: Measurement result of a cross section in Royenda Bazar. (Shibayama et al., 2009a)

In Fig. 5, the inundation level at $x = 18.16$ m was shown on a palm tree. Several people, who climbed upcountry palm trees during the high tide, watched the riverside trees having a soak of water. Eight people were died at $x = 66.44$ m. At $x = 255.0$ m, one person said the inundation depth was 1.75 m over the ground surface, while another person said the water depth was 2.19 m covering the top of a house door. At $x = 341.8$ m, the inundation depth was 2.12 m inside a house. Outside this house, three different values of inundated water depth were shown by three persons of a family, one of which was 1.54 m; these three values possess lower reliability.

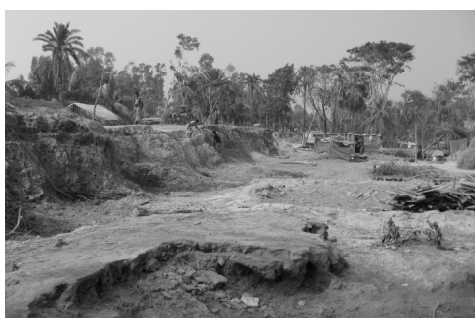
The survey on water level of storm surge was started from the surface water of Burishwar River, where riverbank had eroded into 50m in shape of a semicircle (Fig. 6 and Fig. 7). The old location of riverbank before storm surge was 500m forward. The erosion area was all over a few kilometer of river line.

Figure 6: River shore erosion in Sombonia.

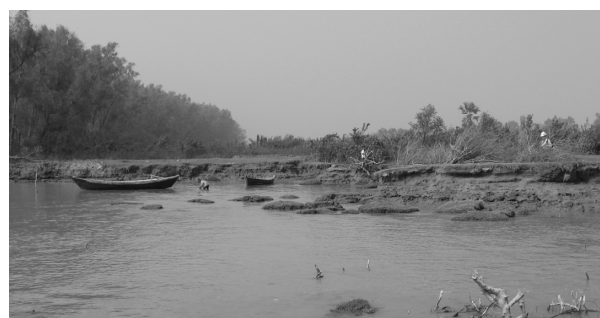
Figure 7: Erosion behind bank in Sombonia.

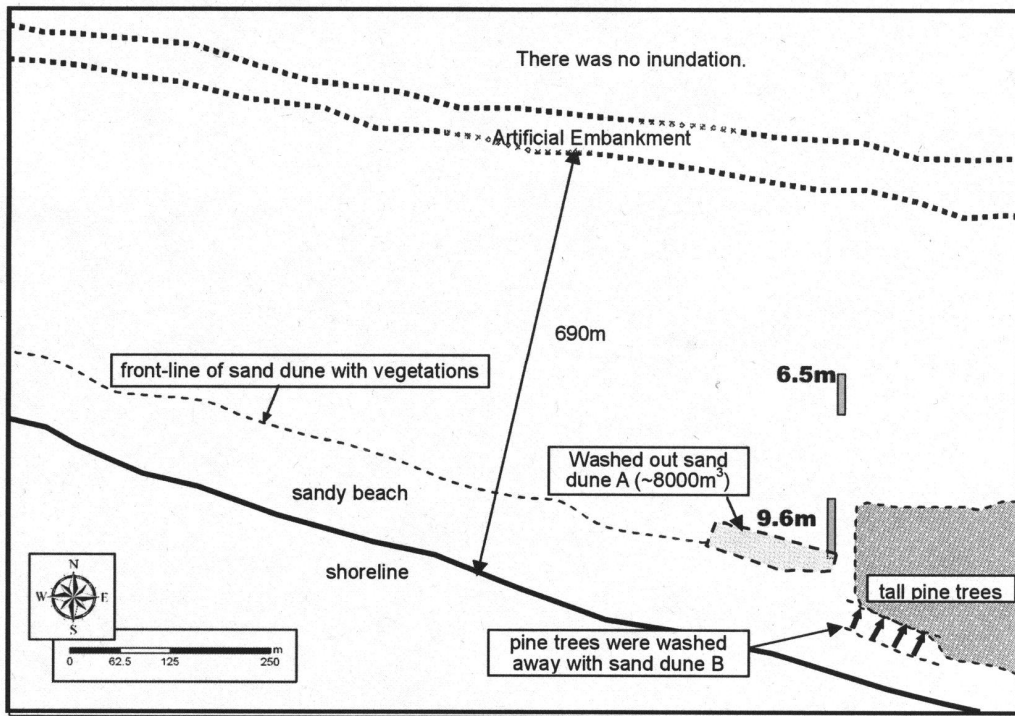
Characteristic features observed in Kuakata are outlined as follows. Fig. 8 overviews observed features in Kuakata. Since the distance from the shoreline to the embankment was relatively long, $L = 690$ m, and various plants were vegetated on the mild slope to the embankment, storm surge did not overtop the embankment. Before the storm, 1.5m-high sand dune was developed (dune A in Fig. 8) and restaurant house was built on the dune. Storm surge completely washed both the house and the sand dune although the surface of the dune was fully vegetated. Estimated volume of the washed sand dune is about 8000m^3 . A part of sand dunes (dune B in Fig. 8) was also washed away. The width and height of

Figure 8. Overview of observed damages around Kuakata. (Shibayama et al., 2009a)

the washed sand dune were about 30m and 1m, respectively.

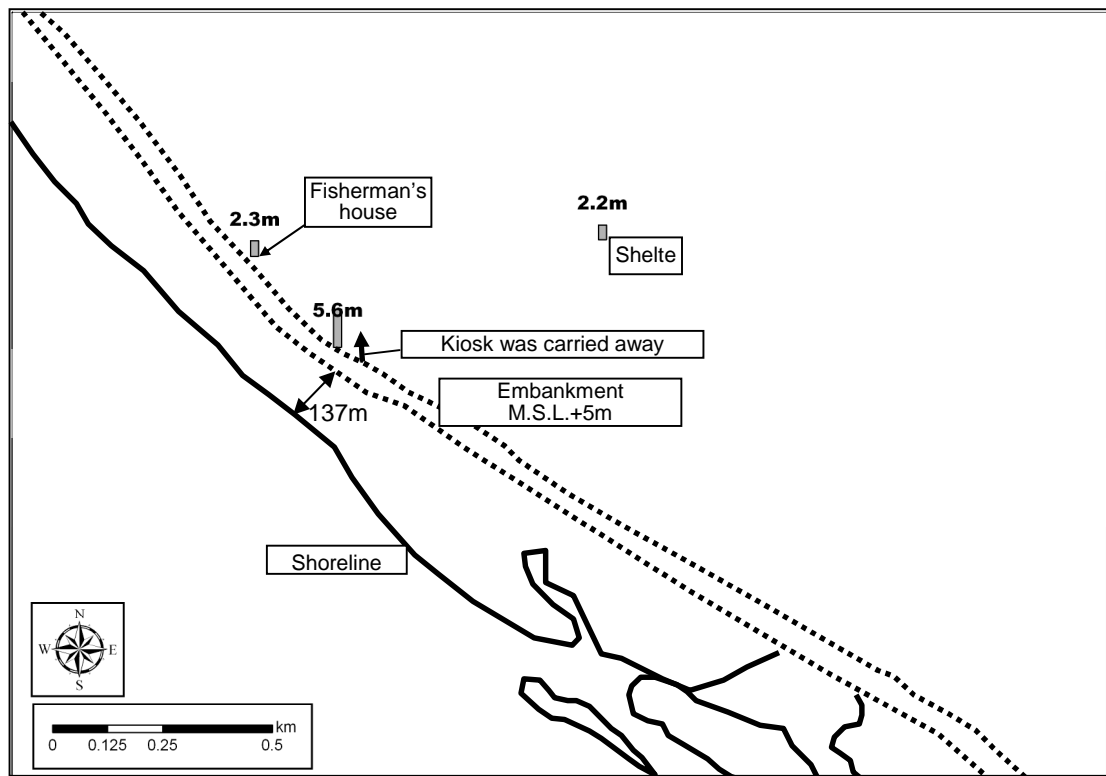
Figure 9: Overview of observed features in West Kuakata. (Shibayama et al., 2009a)

Figure 9 shows overview of West Kuakata. Characteristics features observed in West Kuakata are as follows. Height and width of the embankment were 5m above the mean water level and 12m, respectively. Depth of the flooding water on the embankment was about 60cm. Kiosk built on the embankment was washed in the northward and reached around 55m behind the embankment (Figure 9). The storm surge overtopped the embankment for 10 to 15 minutes. Front slope of the embankment was about 1:2. Sandbags were placed where the front surface was severely eroded due to stormy waves. Many houses, built on the seaside of the embankment before the storm, were all washed away. Backside slope of the embankment is 3:10. Several scours were observed behind the crest of embankment. Inundation depth at fisherman's house just behind the embankment was 72cm. This house was not settled on the foundation and was washed around 1m without suffering structural damages. Stormy waves were witnessed although their heights and periods were unknown. Most of residents took a shelter while some survived by tie themselves to a tree. Inundation depth around the shelter was about 1m. The shelter was built beside school since the school provided the land for the shelter.

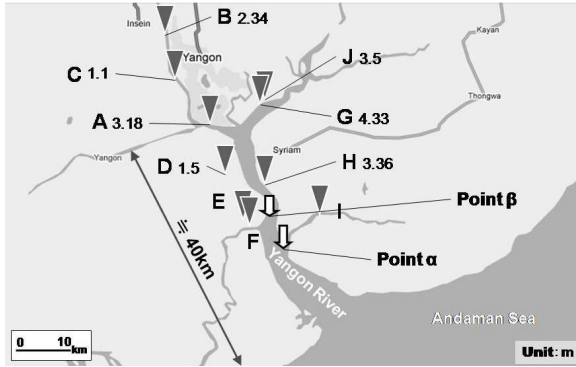
Figure 11: Survey route and measured storm surge height. (Shibayama et al., 2009b)

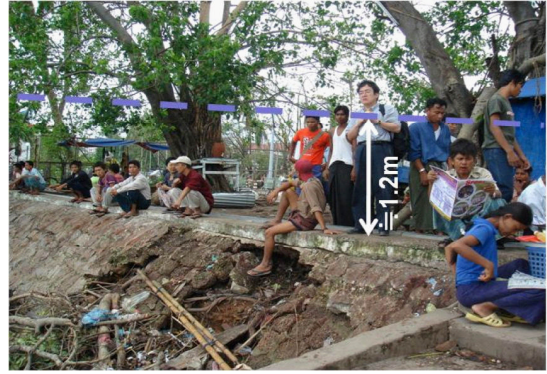
Figure 12 shows one example of flooded height in Yangon area. The storm surge height was around 1.2 m above the bank. The water flooded over port area and many boats are damaged to sink. The high water continued for around four days.

Figure 12: Yangon Ferry

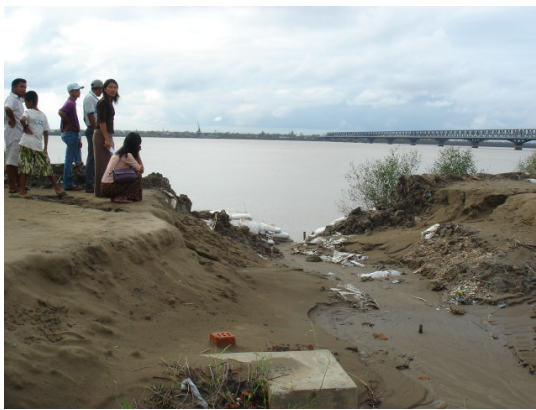
Large numbers of boats were moved and were left in land after the storm. A large scale local scour

Figure 13: Left bank of Bago River

due to return flow of flooded water was observed as shown in the Figure 13.

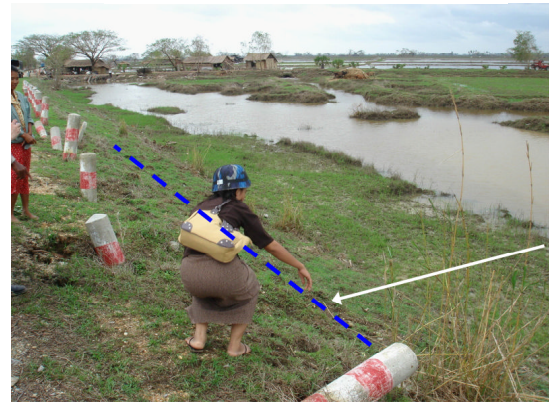
Figure 14: Flood at Rakhine Chaing Village.

Storm surge came to paddy area with height of around 1.5 m through irrigational channels (see Fig. 14). According to interviews with the local residents, it appears that significant flooding took place at inland areas as a result of the upsurge through the tributaries or channels from the main river.
