CHAPTER 15

SOME ASPECTS OF SHORE PROTECTION IN BOSTON HARBOR

George L. Wey
Chief Engineer, Port of Boston Authority
Commonwealth Pier No. 5, South Boston, Mass.

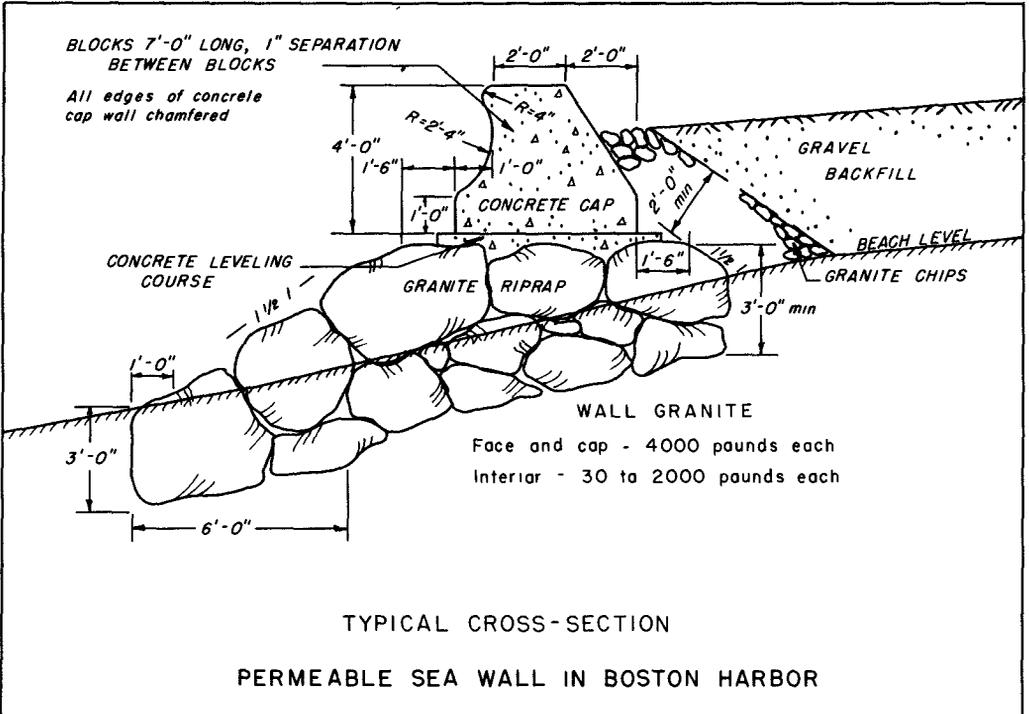
FIGURE 2

There were a number of old plain cement concrete seawalls with a vertical face which showed evidence of bad scour at the base from the abrasive action of coarse beach material carried along with impinging waves. This condition was so bad that failure of the wall was imminent unless immediate repairs or corrective measures were taken. Under severe wave attack considerable over-topping of the wall was observed. There was also another condition which had to be taken into consideration - evidence of lowering of the beach from erosion.

The corrective action consisted of a rip rap base in front of the wall on a $1\frac{1}{2}$ to 1 slope extending up to the level of maximum high water, with a system of rip rap groins to stabilize the beach (Figures 2, 6, 7, and 8). The rip rap base reinforcement not only was more abrasion-resistant, but it presented a more energy absorbing face along with less base turbulence. The reinforced wall observed now undergoing severe wave attack shows considerably less over-topping.

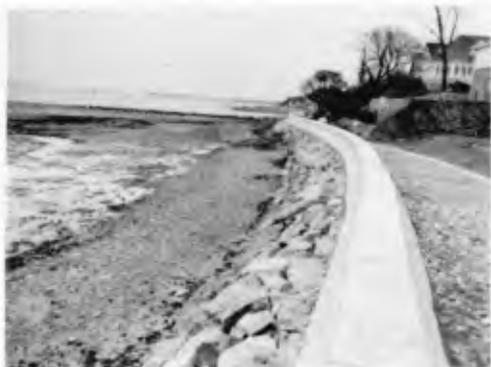
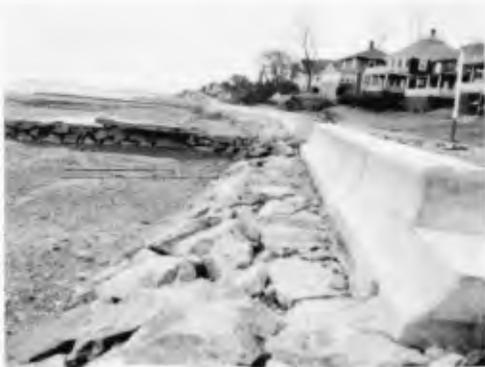
The two-tone color combination of the rip-rap base and the concrete cap, along with the pleasing lines of the cap, makes the wall appear very attractive as shown on Figures 3, 4, and 5. The maintenance is low, as the abrasion of the wall by the coarse beach material carried by the impinging waves is best resisted by the granite rip-rap. The concrete which is not so resistant is above the abrasion zones. The wall with the slots in the cap and voids in the base permits seepage of ground water behind the wall, thus eliminating any heaving of the wall as result of freezing and thawing of entrapped water.

Views of "Permeable Seawall" constructed at North Weymouth, Massachusetts. Note groins on beach.

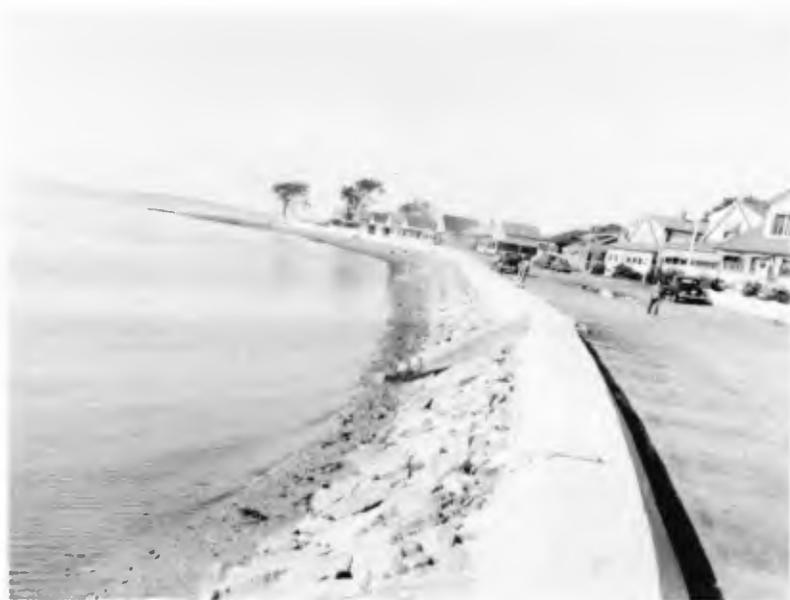
Fig. 5. "Permeable Seawall".

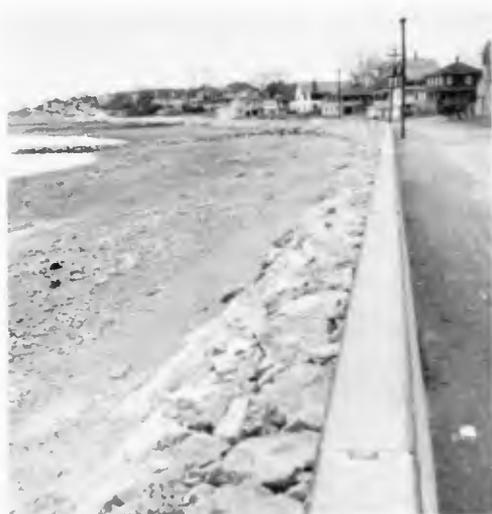
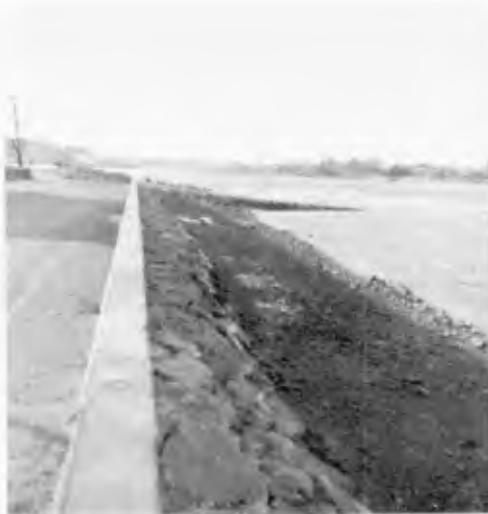
Views of typical seawall reinforcement with granite rip-rap. Note groins on beach.

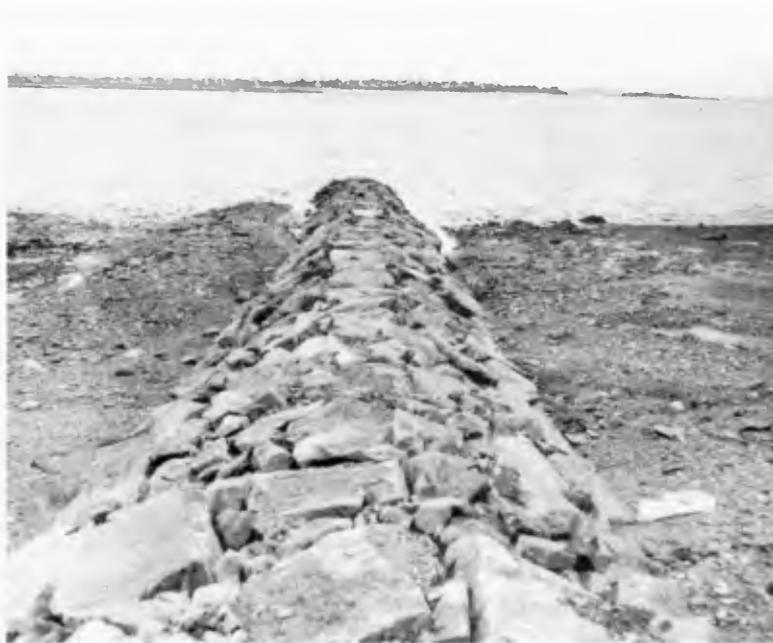
Fig. 8. Typical rip rap beach groin.

A necessary adjunct of this seawall is a system of rip rap groins. These groins project about $3\frac{1}{2}$ feet above the beach, and are relatively short in length, about 100 feet. The cost is about \$5.00 per linear foot.
