CHAPTER 41

CLIFF DRAINAGE AND BEACH DISTRIBUTION

W.T. Fryde, Dip.Ing., C.Eng., M.I.C.E.
Senior Engineer, C.H. Dobbie and Partners

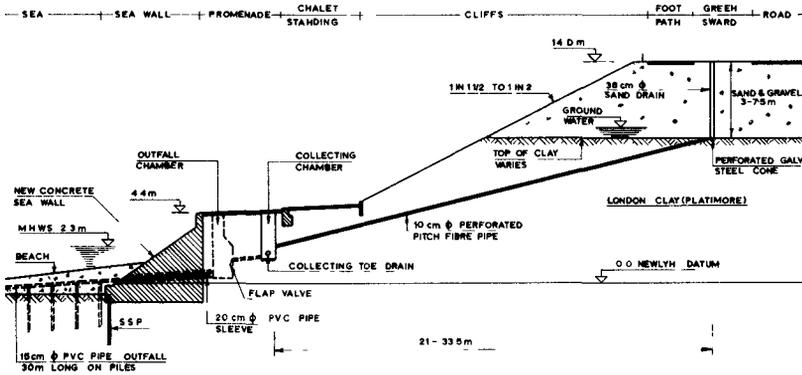
FIG 1 SECTION THROUGH THE CLIFF SHOWING THE DRAINAGE SYSTEM

Generally, the drainage system comprises vertical and inclined auger-bored drains, a toe collecting drain and sea outfalls (Fig.1). Vertical drains were constructed first in order to determine accurately at their locations the top of the clay and also to deal with the perched water table by perforating any impermeable layers within the sand and gravel. Next, from suitably located pits in the promenade, inclined holes were augered through the clay to meet the bottom of the vertical drains. The method of auger boring was specially devised by the sub-contractor using a hydraulic pack. After the auger had been withdrawn perforated pitch fibre pipes were inserted into the hole to provide a permanent drain

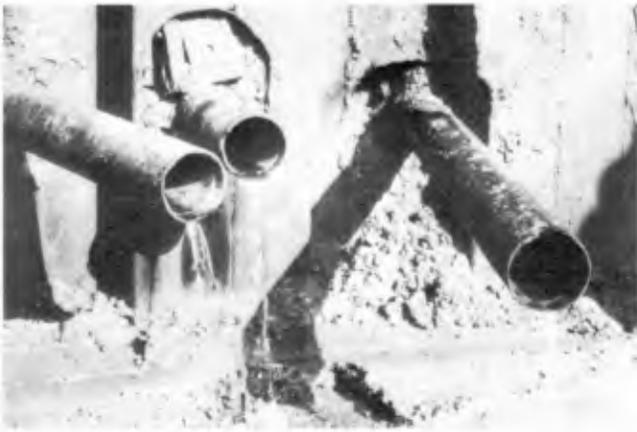
Fig.2: Auger-bored inclined drains lined with pitch fibre pipes ready for connection to the collecting toe drain.

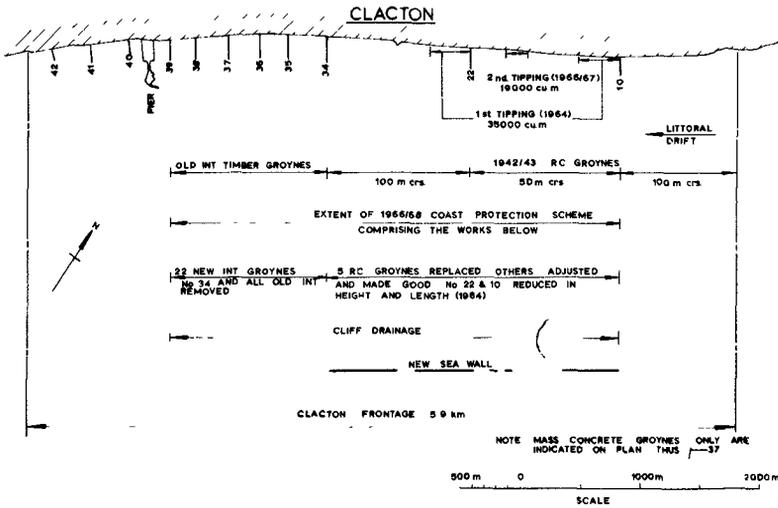
FIG 3 PLAN OF CLACTON FRONTAGE

The previous groyne system (Fig.3) comprised large mass concrete groynes with smaller groynes of reinforced concrete or timber construction. The large groynes (Nos.34 to 43) were constructed in the years 1912 to 1927. These were 125 m. long with the top level 1.0 m. above and sloping to 2.4 m. below M.H.W.S. (2.3 m. above Newlyn Datum) from the landward to the seaward ends. These groynes were spaced at approximately 305 m. At the same time intermediate timber groynes 76 m. long at 100 m. centres were constructed. The frontage with the groynes was protected by a concrete gravity wall built at the end of the last century. In 1942-43 reinforced concrete groynes were added along the almost unprotected cliffs from groyne 34 to the eastern end of the frontage, a distance of 3.4 km. These groynes, 46 m. long and at 100 m. centres comprised reinforced concrete king piles and planks. A number of similar intermediate groynes, each 30.5 m. long, were added later along part of the distance. The cliffs remained unprotected until 1948 when works on a major sea defence scheme commenced. This scheme comprised the construction of the last two (Nos. 22 and 10) mass concrete groynes, a length of 201 m. of concrete gravity sea wall just west of groyne 22, and also a continuous reinforced concrete sheet pile wall east of groyne 10 and in the gaps between various lengths of old sea walls to the west. The mass concrete groynes were each 94.5 m. long with the top level 1.5 m. above M.H.W.S. at the landward end.

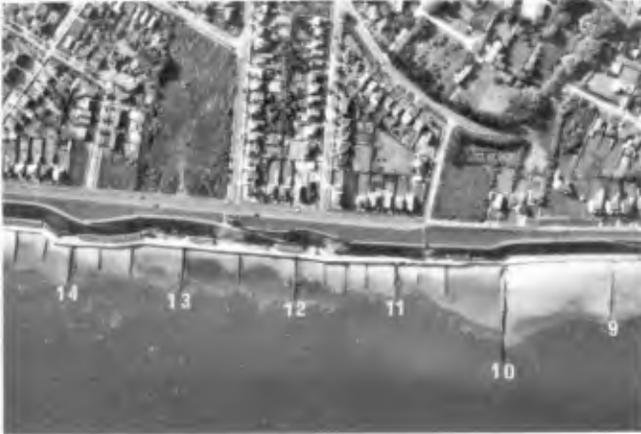
terminal groyne problem developed (Fig. 4 and 5). This also applied to the other large groynes (nos. 34-39) near the Pier, but to a lesser degree. The problem did not arise to the west of the Pier, the conditions there being somewhat different.

Fig. 4: Part of the frontage with large groyne No. 10 (Distance between numbered groyne 100 m.)

To safeguard the sea wall Emergency works were carried out in 1964. These comprised shortening of groynes Nos. 22 and 10 by 30.5 m. and reducing the height by as much as 2.0 m., adjusting planks and making good as necessary the intermediate groynes. This was followed by tipping on to the beach 35,000 cubic metres of imported material.

The imported material was tipped along a distance of approximately 350 m. on the leeward side of each of the two large groynes at an average rate of 40 to 50 cubic metres per metre of frontage. At first the material was spread on the beach by a bulldozer but this was soon abandoned and the job of spreading was left to the tides with good results. Usually it took four to six tides, depending on the rate of tipping, to spread and consolidate the material over the beach sufficiently to be walked on. It is important that the beach is inspected after tipping for any soft areas, but these disappear usually after a few days but in the meantime can be a nuisance or even dangerous.

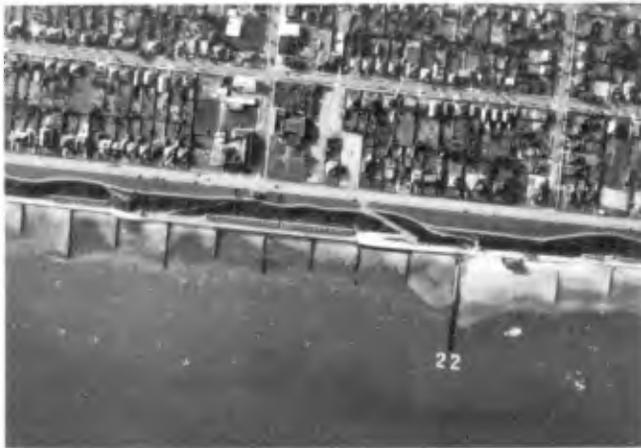
Fig. 5: Part of the frontage with groyne No. 22
