GANSBAAI FISHING HARBOUR - THE DESIGN AND CONSTRUCTION OF A BREAKWATER
ON A HOSTILE COAST

ABSTRACT

This paper describes the design and construction of a fishing harbour on a rocky coastline exposed to the prevailing south westerly swell of the South Atlantic and to severe westerly gales.

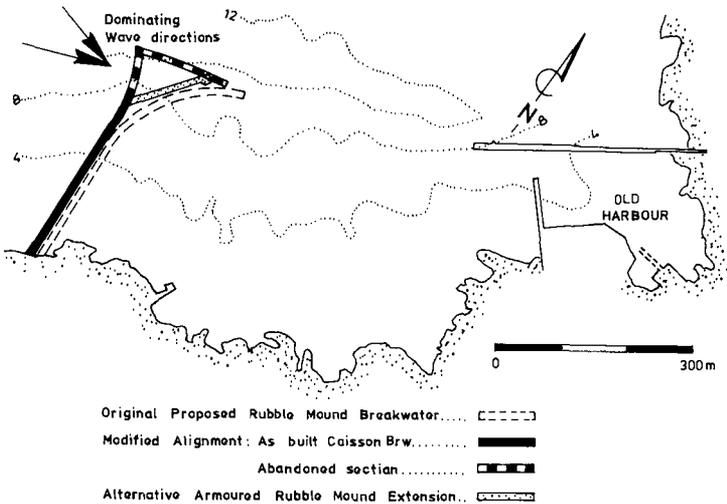
Fig 3. Layout of Breakwaters - Phase I

The alignment of a breakwater required to effectively protect the entrance to the old harbour, presented difficulties because it would have to extend into or across the deep channel, as shown in figure 3. Such a breakwater would be expensive and could create the same problem as that caused by the existing northern breakwater, i.e. forcing incoming boats into the shoaling water on the opposite site of the channel. Reflection of wave energy by the new breakwater could also create turbulent conditions in the entrance channel.

When the caisson wall was incorporated in the model the excessive overtopping of the wall and the reflection of waves from the vertical face was clearly demonstrated. It was evident that the reflection of waves from west north west and north west off the last section of the breakwater would result in extremely rough conditions in the access channel to the old harbour. Various remedial measures were considered but eventually a revised alignment was proposed whereby the wall would initially curve westwards and then at chainage 360, bend sharply eastwards so that the first section would reflect waves to the south western shore and the second section would be almost parallel to the direction of the waves (see figure 3).

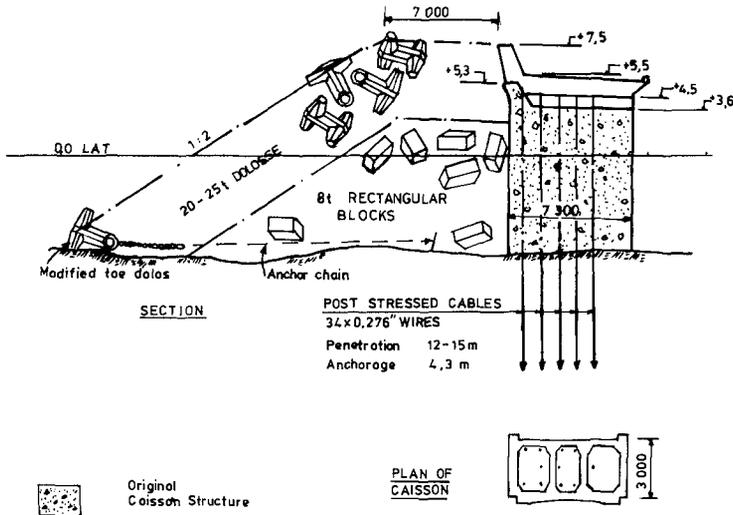
Fig 4. Caisson Breakwater (with armouring added later)

The wall, 6 m wide in shallow water and 7,3 m wide in deeper water, was constructed in open reinforced caissons 3 m long in the direction of the wall and divided into 3 cells with 300 to 400 mm thick walls. The units, approximately 3 m high, were stacked one on top of the other on a bed of broken stone and filled with concrete to within + 400 mm of the top.

During construction of the wall, sea conditions were found to be more severe than anticipated. Placing of caissons was only possible when the wave height was less than about 1,5 metres. Overtopping hampered the work to such a degree that the level of the deck had to be raised from 3,6 m to 4,5 m above low water and the splash wall had to be re-designed at a very early stage of the work.

The rock formation on the sea-bed proved to be highly fractured which made sealing of the holes for the stressing cables very difficult. The grouting and redrilling often had to be repeated several times before the hole could be considered watertight. (This method eventually proved to be ineffective in protecting the cables against corrosion. This was proved by ultrasonic tests on the stressed cables in 1977 and confirmed when a portion of the wall was demolished during a subsequent contract.)

An even more serious problem was the uncertainty regarding the stability of the caisson wall. This wall which had originally been designed with a factor of safety against overturning of 1,5, had subsequently been raised from an effective height of 3,6 metres above low water to 4,5 metres above low water and was also being subjected to attack from waves higher than the original design wave height. New calculations had shown that the factor of safety was lower than originally intended. Factors such as the force taken up by the higher splash wall, an occasional higher still water level due to set up and transverse resonance (recorded locally and confirmed by a mathematical analysis by the Danish Hydraulic Institute) were taken into account. The higher SWL also accounted for higher overtopping than expected.

A series of two dimensional tests confirmed that the factor of safety was nearer 1,0 and in some sections of the wall probably less than 1,0. The 2 dimensional tests which were being conducted to investigate the caisson stability were extended to explore various ways of reducing the overtopping of the wall (such as different shapes of splash wall and a lower splash wall on the seaward side with a secondary splash wall on the leeward side).

Serious doubts had also arisen regarding the soundness of the stressing cables which supplied the major proportion of the moment of resistance against overturning. Ultrasonic tests conducted in 1977 (ref FDC report F92-2) revealed that these wires were in fact seriously corroded especially at the interfaces between the caissons and the sea-bed and the caissons and the deck slab. The continued stability of the wall could probably be ascribed to the angle of wave attack which resulted in the forces on the wall only reaching maximum values over very short sections of wall at any given instant and the transfer of these forces to adjacent caissons through the deck and the keys between the caissons.

20 and 25 t dolosse placed to a slope of 1:2 on a core of 8 t corrugated rectangular blocks were used on the outside of the caisson wall as shown in figure 4 and 25 t dolosse placed to a slope of approximately 1:1,75, were used to protect the rubble mound breakwater as shown in figure 7. A horizontal 7 m wide berm at splash wall level (7,5 m) was used for additional absorption of wave energy.

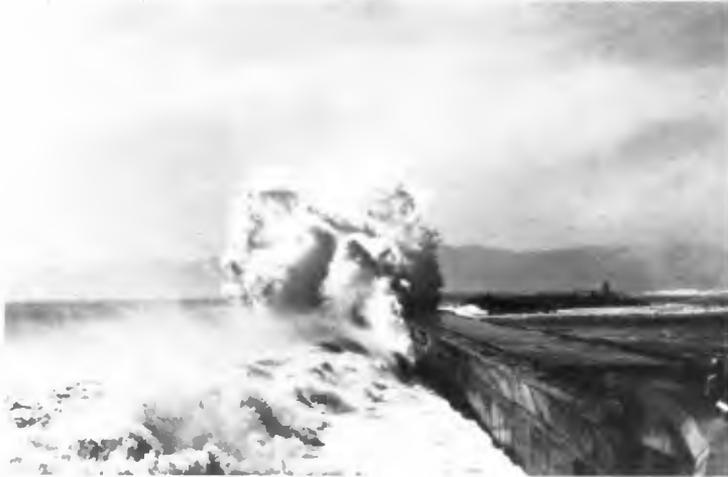
Fig 5. Wave attack on vertical breakwater

During storms the gantry crane which was specially built for the work and ran on rails concreted into the deck had to be moved back onto land. The crane was washed off the breakwater twice during the course of the work. It also became apparent that it would not be possible to use the wall as a quay and that boats would not even be able to moor near the wall because of the excessive overtopping.

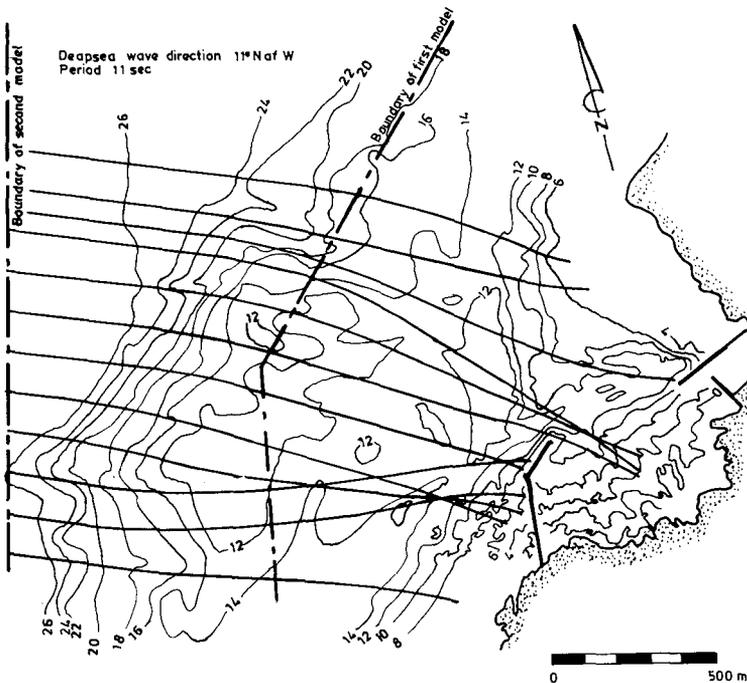
Fig 6. Wave Refraction

The hydrographic survey of the area was also inadequate. The original survey was carried out in a small dinghy with position fixing by theodolites on shore. The high swells and the distance from shore led to inaccuracies and an inadequate coverage of the area seaward of the proposed harbour. Consequently the modelling of the sea-bed was not sufficiently accurate and did not extend far enough out to sea to ensure correct reproduction of the waves in the vicinity of the proposed breakwater. It was not realised at the time that the outlying reefs resulted in marked focussing of waves at certain frequencies on to the line of the proposed new breakwater as shown in figure 6.

The adoption of this unusual alignment was unfortunate because it moved the breakwater towards deeper water and a concentration of wave energy near the proposed bend. Refraction diagrams based on more extensive hydrographic surveys carried out later confirmed this focussing effect. An example is shown in figure 6.

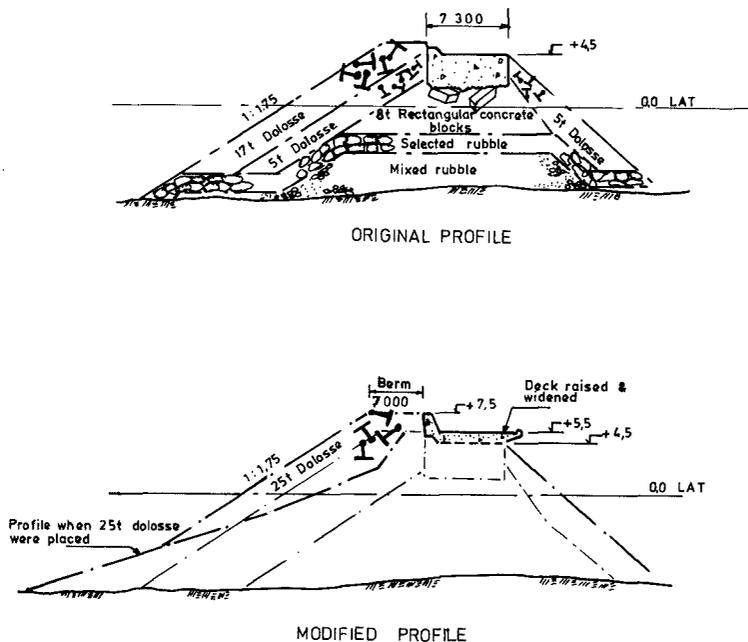
Fig 7. Armoured Rubble Mound Breakwater

Construction of this rubble mound extension of the breakwater proved to be no less difficult than construction of the caisson wall. The fractured quartzitic sandstone available for rubble in the core contained a high percentage of fines of which large quantities were washed away. Due to the shortage of the specified selected rubble a layer of 5 ton dolosse was initially placed over the rubble core. Later 8 ton rectangular blocks were used for this purpose. These units helped to prevent the immediate loss of core material but allowed considerable quantities of fine material to be leached out with the passage of time. This loss of core material combined with the structural weakness of the 5 ton dolosse, resulted in marked settlement of the deck over several sections. One section of the deck had to be demolished and rebuilt in order to fill the large cavity which had developed under the deck.

The weakest section of the rubble mound breakwater was found to be at the interface with the vertical wall. This was probably due to the focussing of waves on to this section of breakwater and the lack of interlock between the vertical wall and the rubble mound breakwater. The deflection of wave energy off the flat end of the caisson wall could also have contributed to the damage which occurred repeatedly to the breakwater along this section. Several unsuccessful attempts were made to reproduce this damage in a wave flume and in a later 3 dimensional model study. The damage was probably aggravated by fracturing of the 5 ton dolosse between the core and the deck or the overlying 17 ton dolos layer and possibly by low packing density of the dolosse.

The leeward slope of the rubble mound breakwater which was protected with 5 ton and later 12 ton dolosse also suffered considerable damage in the first year after completion because of heavy overtopping and because of the penetration of wave energy through the highly permeable 5 ton dolos layers underlying the deck. Reasonably successful attempts were made to repair the erosion of the inner face by sealing the cavities with concrete pumped into filter cloth bags and providing a steeper leeward slope so that overtopping waves could expend their energy into the enclosed basin.

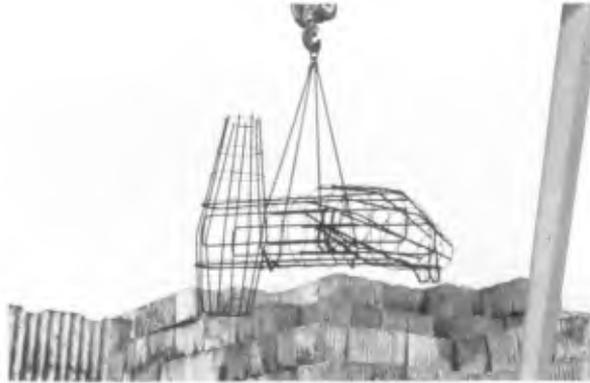
Fig 9. Reinforcing of toe dolos

Specific attention had to be given to the stability of the toe of the dolos layers because of the relatively smooth sea-bed seawards of the caisson wall coupled with reflected wave energy from the wall. Model tests indicated that the toe line of dolosse would move out of position at relatively low wave heights (1,5 m). A special reinforced "toe dolos" was developed with a lowered centre of gravity to prevent overturning and with two projections on the ends of the lower fluke to prevent rocking (see figure 9). To prevent sliding these dolosse were tied back into the mound with heavy chain and a rudimentary anchor.

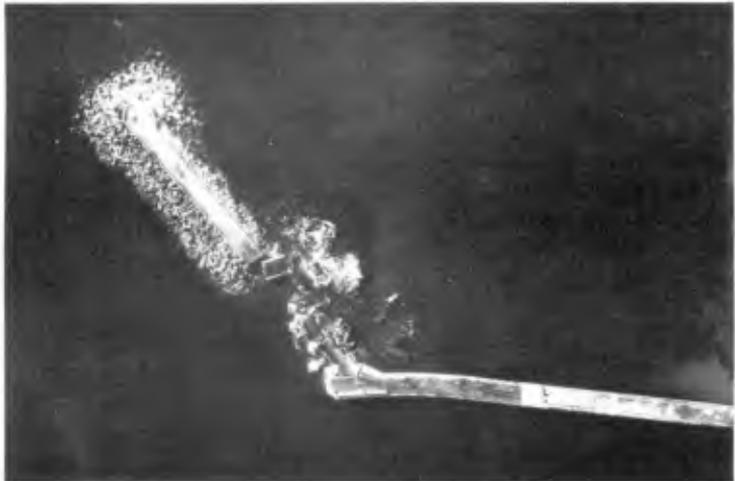
Fig 10. Storm damage to rubble mound breakwater

The contract for the above work was awarded at the beginning of 1979, but in August of the same year, before any remedial work could be carried out, a major storm breached the existing rubble mound breakwater. Other storms followed and eventually almost 60 m of the breakwater was destroyed as shown in figure 10. Model studies were again carried out to determine the most effective way of repairing the breach, and a construction method using 8 t corrugated concrete blocks as a core with a double layer of 25 t dolosse as armouring was eventually successfully used. During the repairs to the breach the junction between the vertical wall and the rubble mound breakwater was reconstructed. The section of the vertical wall extending beyond the rubble mound breakwater was eliminated and a smooth curve introduced. Fortunately no severe storms occurred during these critical stages of the work.
