Experimental Analysis of the Settlement Failure Mechanism Shown by Caisson-Type Seawalls

Shigeo TAKAHASHI¹, Kojiro SUZUKI¹, Katsumasa TOKUBUCHI² Ken-ichiro SHIMOSAKO¹

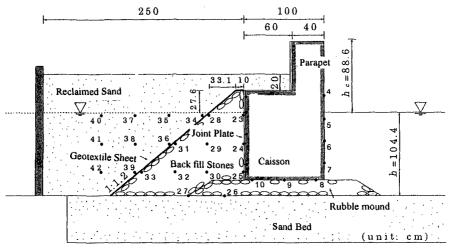
Fig. 3 Cross section of the standard seawall model.

Figure 3 shows a cross section of the standard seawall model in which the geotextile sheet is placed between the backfill stones and reclaimed sand (soil) in order to stop sand from leaking through the backfill. Although the surface of the reclaimed soil is usually paved, this was not simulated in the model.

Models at 1/16-scale were installed in a wave flume on top of a sand bed. The water depth and caisson width were both about 1 m, and crest elevation of the seawall was 88.9 cm, which is relatively high compared to the water depth. Equivalent water depth is about 16 m and crest elevation about 14 m. The locations of more than 40 wave pressure and pore pressure transducers are indicated.

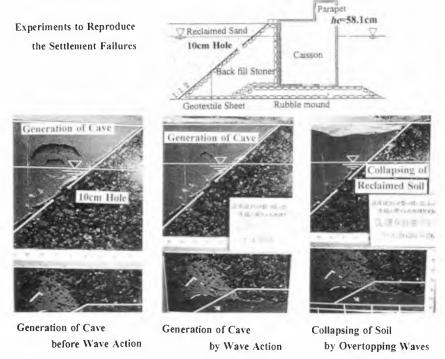
Photo 2 shows the effect of sand leakage before applying wave action. After adding the overlying reclaimed sand, while slowly filling the wave flume with water, sand started leaking through the hole right after the water reached its level, with the end result being the formation of the large tunnel (cave) shown in the photo.

Although larger waves led to a larger tunnel, when wave overtopping occurred, the water motion in the backfill region increased, leading to a higher leakage rate and rapid growth of the tunnel until the weight of the overlying sand suddenly collapsed it. Photo 2 also shows the resultant settlement of the reclaimed sand which is greatest just above the location of the hole.

Photo 2 Soil leakage through a 10-cm hole in the geotextile sheet at a location below the still water level.

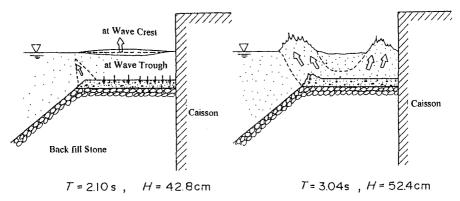
Although no unusual behavior was observed at small wave heights, at a wave height of 42.8 cm, the entire layer of sand appears to lift up as shown in Fig. 9. This is the first indication of sand boiling (liquefaction), with increases in the wave height forcing the sand further upward until boiling occurs. The effect of boiling is disastrous as can destroy both the layer of reclaimed soil and any type of pavement covering this region. As another consequence, the geotextile sheet can be ripped such that an opening occurs.

Fig. 9 Boiling of reclaimed sand.

These experiments confirm that boiling of reclaimed soil occurs when the pore pressure in the backfill region increases close to the overburden soil pressure acting on the backfill region. Consequently, to withstand large wave heights, the layer of the reclaimed soil should be sufficiently thick such that the force produced by the weight of the soil counteracts that produced by the increase in pore pressure in the backfill region; or alternatively, the backfill pore pressure should be reduced by establishing a pressure relief path.

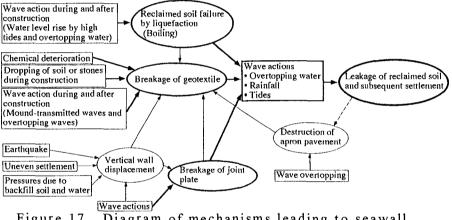
By combining the present experimental results with those from field surveys various mechanisms were found to cause leakage of reclaimed soil, with the loss of this soil subsequently leading to seawall failure by settlement. Figure 17 shows the resultant settlement failure mechanisms using a failure path diagram. For example, failure occurs if the wave actions during and/or after construction breech the integrity of the geotextile sheet, where the soil can then leak into the backfill stone region due to wave actions. The occurrence of sand boiling and damage to the joint plate were also implicated as being important settlement failure mechanisms.

Figure 17 Diagram of mechanisms leading to seawall failure by settlement.
