## CHAPTER 56

### ROCK MOVEMENT IN LARGE-SCALE TESTS OF RIPRAP STABILITY UNDER WAVE ACTION

Thorndike Saville, Jr.

U.S. Army Coastal Engineering Research Center, Washington, D.C.

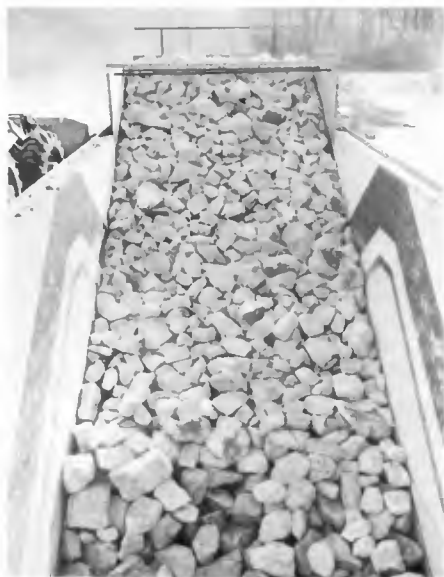
Photo 1  
Limestone before waves.

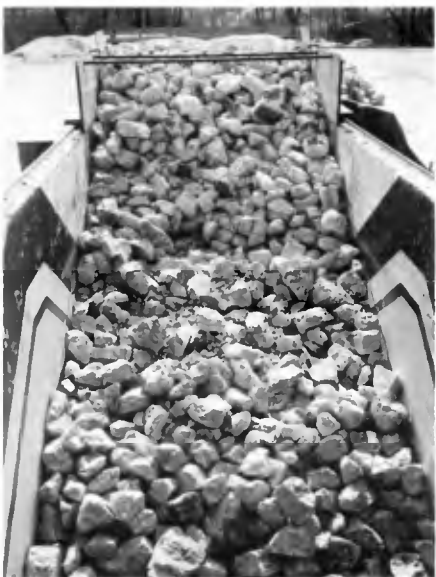
Films will be shown for two rubble covers. Sections of these are shown in Figure 1. The first of these, a Kimmswick limestone, is a graded, well-sorted, subangular rock having a median diameter of 120 lbs. Fifty percent of the stone is in the 9 to 12-inch (50-120 lb.) category and the other fifty percent in the 12 to 16-inch (120 to 275 lb.) category. It thus represents a fairly well-sorted graded material. This was placed from an elevation 7 feet below still water level to an elevation 9 feet above still water level. At elevations lower than -7, larger stone was used primarily to support the Kimmswick stone to this elevation. Stone below -7 was not assumed to be critical or susceptible to movement in the tests. The stone was placed over a layer of smaller spalls, which, in turn, was over a bedding layer, with a bank run gravel core below this. The slope of the structure was 1 on 2. This structure was tested as giving generalized information on well-sorted riprap protection for general application. The particular time lapse film shown is for a wave condition of 3.67 seconds, with waves ranging from 2.55 feet to 3.75 feet in height. Considerable motion is observed at the lower wave heights, with major damage being initiated at a height of 3.45 feet, and severe damage occurring at a height of 3.75 feet.

Photo 2  
Limestone after waves.

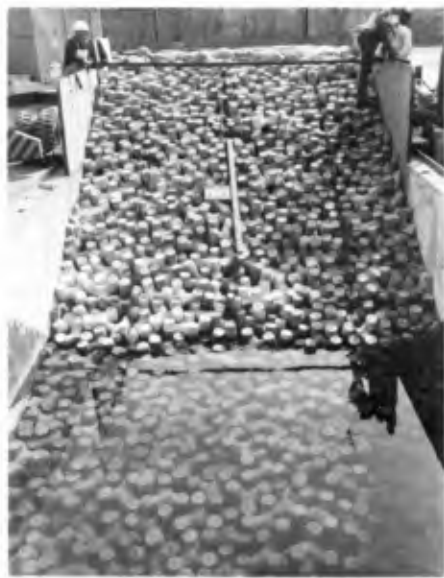
Photo 3  
Tribars before waves.

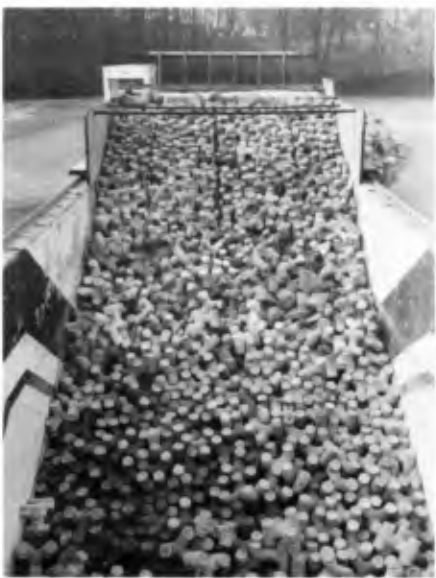
The wave conditions for the pictures are again a 3.67-second period, with heights ranging from 2.55 to 4.35 feet. Once again considerable movement and shifting of the tribars is seen even at the low wave heights; damage is initiated at a height of 4.05 feet, with severe damage occurring at the height of 4.35 feet.

Another interesting factor shown in the pictures is that frequently when a stone is plucked out or otherwise removed from a place in the structure, leaving a damage hole, stone or rubble near to it tend to move into this hole and reheal the damaged section.

Photo 4  
Tribars after waves.
