LARGE SCALE IMPACTS OF JETTIES AND TRAINING WALLS - EXPERIENCE ON THE AUSTRALIAN EAST COAST

Angus Gordon, Coastal Zone Management and Planning, angusczm@icloud.com
Alexander Nielsen, Advisian Worley Group, lex.nielsen@avisian.com

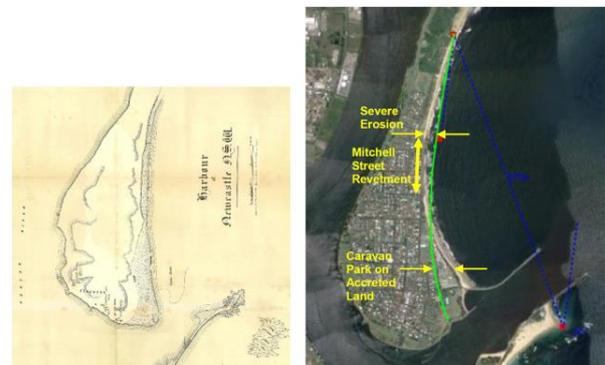
Figure 1 - Left: Entrance to Newcastle Harbour (circa 1850). Right: Present-day entrance with MEPBAY 1850 predicted shoreline superimposed indicating foreshore realignment and severe erosion and accretion.

Between 1898 and 1912 an 890 m long jetty was constructed on the northern side of the Hunter River ocean entrance. This had a significant impact on the shoreline at Stockton. The jetty cut off the flood tide channel that had run south along the beach and into the entrance. The result was not only the effective removal of the entrance sand bar but, by cutting off southerly wave influences in its vicinity, also resulted in a significant accretion of sand on the northern side. This accretion moved the shoreline approximately 300 m seaward at the jetty and resulted in a buildup of beach sand estimated to be in the order of two million cubic meters (see Figure 1).

However, beach erosion to the north was induced as the shoreline responded to the changed tidal flow and wave conditions. A software package called Model for Equilibrium Planform of Bay Beaches (MEPBAY; Klein *et al.* 2003) was used to calculate the shoreline planform of Stockton Beach prior to jetty construction (Figure 1 right). This modelled shoreline was verified by reference to historical surveys (Figure 1 left) and indicated both the accretion that has occurred on the northern side of the jetty and the severe erosion that has occurred on Stockton Beach resulting from the formation of a crenulated-shaped embayment.

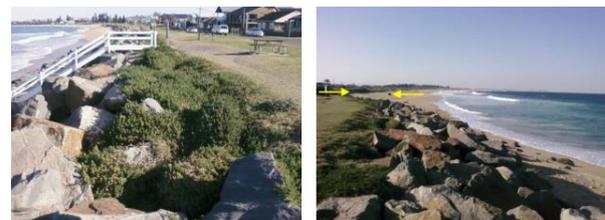
Figure 2 - Left: Rock revetment to protect Mitchell Street Right: Severe erosion north of the rock revetment

The erosion has continued due to both the realignment of the beach and the net loss of sand blown into the dunes of Newcastle Bight (Gordon & Roy, 1977). This has resulted in the requirement to construct a rock revetment to protect Mitchell Street and the village (Figure 2). More recently it has been necessary to undertake beach nourishment to offset the on-going coastal recession.

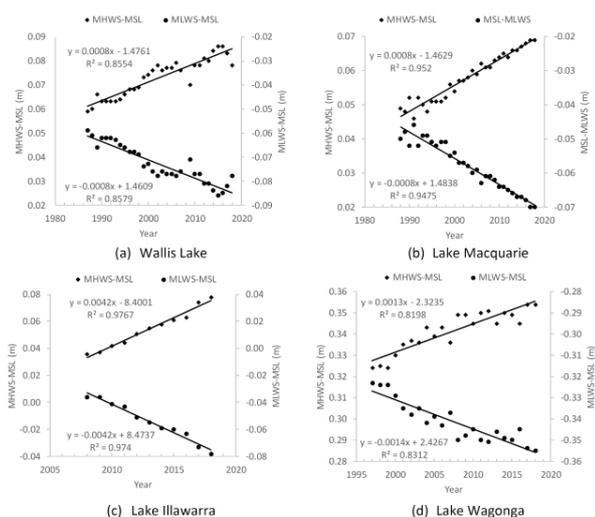
Figure 3 - History of changes in spring tidal planes in (a) Wallis Lake, (b) Lake Macquarie, (c) Lake Illawarra and (d) Lake Wagonga. Notes: various scales; Data courtesy of NSW Office of Environment and Heritage.

Field data and hydraulic theory confirm that jetties have increased the tidal conveyance of entrance channels by removing sand bars, extraneous littoral currents and associated sand movements that, previously, impeded ebb tide discharges (Nielsen & Gordon 1980, 2008, 2011, 2015, 2016; Couriel *et al.* 2013). Comprehensive water level monitoring in several NSW coastal lakes where entrance jetties have been constructed has shown that tidal ranges have been increasing steadily for decades (Figure 3), if not centuries in the case of Lake Macquarie, with high tide planes rising, low tide planes falling, tidal velocities increasing, channels scouring and tidal deltas growing, all having adverse impacts on marine ecologies.

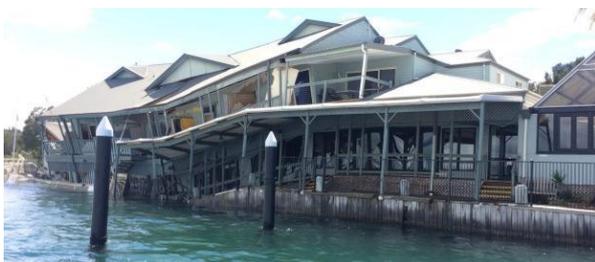
Figure 4 - Swansia Channel foreshore building collapse due to bed scour (Photo: 8/2/2016 Fire & Rescue NSW).

Training walls also can cause scour. A channel with a single training wall can have 16% higher discharge and a channel with twin training walls can have 20% higher discharge than a natural channel of equivalent cross-sectional area (Nielsen & Gordon 2016), increasing velocities and, potentially, channel scour (Figure 4).
