Building Foundation Instability Induced by Tsunami Scour

INTRODUCTION

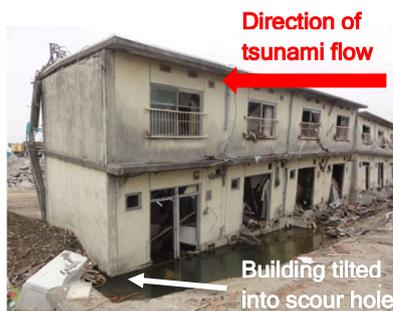
Figure 1 - Apartment block scouring at the seaward end in Yuriage, Japan due to the 2011 Tohoku tsunami (Fraser et al., 2013)

Soil weakening following a tsunami wave can result in foundation failure for shallow foundation buildings, mainly due to bearing failure which causes undermining and subsequently, tilting, as seen in Fig. 1 (taken from Fraser et al., 2013). Tsunami scour can cause the reduction in foundation depth. As a result, loading from the building

and any other imposed loads can no longer be transferred into the ground, resulting in the collapse of the building, either immediately or over time.
