RECOVERY OF SANDY BEACH AFTER TYPHOON WAVES - CASE STUDY ON CHIGASAKI COAST

Toshinori Ishikawa¹, Takaaki Uda², Jun-ichi Hosokawa³ and Toshiro San-nami⁴

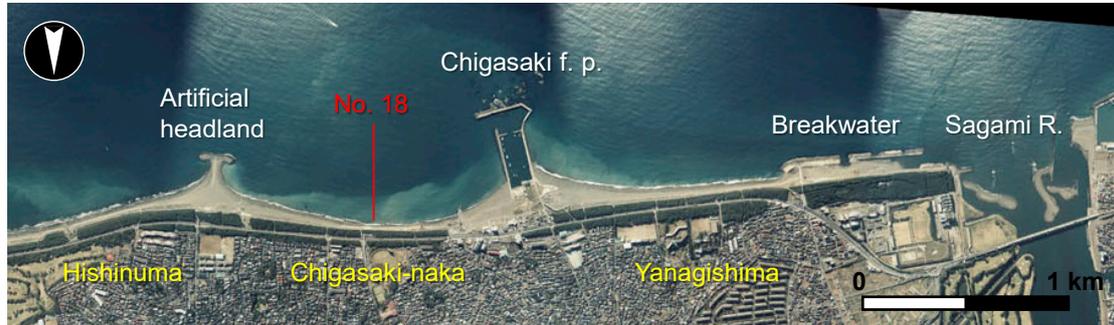
Figure 1. Satellite image of Chigasaki-naka area.

The Chigasaki coast is located 1 km east of the Sagami River mouth, as shown in Fig. 1. This coast has been formed owing to the deposition of sand supplied from the Sagami River and transported by eastward longshore sand transport. The beach, however, has been eroded owing to a rapid decrease in fluvial sand supply from the Sagami River and the blockage of eastward longshore sand transport caused by the construction of the Chigasaki fishing port (Ishikawa et al., 2009). As a measure against beach erosion, an artificial headland was constructed 1 km east of the fishing port in 1990, and beach nourishment using materials composed of sand and gravel with grain sizes greater than those of the original seabed materials has been carried out at a rate of 3×10^4 m³/yr on the Chigasaki-naka area since 2005 (Ishikawa et al., 2013; 2018). As a result, the shoreline has markedly advanced by 2019. However, storm waves of the largest level in observation history associated with typhoons hit this coast several times since 2007, causing the damage to the cycling road along the coastline. Figure 2 shows the occurrence of significant wave height and wave period in these typhoon events, measured at a 20 m

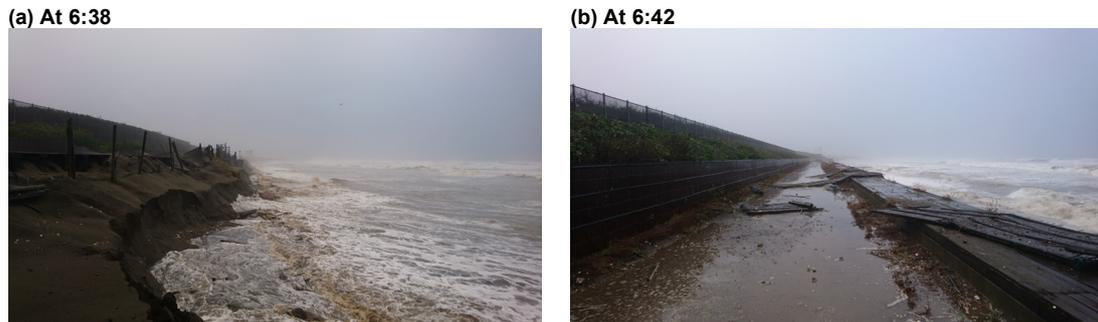
Figure 4. Erosion of sand mound along the coastline and wave overtopping to walkway in Hishinuma area during T1721 measured at 6:38 and 6:42 on October 23, 2017, respectively.

In Fig. 3, part of wave observations is lacking during T1115, T1721, and T1919. For example, although wave data were not available after the observation of $H_{1/3} = 7.1$ m ($T_{1/3} = 11.2$ s) at the Hiratsuka wave observatory when T1721 hit on October 23, 2017, high waves with $H_{1/3} = 8.28$ m ($T_{1/3} = 11.1$ s) was measured offshore of the Seisho coast 6 km west of the coast on the same day. Moreover, in these events, the duration of storm waves with a wave height over 2 m and a period longer than 10 s was extremely long compared with that in the other events, and the sea level significantly increased, as shown in Table 1. As a result, storm waves ran up to the backshore, and overtopping waves reached the cycling road. In the Hishinuma area, the cycling road was destroyed during T1721, as shown in Figs. 4(a) and 4(b).

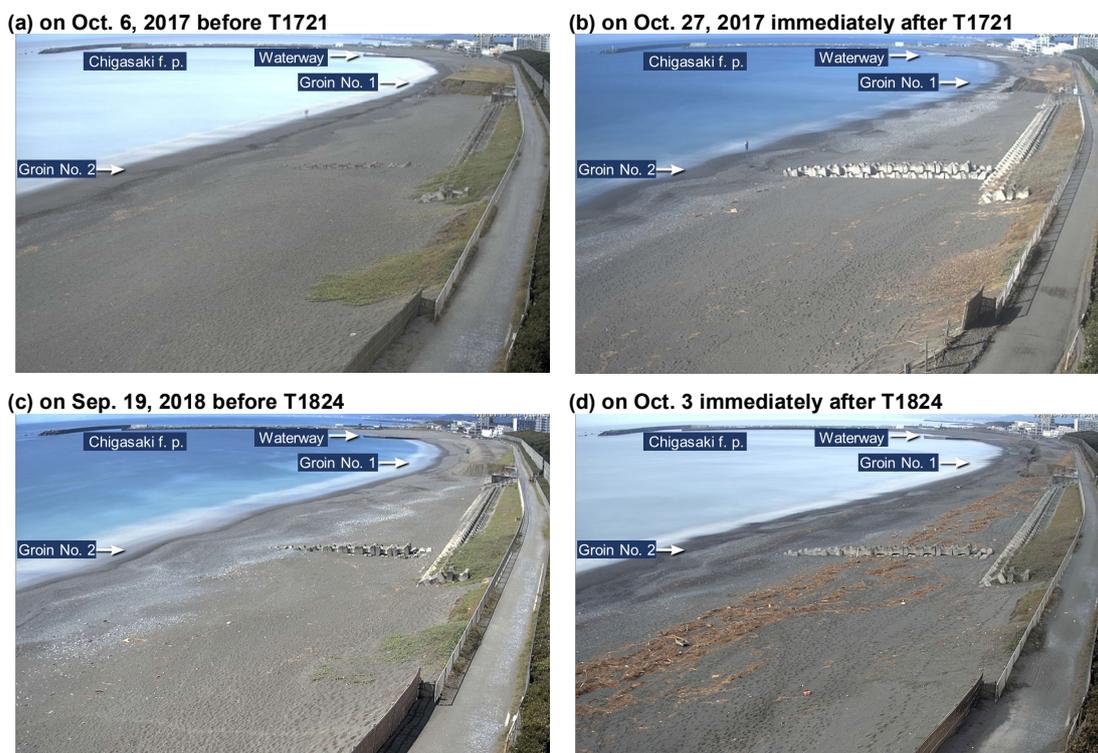
Figure 7. Images of the coast taken from a fixed point before and after T1721 and T1824.

On October 23, 2017, T1721 hit the coast, causing damage to the walkway along the coastline and the fences for preventing windblown sand. Figures 7(a) and 7(b) respectively show the images of the coast on October 6, 2017 before T1721 and October 27, immediately after T1721, taken from a fixed point on the Chigasaki-naka area. After the rough waves of over $H_{1/3} = 7.1$ m and $T_{1/3} = 11.2$ s during T1721, concrete armor units composing a groin buried under the beach surface were exposed by a relative height of approximately 1 m, indicating erosion of the backshore during the storm. Moreover, the fences for preventing windblown sand to the walkway were severely damaged by run-up waves. On the other hand, beach cusps composed of gravel were formed on the beach face within three days immediately after the storm waves.

In 2018, another typhoon T1824 hit on October 1 with rough waves of $H_{1/3} = 5.7$ m and $T_{1/3} = 10.4$ s, as shown in Fig. 3(c). Figures 7(c) and 7(d) show the foreshore and backshore changes before and after T1824 respectively. On September 19 before T1824, large amounts of sand and gravel were deposited on the shoreline, and the second layer of the groin composed of concrete armor units was invisible on the backshore because of the sand deposition. However, on October 3 after T1824, the backshore was eroded similarly to the event immediately after T1721, as shown in Fig. 7(b). Although a trough remained on October 6, 2018 with the change in longitudinal profile, as shown in Fig. 8(c), the effect of storm waves during T1824 have partly remained.
