# WAVE OVERTOPPING TESTS TO DETERMINE TROPICAL GRASS SPECIES AND TOPSOILS FOR POLDER DIKES IN A TROPICAL COUNTRY

A dike or levee will protect a polder to build in a tropical country against coastal flooding. To ensure that the performance of the dike is in accordance with the safety standard, wave overtopping tests with a wave overtopping simulator have been performed on a mock-up dike. These wave overtopping tests will guide the selection of the grass species and topsoil for the grass cover of the landward side of the dike. The paper describes the design of a new dedicated wave overtopping simulator, the construction of the mock-up dike, the results of the eight tests on the mock-up dike and the critical velocities (strength indicator of the grass cover) established with the cumulative overload method.

*Keywords: wave overtopping, wave overtopping simulator, grass cover, dike, levee*

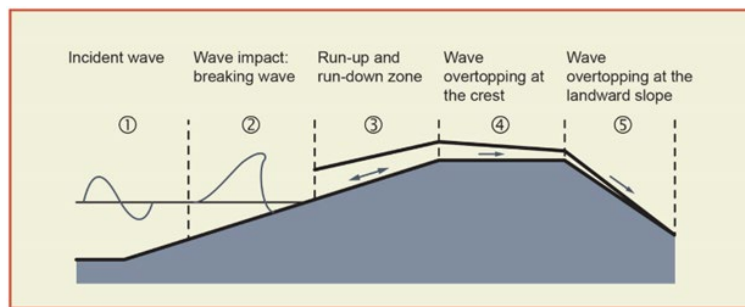
Wave overtopping has been described in EurOtop (2018) and is adopted in this wave overtopping test. Figure 1 shows the process of wave breaking, run-up and overtopping at a dike. Calculations that will be the input for the design of the wave overtopping simulator are performed up to aspect 4 in Figure 1. The wave overtopping simulator will simulate overtopping waves on aspect 5 in the graph, where the landward slope is the subject of the testing.

Figure 1. Wave breaking, run-up and overtopping at a dike. Original Fig. 4.32 in EurOtop (2018).

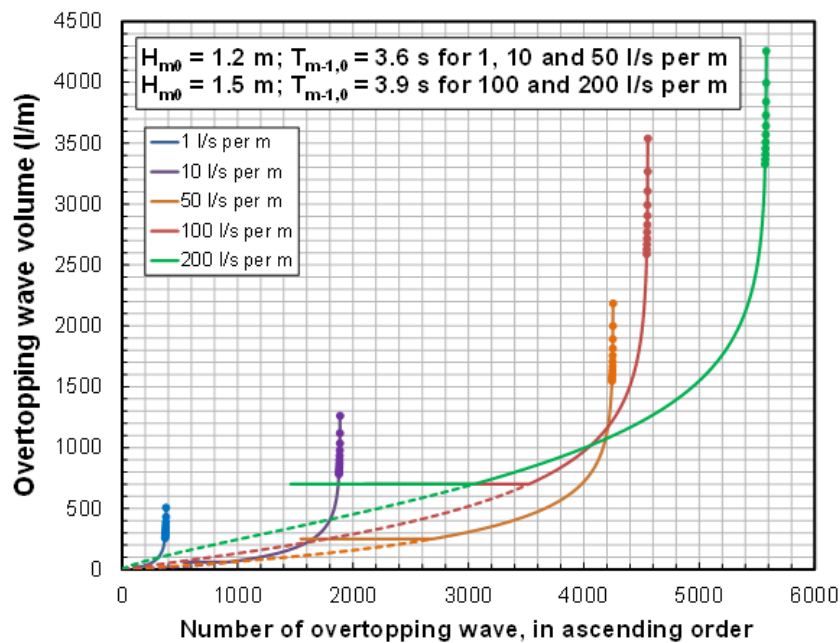
Figure 2 gives the distributions of overtopping wave volumes for all test conditions. The first test condition of 1 l/s per m has only 400 overtopping waves and a maximum of only 500 l/m. The graph with solid lines shows the overtopping volumes that have been simulated and the 10 largest volumes of each overtopping rate were indicated with markers. The dashed line gives the theoretical lower part of the distributions, the horizontal lines represent the minimum volumes that can be simulated by the wave overtopping simulator, depending on the pump discharge rate (i.e. volume and time taken to fill the simulator). The distributions of overtopping wave volumes in Figure 2 have been randomly simulated during testing.

Figure 2. Distribution of overtopping wave volumes as simulated for all test conditions.

A dedicated design of the overtopping simulator was made to match the design conditions at the project site and beyond. Design calculations for the wave overtopping simulator, as shown in Figure 2, led to a minimum volume of the simulator of approximately 4 m<sup>3</sup> per m. The simulator was 4 m wide, equal to the Dutch and Vietnamese simulators and had a volume of 4.3 m<sup>3</sup> per m width, or 17.2 m<sup>3</sup> in total.

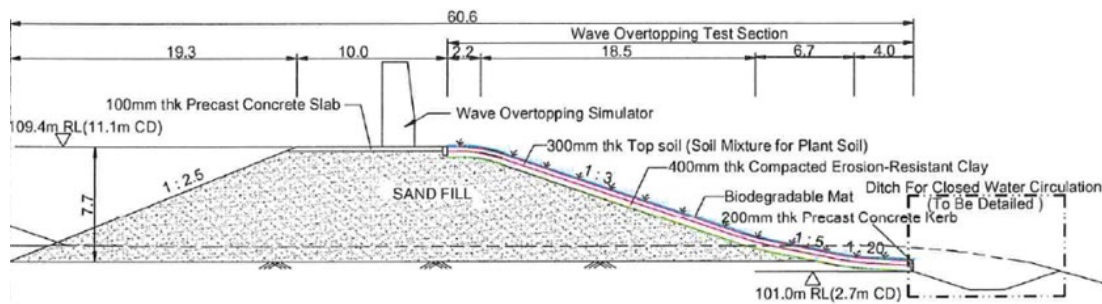
A cross-section of the mock-up dike for test plots 1-6 is shown in Figure 3. The first three combinations had a 300 mm topsoil, given as the so-called CUGE’S Alternative Soil Mix. The next combinations had the HDB Standard Soil Mix. Two types of grass were seeded in three combinations: Bermuda Grass (Cynodon Dactylon), Manila Grass (Zoysia Matrella) and a combination of 50% Bermuda with 50% Manila grass. Table 1 gives an overall view of the 8 test combinations with top soil and grass cover. Test plots 7 and 8 had the HDB Standard Soil Mix with the 50% combination of Bermuda with Manila grass. Topsoils and grass types were specified by the HDB.

**Figure 3. Cross-section of the mock-up dike for Test plots 1-6. The landward side (right) from the crest till toe has been constructed as designed for the actual dike.**

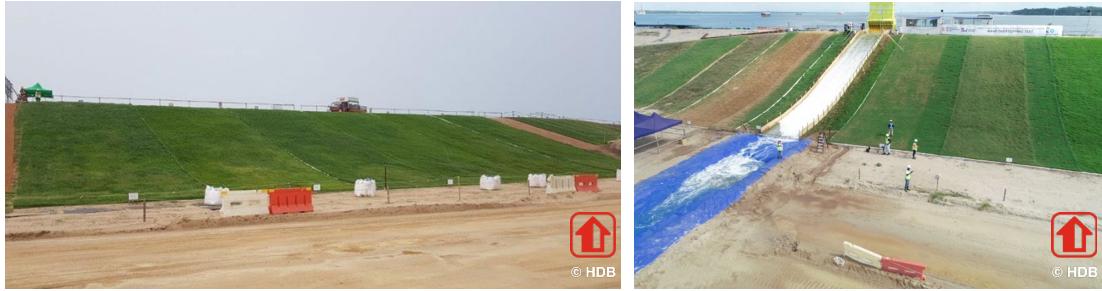
Figure 4 (left) gives an overall view of test plots 1-6 after half a year of seeding in September 2019. At that time the situation grass growth was already quite established and the first grass pull tests were performed after half a year of seeding.

The actual testing with the wave overtopping simulator started in March 2020, one year after seeding of the grass. The grass pull tests were also repeated. Due to the COVID-19 pandemic in March 2020, the testing did start, but was temporarily suspended after two tests on test plot 1 and 2. The tests for the remaining plots resumed in October 2020 and all the tests had been finished by November 2020. Figure 4 (right) shows an overall view of the test sections in March 2020, when testing test plot 2.

**Figure 4.** Overall view of Test plots 1-6, September 2019 (left). Overall view by drone of testing test plot 2. The tested Test plot 1 (brown grass) is on the left side and Test plots 3-5 on the right side.

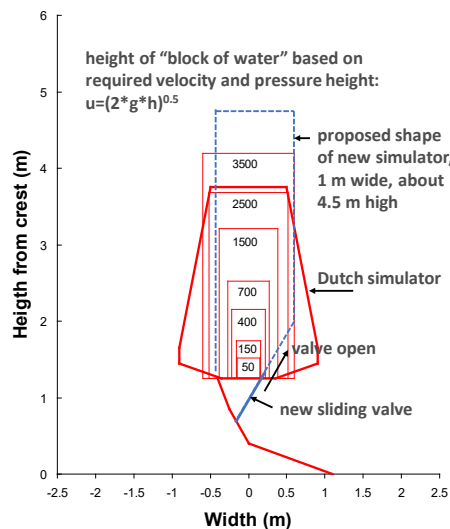
Figure 5 gives the theoretical cross-section of the new simulator. The cross-sectional width is 1 m and rectangular in shape. In order to guide the released water best, a drawer type valve is designed under an angle of about 45° and opens upwards. The height, from lowest point of valve up to the top, will be around 5 m, giving the total volume of 4.3 m<sup>3</sup> per m width.

**Figure 5.** Cross-section of the new wave overtopping simulator.

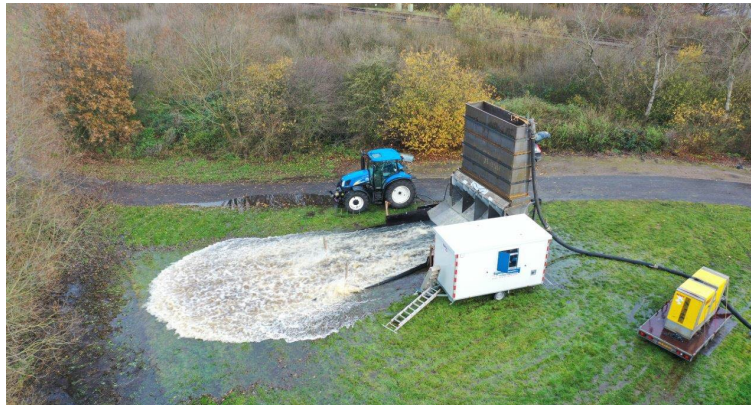
The wave overtopping simulator was designed and constructed in the second half of 2019 and calibrated in December 2019 in the Netherlands. Figure 6 shows the set-up for this system test. Outflow velocities were measured and were according to expectations. The steering system was also tested and worked well. The simulator was transported in three pieces (the lower frame with valve, a middle box and an upper box) to the project site in 40 feet container in January 2020.

Figure 6. One of the first wave releases during the system tests, directly after fabrication.

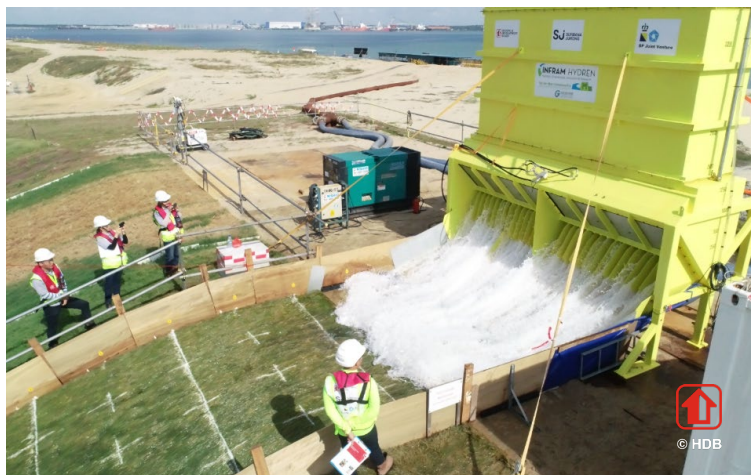
In February 2020, the test was set-up at the project site for test plot 1. The wave overtopping simulator was placed on a concrete crest with the outflow 1.5 m from the start of the grass at the

landward side of the crest, see Figure 7. Two pumps with a capacity of about 800 m<sup>3</sup>/hour were installed to extract seawater to the simulator via a pipeline as shown in Figure 7.

Figure 7. The wave overtopping simulator in action, taken by drone. The pipeline for water supply is shown in the background behind the simulator.

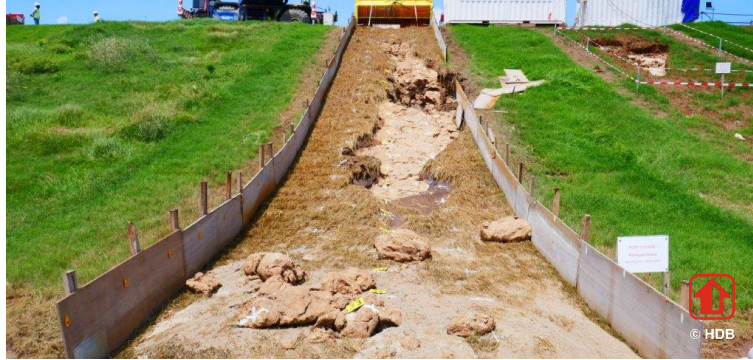
Some of the test plots failed at some instance, a few withstood the whole test sequence up to 200 l/s per m of overtopping discharge. Figure 8 shows the final situation of test plot 3 after a little more than 1 hour with the last subtest of 200 l/s per m overtopping that is far beyond the design requirements. Superficial erosion of the topsoil led to small erosion holes and subsequently a large erosion hole where the subsoil had also eroded.

Figure 8. Test plot 3. The outcome after 1 hour and 11 minutes with 200 l/s per m (a condition far beyond design requirements). The side wall was undermined and failed. Large lumps of subsoil were eroded.

minutes testing with 200 l/s per m. The total cumulative overload after 6 hours with 1, 10, 50, 100 l/s per m and 1 hour and 11 minutes testing with 200 l/s per came to  $D = 6162 \text{ m}^2/\text{s}^2$  for  $U_c = 7 \text{ m/s}$  and that is close the criterion for failure of  $D = 7000 \text{ m}^2/\text{s}^2$ .

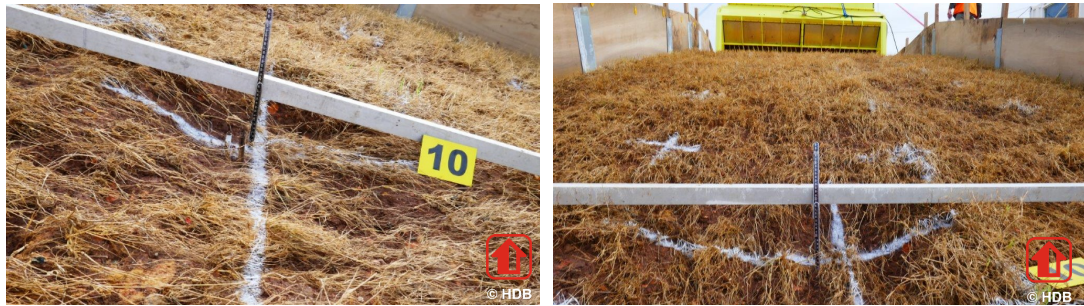
Similar processes were also observed in test plot 4. Superficial erosion of the topsoil led to larger erosion holes, as seen in Figure 9 after 50 l/s per m of overtopping. Although the topsoil has eroded, the grass is still maintained. Grass was only removed when all the topsoil had been eroded as shown in Figure 10.

Figure 9. Test plot 4. Initial erosion hole after 6 hours with 50 l/s per m. The topsoil is largely eroded with the grass still maintained.

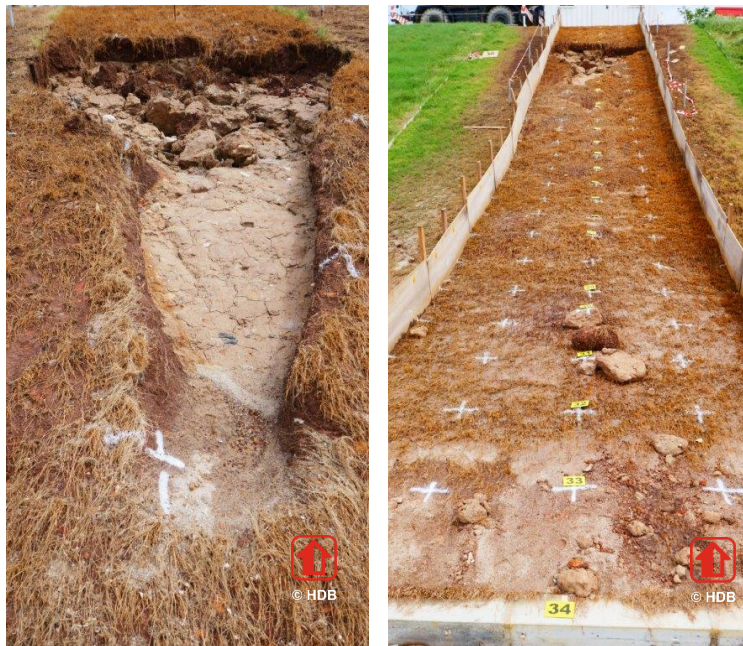
The final damage at test plot 4 also occurred about 1 hour into the test with 200 l/s per m overtopping that is far beyond the design requirements. Refer to Figure 10. The topsoil, as well as the subsoil, had been eroded and the sand core eroded quickly. In addition, the mechanism of head-cut erosion was

present and can be noticed in Figure 10. In such a case, water infiltrates the clay above the hole and large lumps of clay fall into the erosion hole and are then taken by large overtopping waves. In such a way, a vertical front is present and this vertical front travels upwards to the crest.

Figure 10. Test plot 4. The final situation after terminating the test at 1 hour and 38 minutes with 200 l/s per m (a condition far beyond design requirements); left the large erosion hole with the mechanism of head cut erosion and right the whole slope seen from the toe.

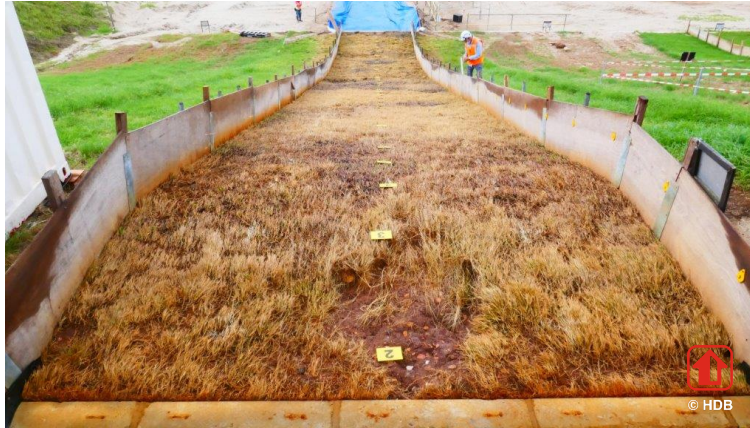
Test plot 5 did not show major damage and survived the full sequence of testing as shown in Figure 11. The topsoil eroded less and seemed to be stiffer than at all other plots. Small erosion holes and an erosion hole near the crest at the transition from concrete crest to grass were detected. In most of the plots that kind of damage or erosion occurred, but it never led to deep erosion or failure at the crest.

**Figure 11. Test plot 5. The slope at the crest after 200 l/s per m, with the erosion area directly behind the crest.**

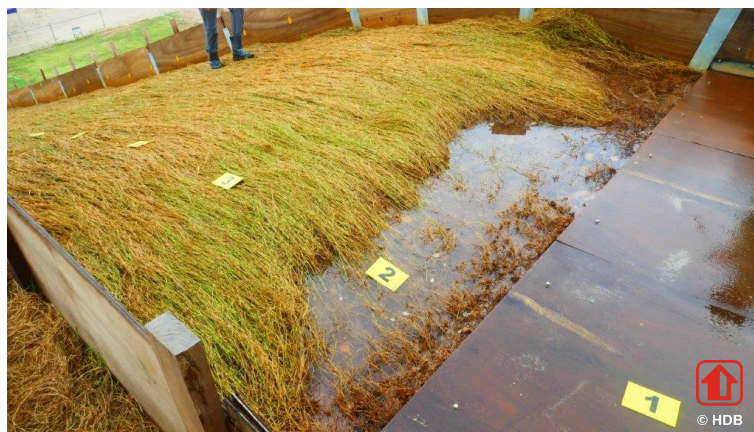
The Bermuda grass at test plot 6 had taken over Manila grass. However, the grass in test plot 6 had not yet been mowed to test the influence of long and not mowed grass on the erosion resistance. The grass was about 30-40 cm long with some individual grasses over 1 m in length. The grass acted as an armour to the topsoil, see Figure 12. There was little superficial erosion, but no erosion holes were detected. The pack of grass became thinner during testing, but it acted as an armour during the whole testing. Only some erosion was noticed at the transition from the concrete crest to grass as shown in Figure 12 but did not lead to failure.

**Figure 12. Test plot 6. Long grass (30-40 cm). Final situation after 200 l/s per m discharge at the crest.**

If no failure was reached, then a minimum critical velocity was given. For example, test plot 6 did not fail after the full test of 200 l/s per m. A cumulative overload of  $D = 16,069 \text{ m}^2/\text{s}^2$  is related a critical velocity of 7 m/s. As the slope did not fail the critical velocity is certainly larger than 7 m/s. But for a critical velocity of 8 m/s the cumulative overload is only  $1418 \text{ m}^2/\text{s}^2$  and that is much smaller than the failure criterion with  $D = 7000 \text{ m}^2/\text{s}^2$ . One cannot say that the critical velocity should be larger than 8 m/s. Therefore, the critical velocity will be larger than 7 m/s, in between 7 m/s and 8 m/s where the cumulative overload of  $D$  is equal to  $700 \text{ m}^2/\text{s}^2$ .

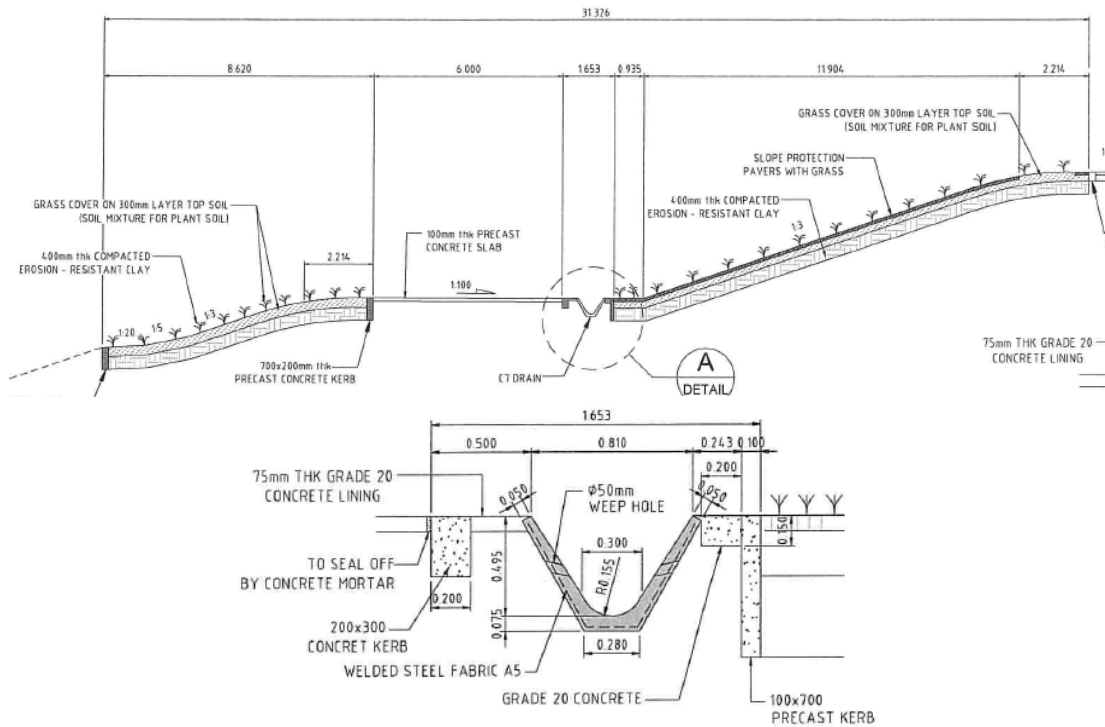
Test plot 7 had a ramp or road crossing in the mid-section of the slope, see Figure 13. The upper slope consisted of open pavers and bricks. A drain with precast concrete elements had been designed between the upper slope and the ramp, which was constructed in sand. Earlier tests had shown that erosion of sand may lead to early failure. Therefore, test plot 8 had been designed without a drain and pavers.

Figure 13. Cross-section of the road crossing at test plot 7.

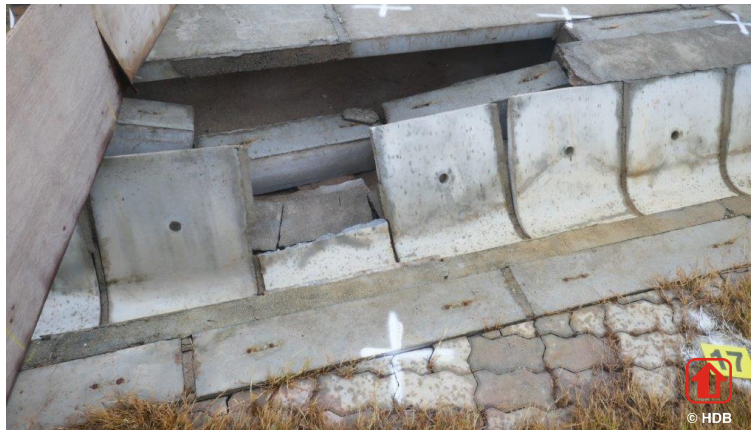
The overtopping waves eroded the topsoil from the open pavers on the upper slope and then also beneath the pavers. The waves could reach the sand underneath the drain and started to erode this sand. It undermined the precast drain and just after the start of the 100 l/s per m (a condition that is far beyond the design requirement) the drain collapsed, see Figure 14. Not only the drained had been undermined, but also quite a large part underneath the ramp or crossing road (the horizontal concrete plate at the top in Figure 14). At the time of this failure, the open pavers that were undermined were still present. They

acted as an arc without support of soil and it could be assumed that it was only a matter of time that this structure would also have collapsed.

Figure 14. Test plot 7. Collapsed channel drain and large erosion hole underneath the road section, after 31 minutes of 100 l/s per m (a condition far beyond design requirements).

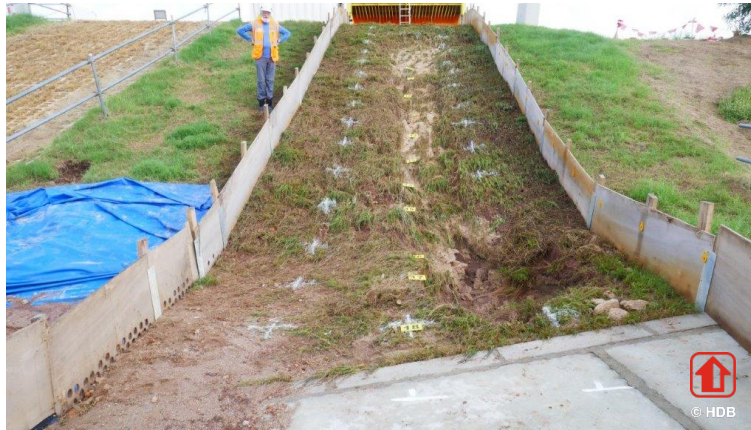
As test plot 8 had the same ramp as in test plot 7, but with no drain or open pavers, it was expected that this section would be stronger. But due to unknown reasons the topsoil of the upper slope appeared to be very erodible. After 2 hours of 50 l/s per m, a condition beyond design requirements, the upper slope has eroded and the sand core has exposed. See Figure 15. Due to this early failure of the upper slope, it was not possible to test the transition from grass to ramp up to failure, and the difference in design with and without drain could not be determined.

**Figure 15.** Test plot 8. The final situation of upper slope seen from the road after 2 hours of 50 l/s per m (a condition beyond design requirements).

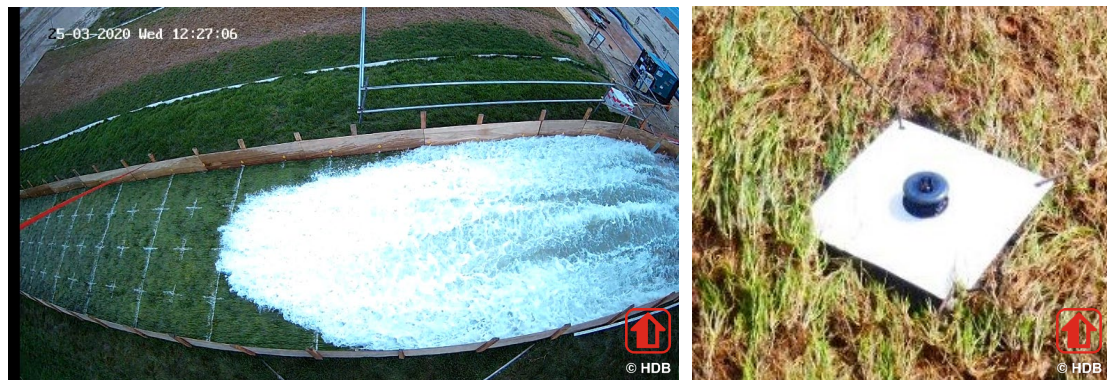
In order to apply the cumulative overload method, it is necessary to measure the front velocity of overtopping wave volumes. First a dome camera on a pole was used to record the flow of overtopping wave volumes over the slope. The camera took 50 frames per second and by counting the number of frames needed for the wave front to travel 2 m, the average front velocity over these 2 m could be calculated, see the left picture of Figure 16. Secondly, paddle wheels were placed 3 cm above a plate that was mounted to the soil, see the right picture of Figure 16. The distance between the paddle wheels was 3 m along the slope. Paddle wheels measured the velocity over time at a certain location, which is different from the front velocity.

**Figure 16.** Left: an overtopping wave volume of 1500 l/m reaching the 12 m line 13 frames after reaching the 10 m line; front velocity 7.67 m/s. Right: Paddle wheels mounted on the grass slope, 3 cm above the slope.

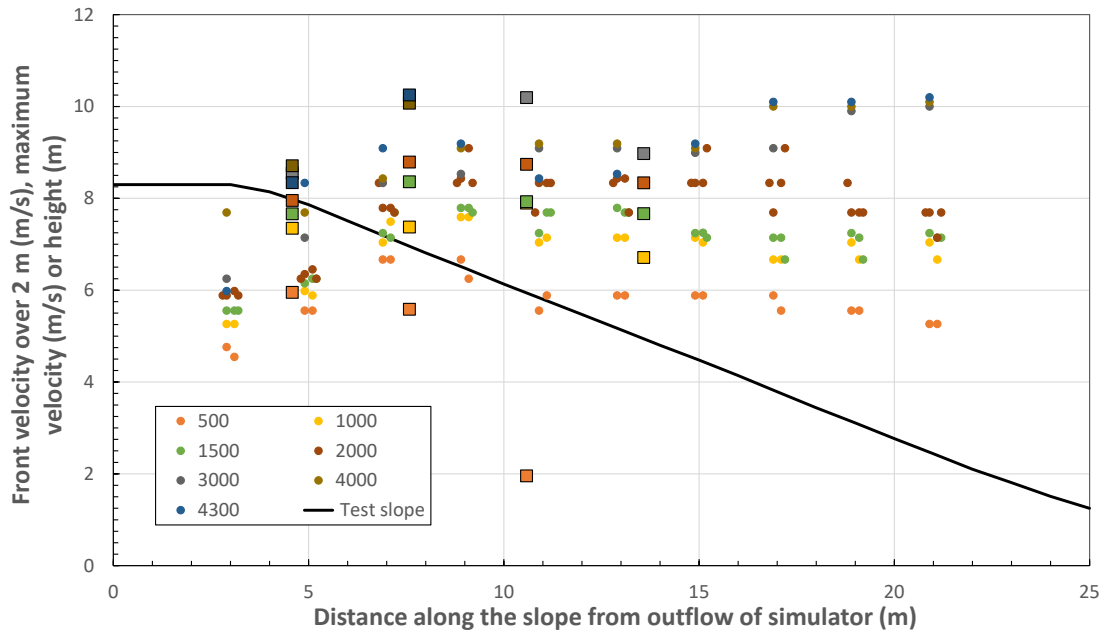
Front velocities were determined for specific released overtopping wave volumes from 250 l/m to the maximum of 4300 l/m and from 2 m from the crest up to 22 m along the slope. Maximum velocities were measured at 1.5 m, 4.5 m, 7.5 m, 11.5 m and 14.5 m. Figure 17 shows all the results with the geometry of the slope in a graph.

Near the wave overtopping simulator the front velocities may differ (slightly) from maximum velocities measured with a paddle wheel. This is because when the water is first released from the simulator, the valve is not fully open and this front determines the front velocity over the first few meters. This probably explains why the graph in Figure 17 shows an increase of front velocity from 3 m to 5 m. This increase could also partly cause by the acceleration of the water down the slope. In general, all overtopping wave volumes show an acceleration from 3 m up to about 9 m. This is expected as gravity will increase the flow over the slope. At some point the flow becomes in balance with the friction and energy dissipation of the grass and becomes more or less constant and may, due to the friction, even reduce in speed. For large velocities on the slope the front velocity and maximum velocity become similar.

Figure 17. Averaged maximum velocities (square symbols) as a function of location on the slope, compared to front velocities (small circles). Similar colours have similar overtopping wave volumes (in l/m in the legend).

Overtopping waves that run over the crest accelerate on the down slope due to gravity. The increase in front velocity may be 2-3 m/s and front velocities of overtopping wave volumes larger than 3000 l/m may become larger than 10 m/s. The largest velocities were found between 5-20 m from the crest and in this area most of the damage was found. It can be concluded that objectives a) and b) were fulfilled as it can be concluded that the dike is safe under design conditions and the wave overtopping tests gave a significant insight in the strength and safety of the dike.
