# RIP CURRENT DETECTION IN AN OPEN AREA AND ALONG JETTY USING AI

*Keywords: rip current; flash rip; fixed rip; field observation; jetty; AI*

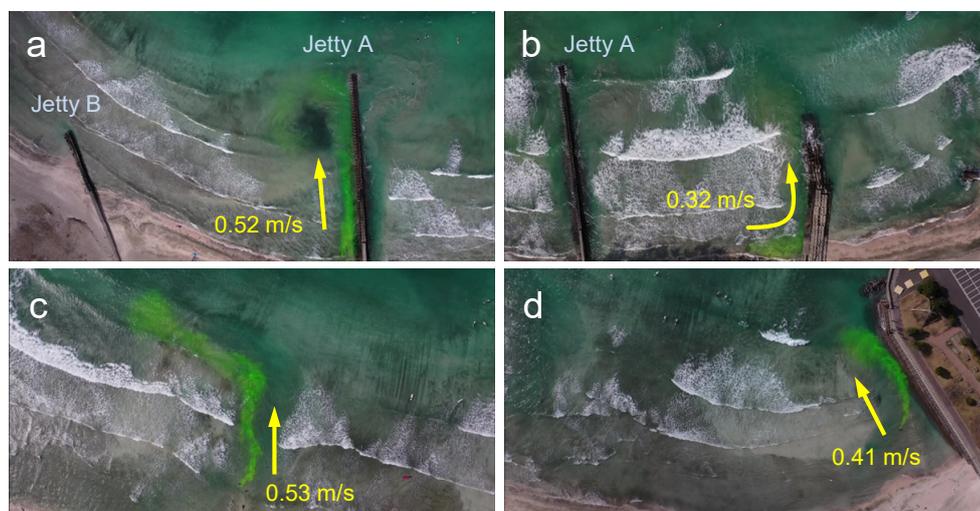
Figure 3. Results of color dye survey.

survey in February 24, 2021. The breaking wave height was approximately 0.5 m. Also, observed wave conditions were  $H_{1/3} = 1.15$  m and  $T_{1/3} = 7.8$  s at Tsuruga wave observatory which is located 53 km northeast of the study beach. Figure 3 shows the results of the color dye survey. It was actually confirmed that rip currents occurred at all areas even under relatively calm wave conditions. Therefore, we installed four web cameras on the beach so that these locations would be within the shooting range of the fixed-point camera. In the shooting range of the cameras 1 and 2 (Cam 1 and 2), rip currents occurring in an open area can be shot, and that of the cameras 3 and 4 (Cam 3 and 4), rip currents occurring along jetty A and B can be shot, as shown in Fig. 4.

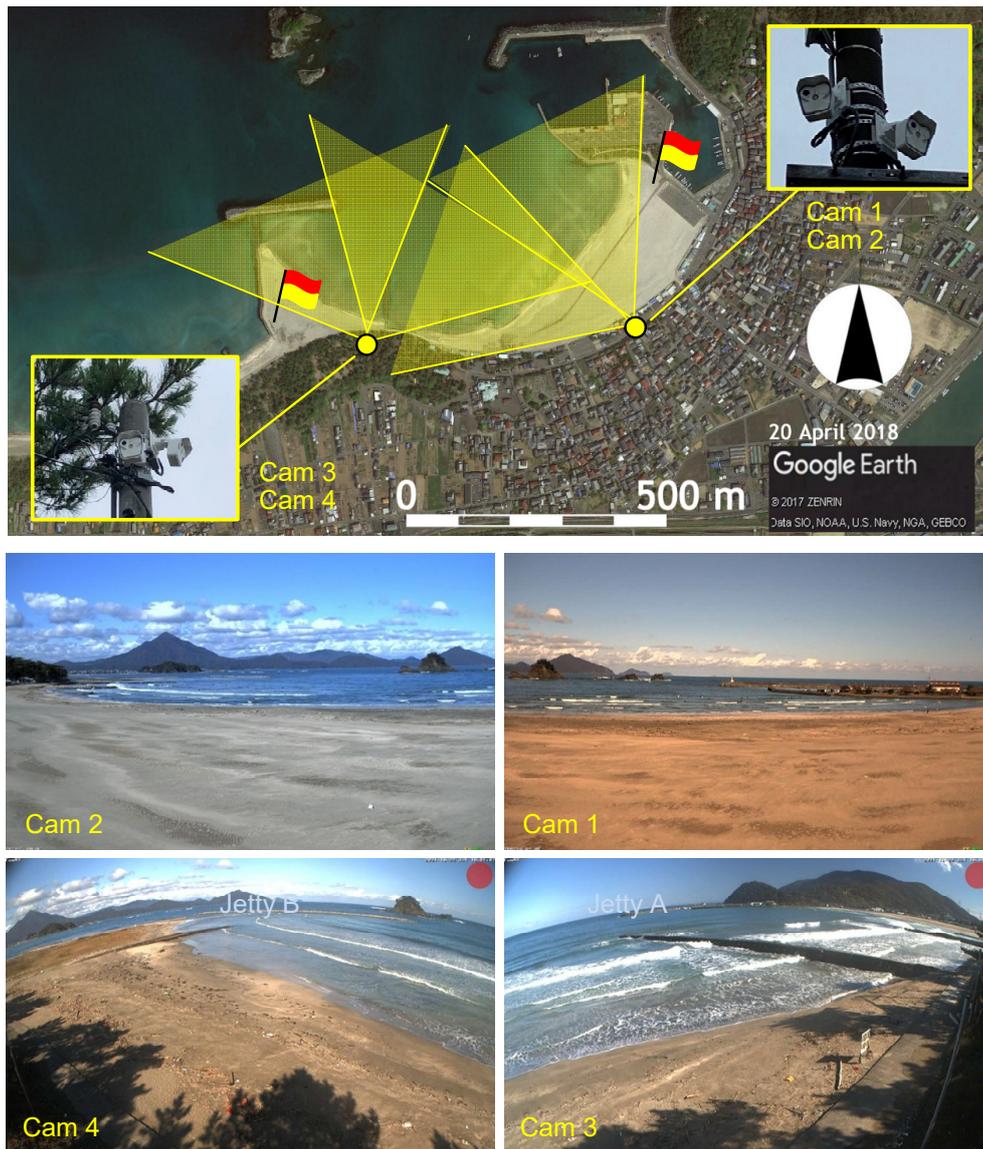
Figure 4. Images of shooting areas by 4 web cameras.

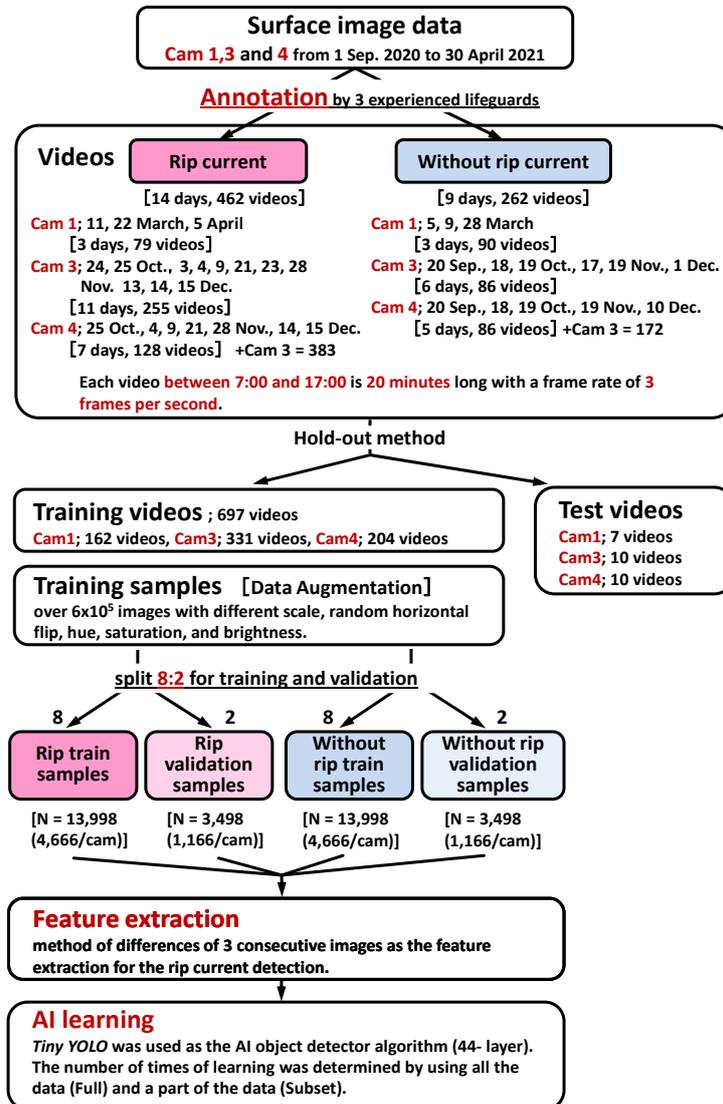
Figure 6. AI learning method and composition of data.

We created a single AI model that can detect two rip types with distinct characteristics using the surface image data of Cam 1, 3 and 4 from September 2020 to April 2021. Also, we didn't use images of Cam 2, because there were very few rip currents. Wave conditions during this period are shown in Fig. 5, high waves hit frequently during this period. Figure 6 shows the AI learning method and composition of data. For AI deep learning, we extracted 14 days for rip current annotations, and 9 days for images without rip currents by three experienced lifesavers. Then, we prepared 383 annotation videos of rip currents along jetties, and 79 annotation videos of the open area with different dates and times. In addition, 172 videos of jetties and 90 videos of the open area without rip current were prepared. Each video was shot between 7:00 and 17:00 and was 20 minutes long with a frame rate of three frames per second. Next, we set 697 videos for AI learning and 27 videos for testing. For training videos, we made more than 600,000 training samples with a different scale, random horizontal flip, hue, saturation, and brightness. These training samples with and without rip currents were split 8:2 for train samples and validation samples. About the feature extraction, we used the method of differences of three consecutive images as the feature extraction method for the rip current detection. Figure 7 shows an example of the feature extraction images of Cam 1 and 3. Pixels that have changed in three

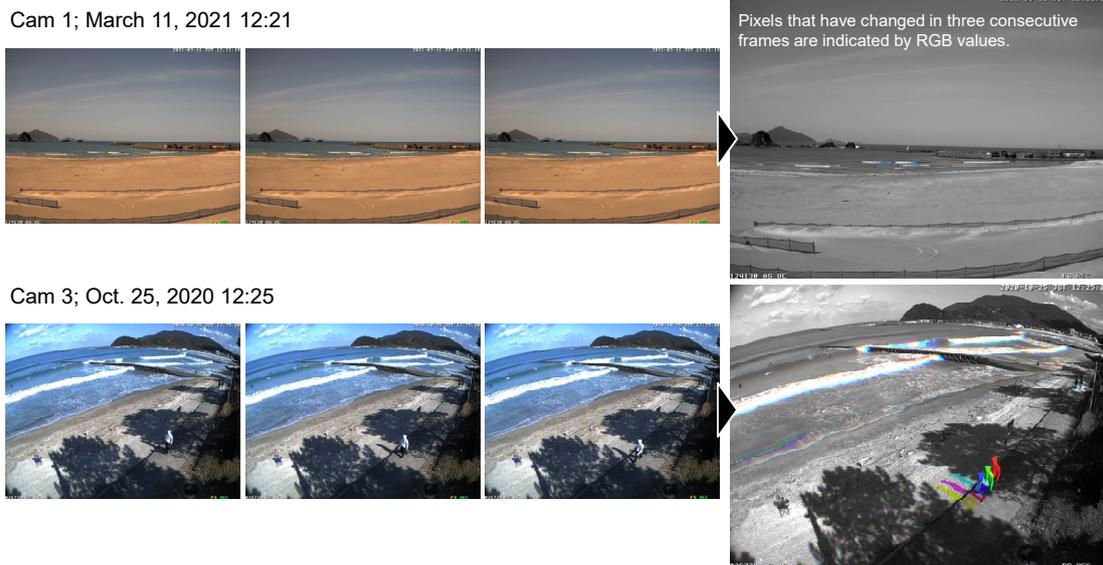
Figure 7. Examples of feature extraction images.

consecutive frames are indicated by RGB values. Therefore, the rip current area is recognized as a no change or a small change area. Also, because three frames of image data are acquired per second, AI repeats the analysis at intervals of about one second. For AI learning, Tiny YOLO (Redmon and Farhadi 2017) was used as the AI object detector algorithm for rip current detection.

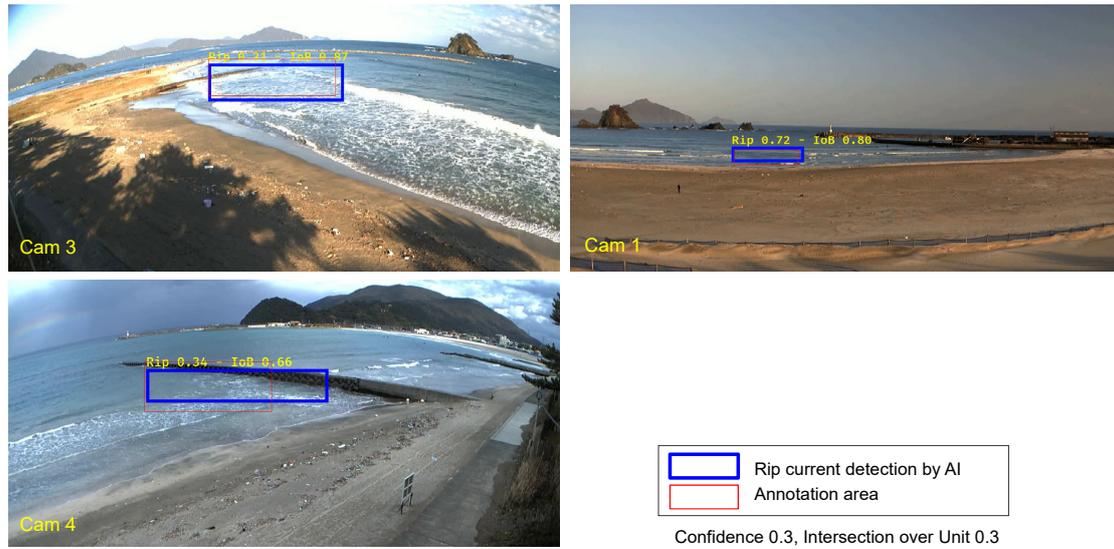
Figure 8. Comparison of the rip current detection by AI and the annotation area.

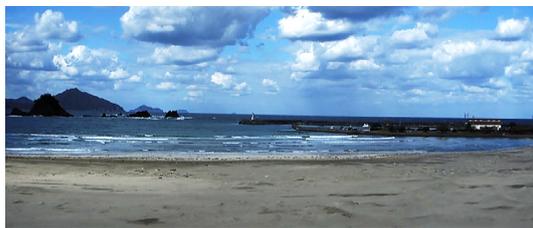
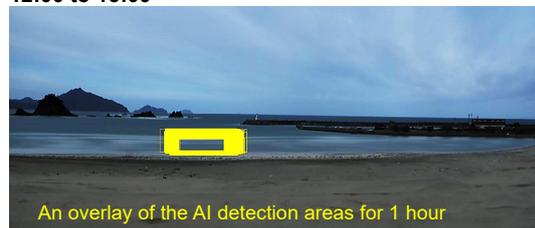
(a) Shooting image 12:00, October 23, 2021

(b) Detection areas overlaid an averaged image from 12:00 to 13:00

Figure 11. Example of rip current detection results by AI of Cam 1.

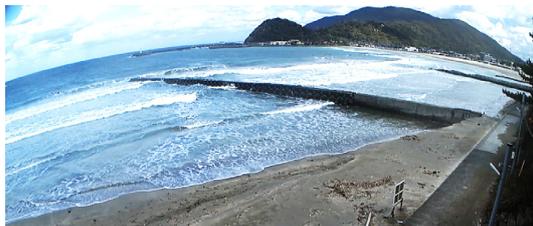
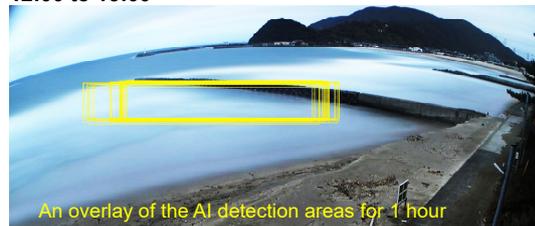
(a) Shooting image 12:00, October 23, 2021

(b) Detection areas overlaid an averaged image from 12:00 to 13:00

Figure 12. Example of rip current detection results by AI of Cam 3.

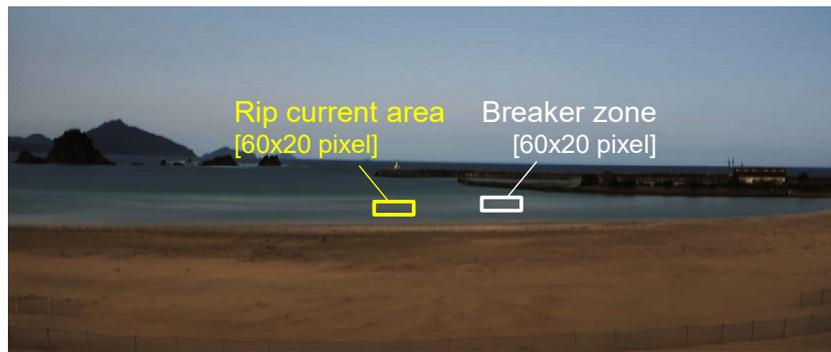
Figure 13. Pixel value comparison areas set for wave breaking zone and rip current area in the averaged image of Cam 1.

Next, we investigated whether the AI was able to detect the occurrence of actual rip currents during the period by a method using the image analysis. This method determines the occurrence of a rip current during the verification period from the difference in pixel values of comparison areas between the wave breaking zone and the rip current area in the averaged image (Shimada et al. 2022). Figure 13 shows comparison areas at the rip current area and the wave breaking zone of Cam 1. Each area was set at 60x20 pixels. In the averaged image, the rip current area where waves do not break easily has a lower brightness than the breaking wave zone, and the average pixel value approaches zero. On the other hand, the wave breaking zone is brighter than its surroundings, and the average pixel value approaches 255. Therefore, when the value obtained by subtracting the average pixel value of the rip current from that of the wave breaking zone is a positive value, it can be defined that a rip current was occurring. Figure 14(a) shows hourly results of rip current detection with a confidence of 0.3 for Cam 1. It was considered that the rip current occurred intermittently in the open area. Figure 14(b) shows the difference in average pixel values for each hour in the captured images of Cam 1. This result shows a good correspondence with the rip current detections by AI. Furthermore, the positive pixel value differences indicating the occurrence of rip currents was 176 hours of the 187 hours in total when rip currents were detected by AI. This means the AI could detect 94% of occurrence of rip currents for Cam 1. Thus, it was considered the created AI model can appropriately detect rip currents that occurred intermittently in the open area. On the other hand, it was 43% of cases where the AI judged that there was no rip current, actually there was no rip current. This means the AI could not detect 57% of occurrence of rip currents.

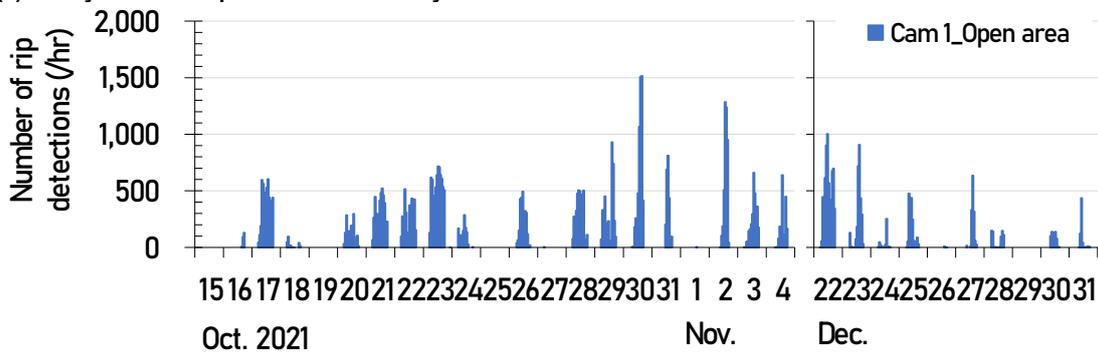
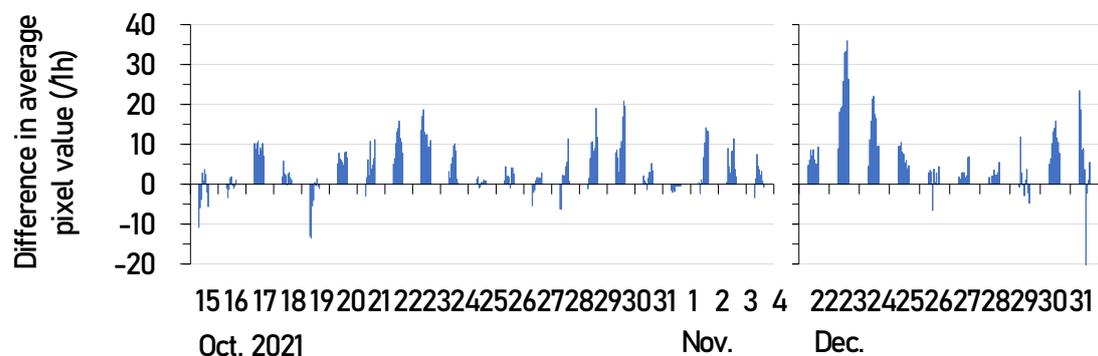
(a) Hourly results of rip current detection by AI

(b) Difference in Hourly average pixel values.

Figure 14. Results of image analysis for Cam 1.

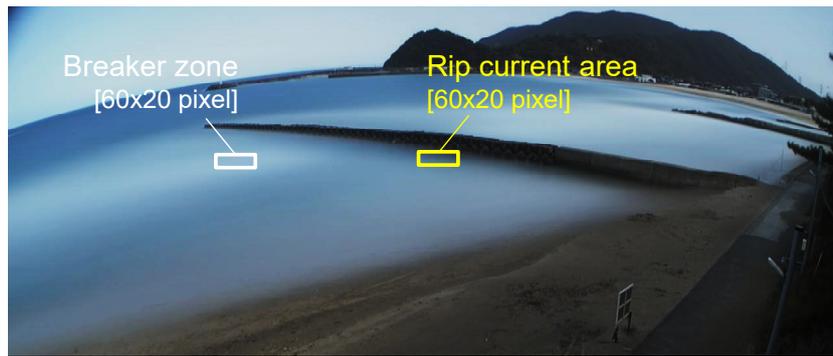
Figure 15. Pixel value comparison areas set for wave breaking zone and rip current area in the averaged image of Cam 3.

The comparison areas at the rip current area and the wave breaking zone of Cam 3 is shown in Figure 15, and the results of image analysis for Cam 3 are shown in Fig. 16. The positive pixel value differences indicating the occurrence of rip currents was 128 hours at 98 % of the 130 hours in total when rip currents were detected by AI. On the other hand, it was estimated that rip currents occurred continuously along the jetty during the verification period according to Fig. 16(b). In 2% of cases where the AI judged that there was no rip current, actually there was no rip current. This means the AI could not detect 98% of occurrence of rip currents for Cam 3. Therefore, although the AI model was able to detect rip currents along jetty, it thought that the AI overlooked many rip currents. Figure 17 shows an example of an averaged image in which AI could not detect rip currents for images taken by Cam 3. It is thought that rip currents were occurring during this time. Figures 18 and 19 show comparison areas and results of image analysis for Cam 4. It was thought that the AI overlooked many rip currents similar to that of Cam 3. The AI overlooked many rip currents especially in December.

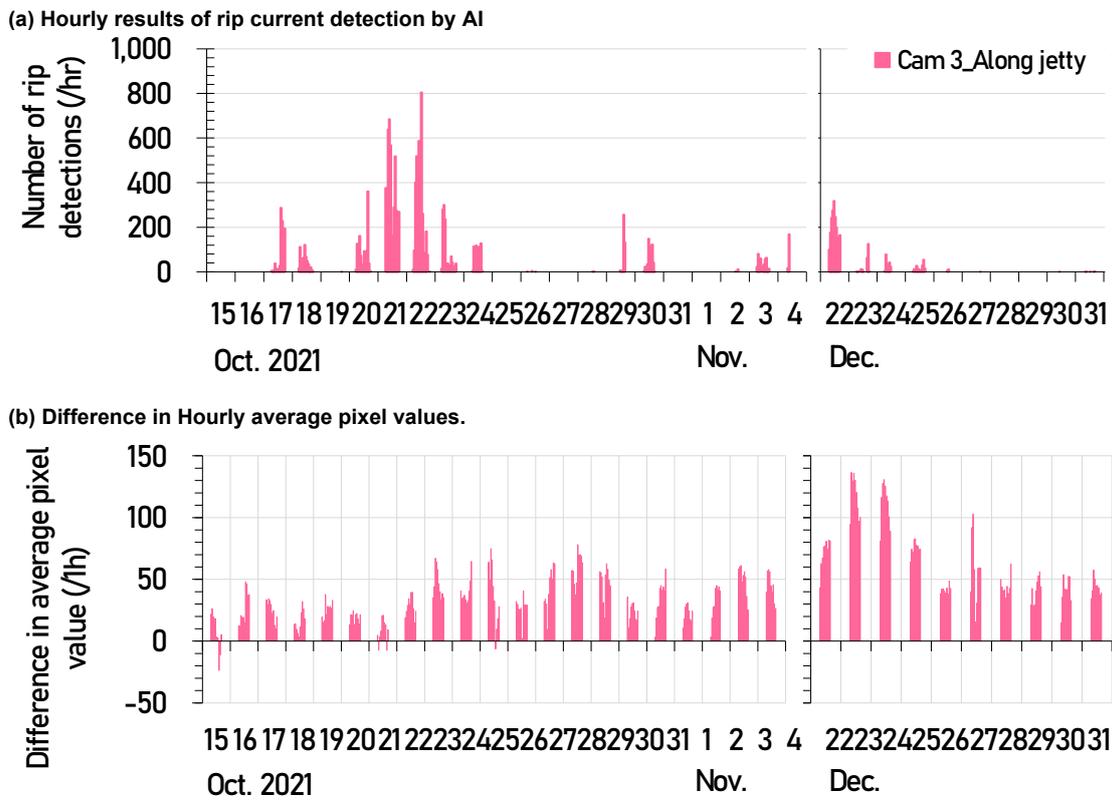
Figure 16. Results of image analysis for Cam 3.

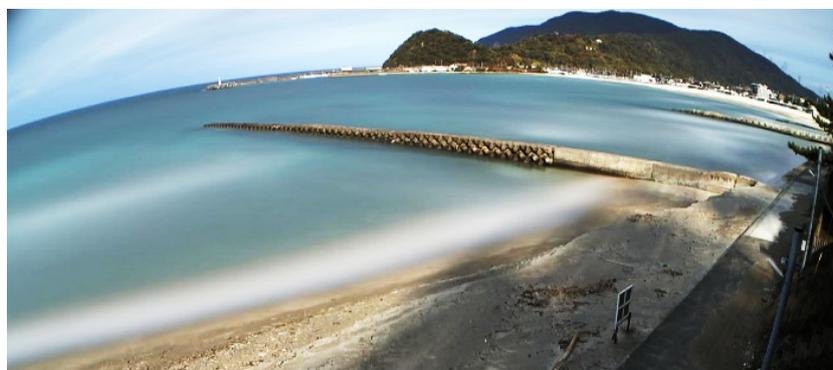
Figure 17. An example in which rip currents could not be detected in the image by Cam 3 (1 hour average image from 14:00 to 15:00 on October 28, 2021).

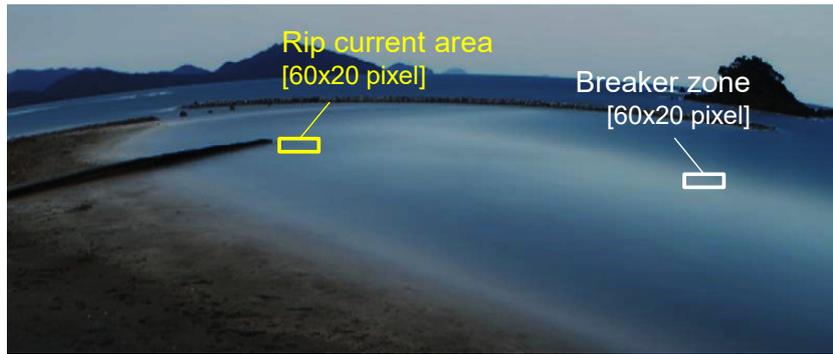
Figure 18. Pixel value comparison areas set for wave breaking zone and rip current area in the averaged image of Cam 4.

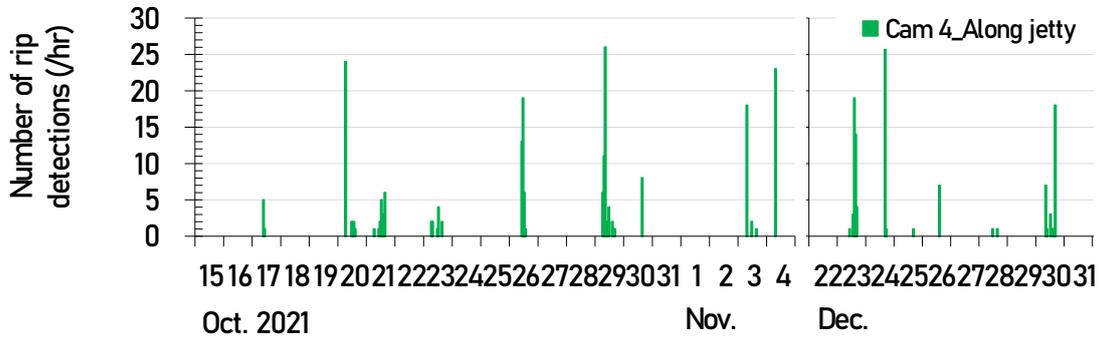
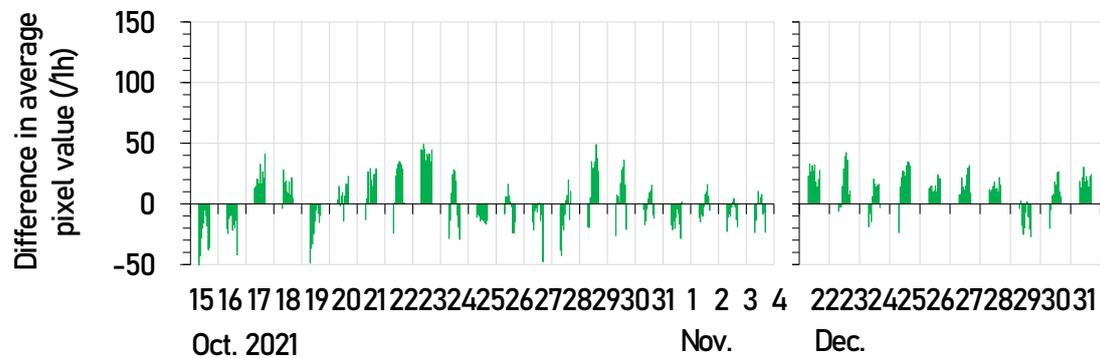
(a) Hourly results of rip current detection by AI

(b) Difference in Hourly average pixel values.

Figure 19. Results of image analysis for Cam 4.

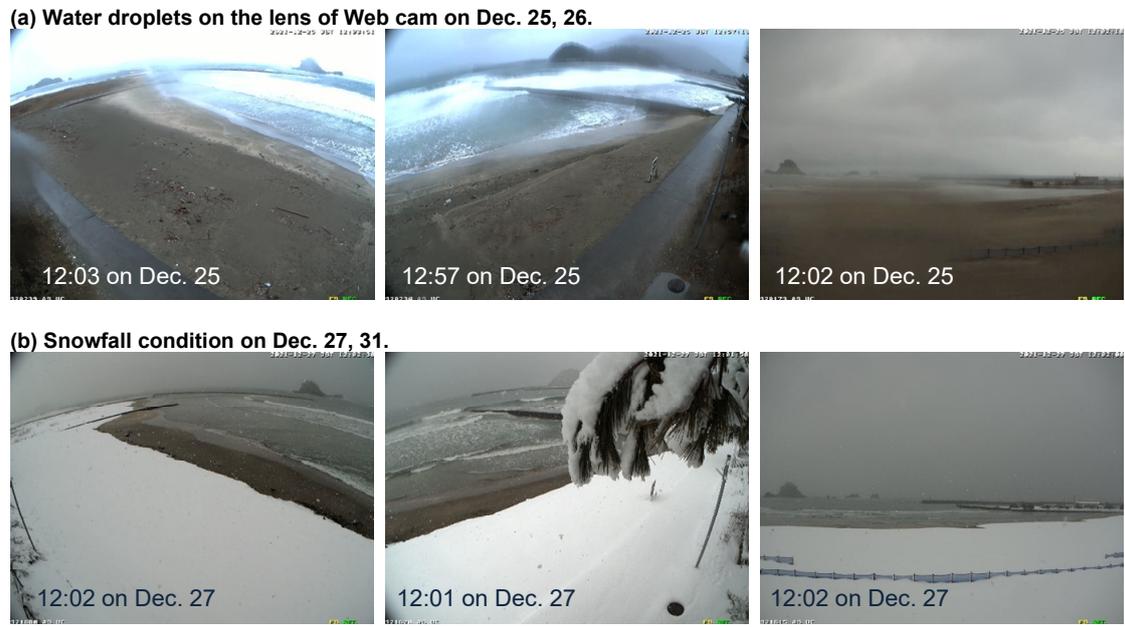
Figure 22. Examples of situations of rainfall and snowfall.

Figure 20 shows the distribution of wave height and wave period. Although the wave height was slightly higher in December, the wave conditions during the verification period were roughly the same as for the AI learning data. On the other hand, there were rainy and snowy days in December, as shown in Figure 21. On rainy and snowy days, conditions different from AI learning, such as water droplets on the lens of Web cams and snowfall were confirmed, as shown in Fig. 22.
