STUDY OF METHODS FOR DETECTING OCCURANCE OF RIP CURRENT USING IMAGE ANALYSIS

Ryo Shimada¹ Toshinori Ishikawa² and Tsutomu Komine³

Keywords: rip current; image analysis; average image; wave condition; Wakasawada Beach

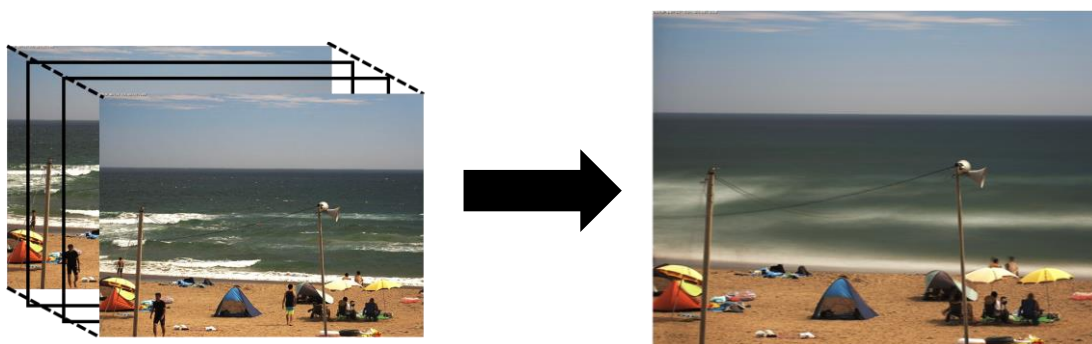
Figure 1. Example of average images.

There are from 2,000 to 3,000 rescues every summer at bathing beaches in Japan. 54 % of drowning accidents were caused by rip currents (Ishikawa, T. et al., 2014), therefore rip currents are the main cause of drowning accidents in Japan. To analyze the rip current surveys, a method for visualizing rip currents with average images can be used. It is a method for visualizing currents by averaging consecutive images of the coast into a single image (Lippmann and Holman, 1989). The breaker zone is shown in the lighter-shaded area, and the current area is shown as the darker-shaded area (Figure 1). However, in case of the investigation over a long period, such as several months, it is necessary to confirm the occurrence of rip currents through thousands of averaged images by human eyes. In this study, we suggest a new method for detecting the occurrence of rip currents automatically by analyzing the pixel values of averaged images.

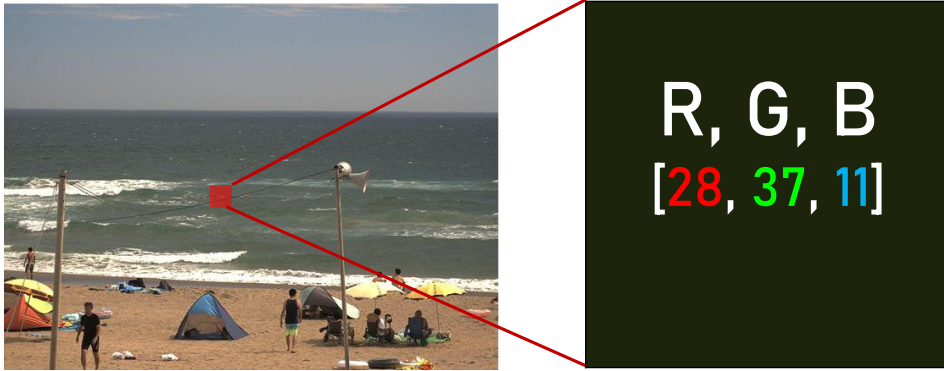
Figure 2. Example of the pixel value.

The following steps are used to create an average image. First, prepare n consecutive images to be averaged. Note that the images must be consecutive to perform averaging. Second, obtain the pixel value of each pixel in the first image. Each pixel stores three values called pixel values as shown in Figure 2. Pixel values represent red, green, and blue, respectively, which have a maximum of 255 and a minimum of 0. (Figure 3). If the number of vertical pixels in the image is h , the number of horizontal pixels is w , the red pixel value is r , the green pixel value is g , and the blue pixel value is b , then an image is given by:

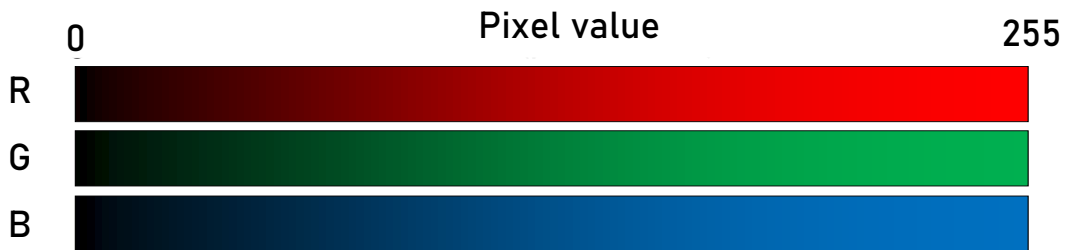
Figure 3. Explanation of the pixel value.

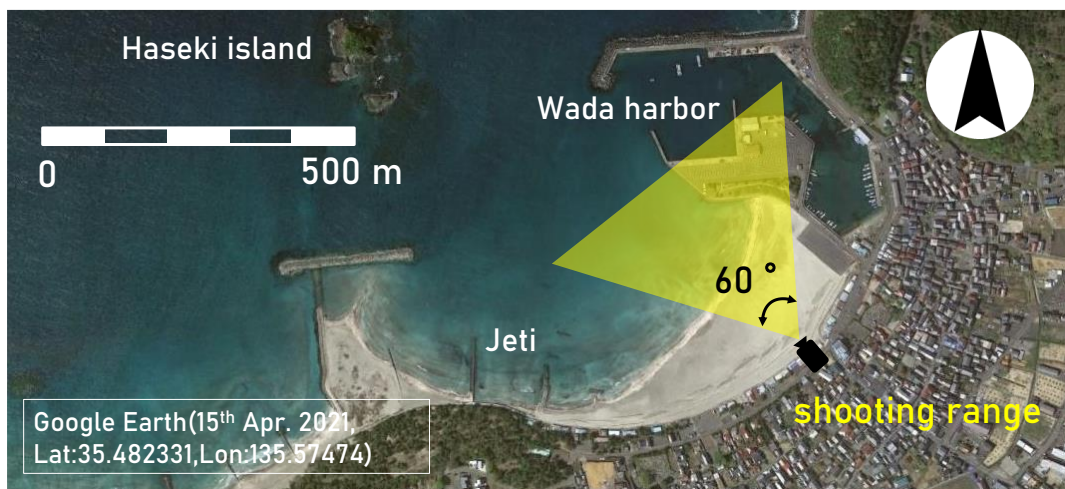
Figure 5. Overhead view of study beach.

The study beach is Wakasawada beach which is located on the west coast of Japan (Figure 4). Figure 5 shows an overhead view of the study beach. This beach has an approximately 1 km shoreline. This beach is surrounded by Wada harbor, Haseki island, therefore the wave direction from the North is dominated. The camera was installed and took approximately 3 frames per second, and the shooting range was 60 degrees. Figure 6 shows an example of image shooting from this camera. As a result of the color dye survey near the shoreline in the study area, a rip current was observed on the 24th of February 2021 as shown in Figure 7. Figure 8 shows wave conditions in 2021, and $H_{1/3} = 1.3$ m, $T_{1/3} = 8$ s at the time of the color dye survey. $H_{1/3} = 0.8$ m was the average, and the maximum was $H_{1/3} = 6.8$ m occurring on January 7th.

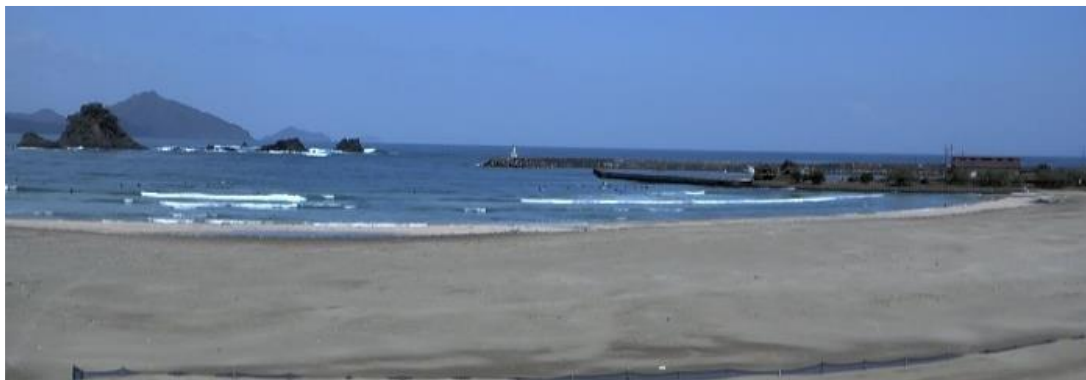
Figure 6. Example of image shooting from this camera.

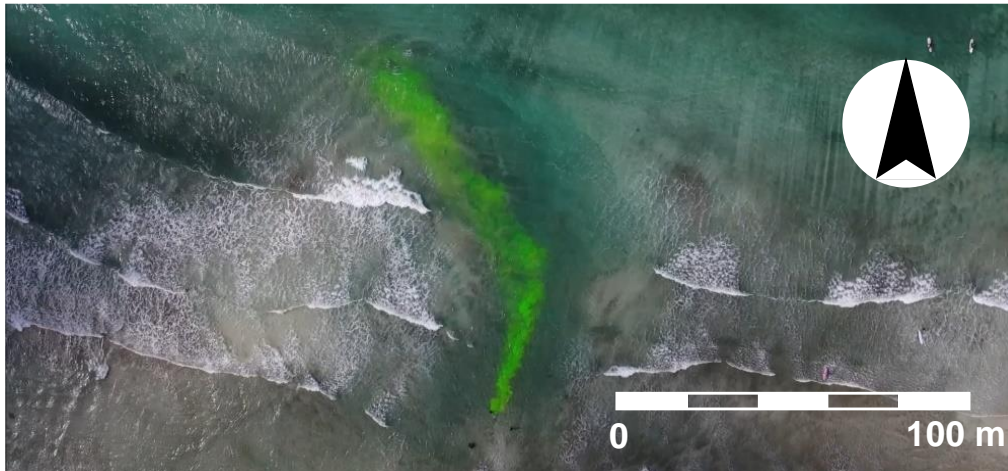
Figure 7. Results of the color dye survey on 24th February 2021

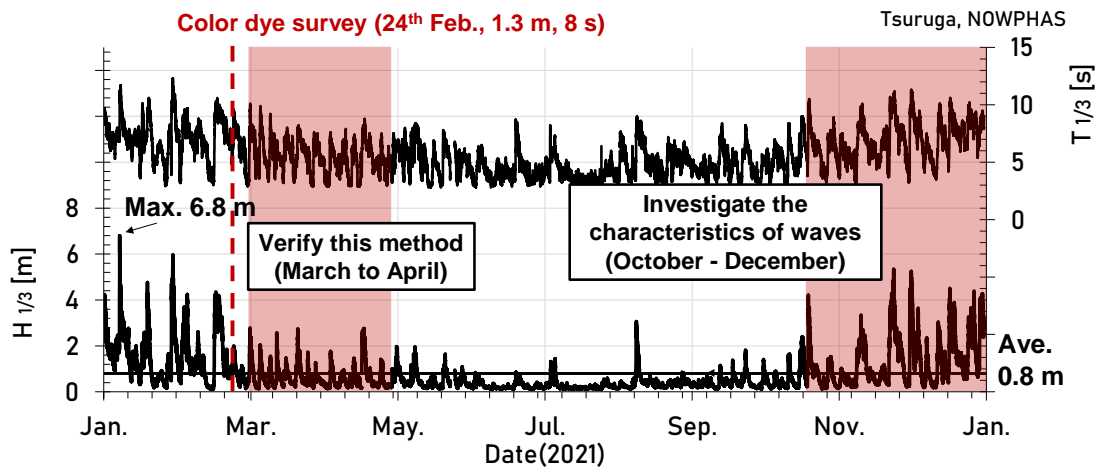
Figure 8. Example of image shooting from this camera.

To verify this method, 2-month image data from March to April was used. This method was applied to 3-month image data, from October to December (Figure 8). Figure 9 shows the outline of preparing datasets. To verify this method, the analysis dataset, validation dataset and verification dataset were created. At first, the video data of rip currents was visually verified by three experienced lifesavers over the six days of the study period (March to April). They selected a dataset of 26 hours of video data with rip currents, and 30 hours without rip currents, respectively. Therefore, the total number of images with and without rip currents was approximately 2.9 M and 3.2 M respectively. An average image was made from approximately 720 consecutive images in a 4-minute video, as in our previous method (Shimada et al., 2020). Then, 395 averaged images as rip currents and 450 as no rip currents were created from the images. Figure 10 shows consecutive images and the averaged image in which an experienced lifesaver observed a rip current. There is a dark shaded area in the center of the image, and it was found that it has a good coincidence between the area where rip currents occurred and the dark shaded area. On the other hand, Figure 11 shows an example of an averaged image without rip currents. There was no dark shaded area in the entire area. Next, averaged images were split 8 to 2 for analysis and validation. As a result, the analysis dataset had 676 images, and the validation dataset had 169. To verify the generality of this method, the verification dataset was created which had 910 new averaged images taken in April.

In order to investigate the characteristics of wave conditions when rip currents occur at the study beach, we applied this method to 3-month image data from October 1st to December 31st, 2021. The average wave height from October to December was 1.18 m, and the average in the entire period was 0.83 m (Figure 8). The number of averaged images when wave heights were 0.5 m or higher was 5,879 in 13,800 of the totals. Figure 19 shows the results of applying this method to a 3-month image dataset. The red shows that rip was obtained, whereas the blue shows that rip was not obtained. As a result, 1,722 images were verified as rip currents, and 4,157 images did not verify as rip currents, respectively. The date of the maximum score was 19th December, and Figure 20 shows an average image at that time. The rip current was observed in the center of the image.

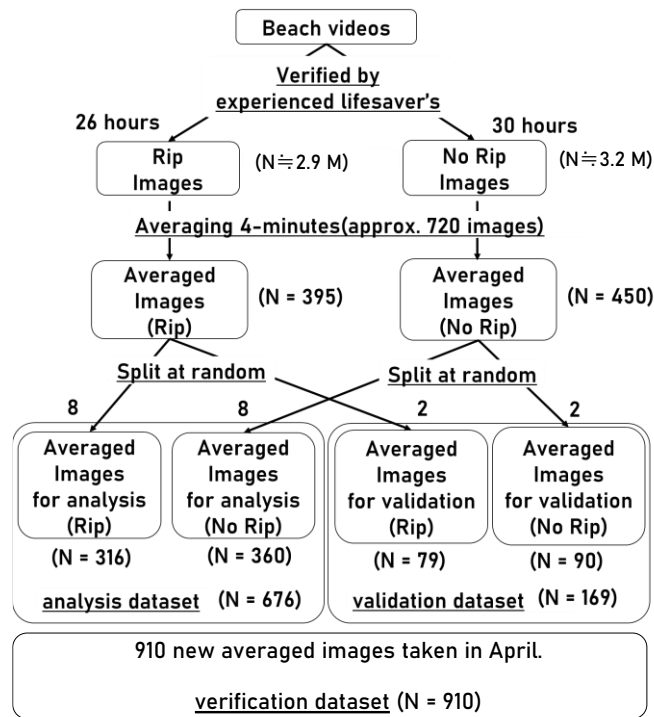
Figure 9. Outline of preparing datasets.

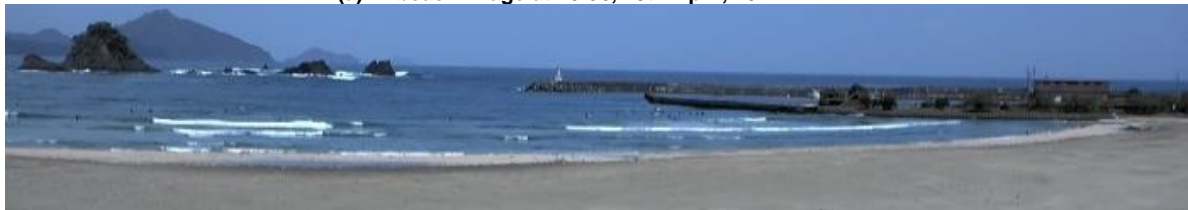
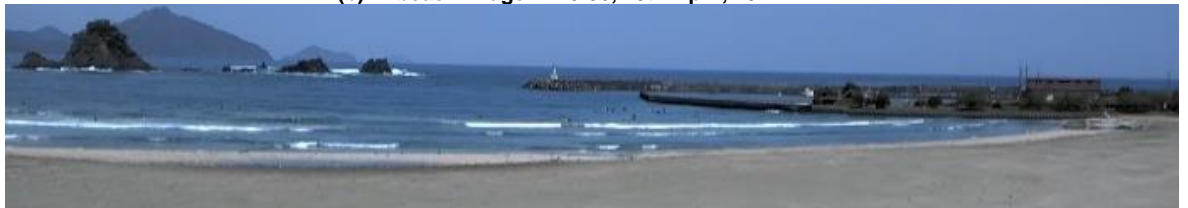
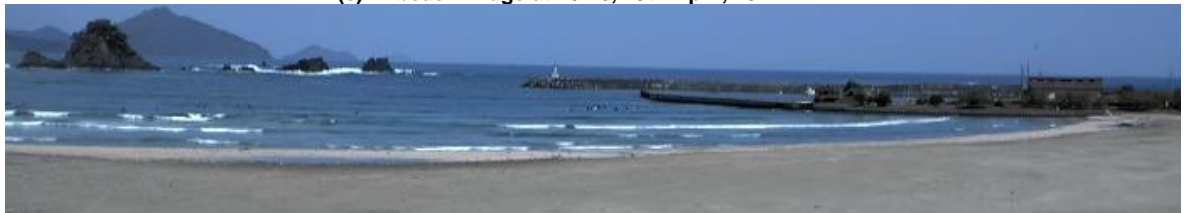
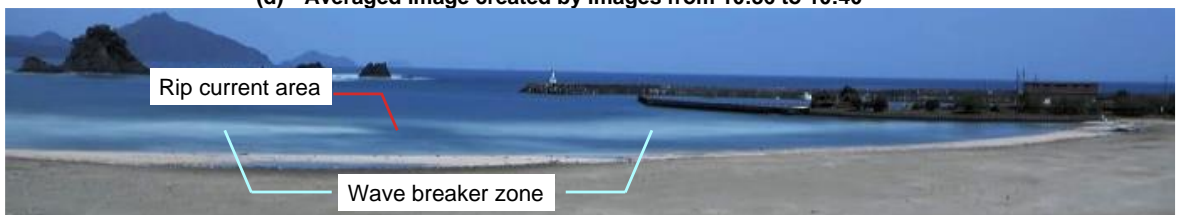
(a) A beach image at 10:36, 19th April, 2021

(b) A beach image in 10:38, 19th April, 2021

(c) A beach image at 10:40, 19th April, 2021

(d) Averaged image created by images from 10:36 to 10:40

Figure 10. Consecutive images and the averaged image when an experienced lifesaver observed a rip current

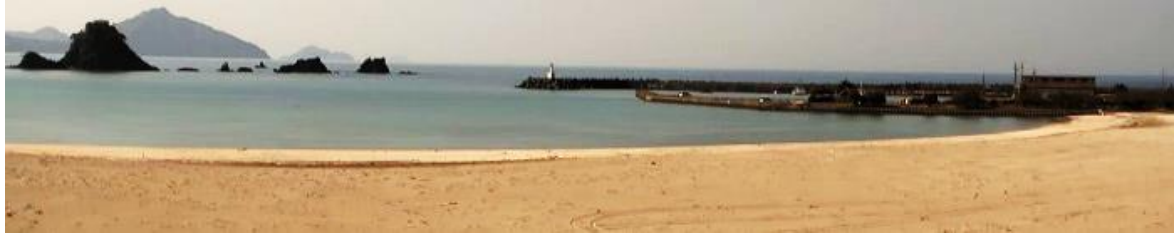
Figure 11. Example of an averaged image without rip currents

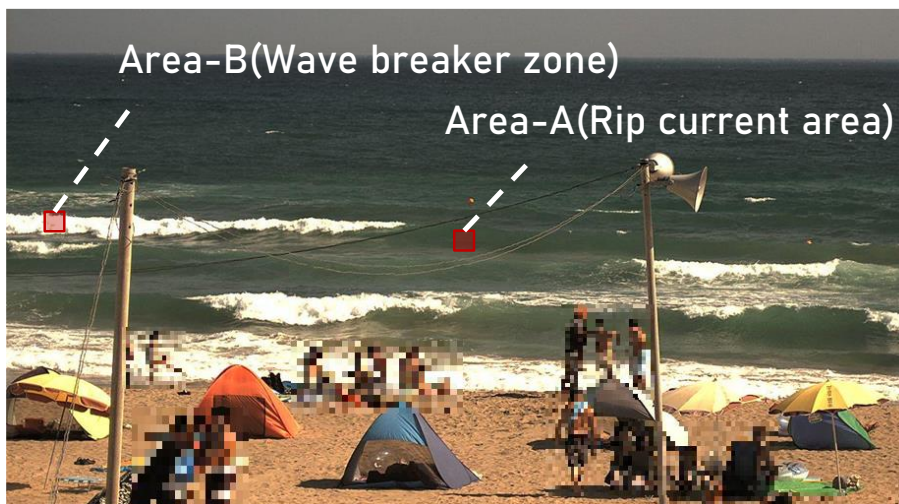
Figure 13. Examples of the area-A and the area-B

Figure 12 shows a mean of the pixel values. 0 appears dark, whereas 255 appears light. Therefore, in the rip current area, the mean pixel value appears to be 0, whereas, in the wave breaker zone, it appears to be 255. An area-A was defined as the rip current area and an area-B as the wave breaker zone (Figure 13). It was defined that if there was a difference between the area-A and the area-B mean pixel values, a rip current occurred. To investigate the tendency where rip currents occurred, we created the averaged image from images when the rip current occurred in the analysis dataset (Figure 14). In Figure 14, an experienced lifesaver defined the rip current area and the wave breaker zone (Figure 15). The area A was defined as the 10×10 pixel box located in the rip current area, which minimized the mean pixel value. On the other hand, the area B was defined as the box located in the wave breaker zone, which maximized the mean pixel value. The score was defined as:

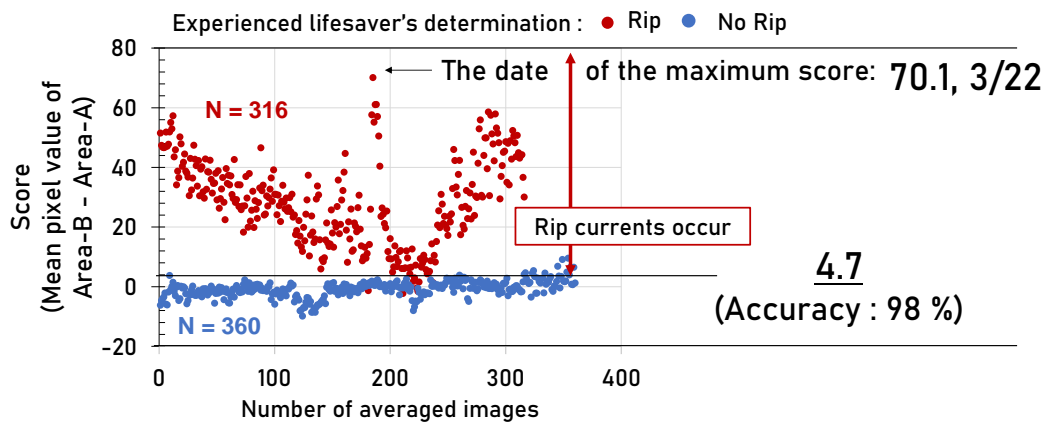
Figure 14. Results of scores of analysis dataset (N=616)

The score was calculated for each image in the analysis dataset to set the threshold. Figure 14 shows the results of the scores of the analysis dataset. The red plots show that a rip was determined by 3 experienced lifesavers, whereas the blue plots show there was no rip determined. Figure 15 shows an average image on the date of the maximum score, and the rip current was observed in the center of the image.

As a result, it was found that the optimized threshold was 4.7 with 98% classification accuracy.

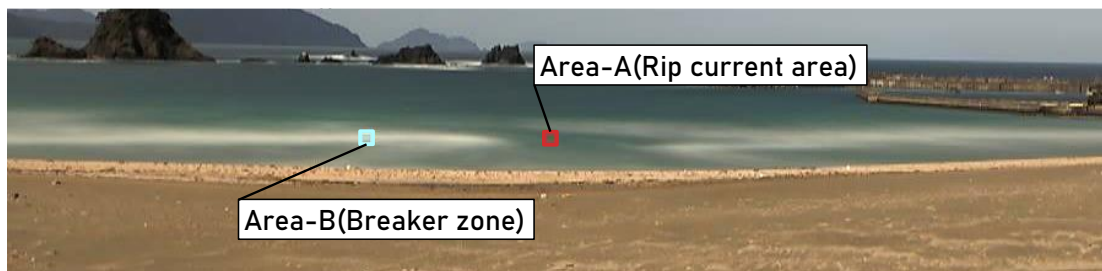
Figure 15. Average image on the date of the maximum score (22nd March 2022)

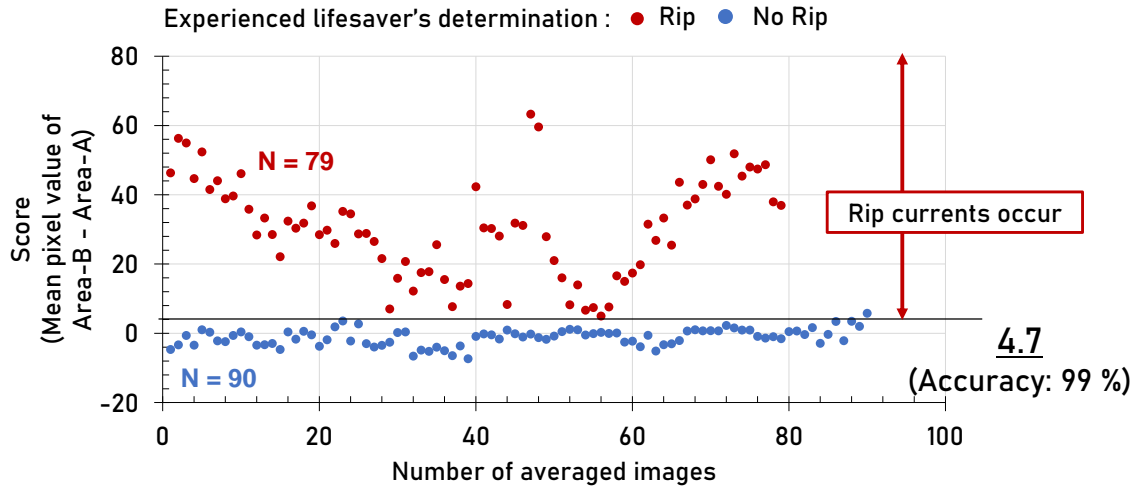
Figure 16. Results of scores of validation dataset (N=169)

To validate the method, we applied the optimized threshold value to the entire 169 validation image dataset. Figure 16 shows the results of scores of the validation dataset, and it found that the accuracy was 99 % for the validation dataset. To verify the generality of this method, we applied the optimized threshold to the verification dataset that had 910 new averaged images taken in April. Figure 17 shows the result, it found that the verification dataset had an accuracy of 57% which was lower than the validation dataset. It was considered that wave conditions affected the result of accuracy.

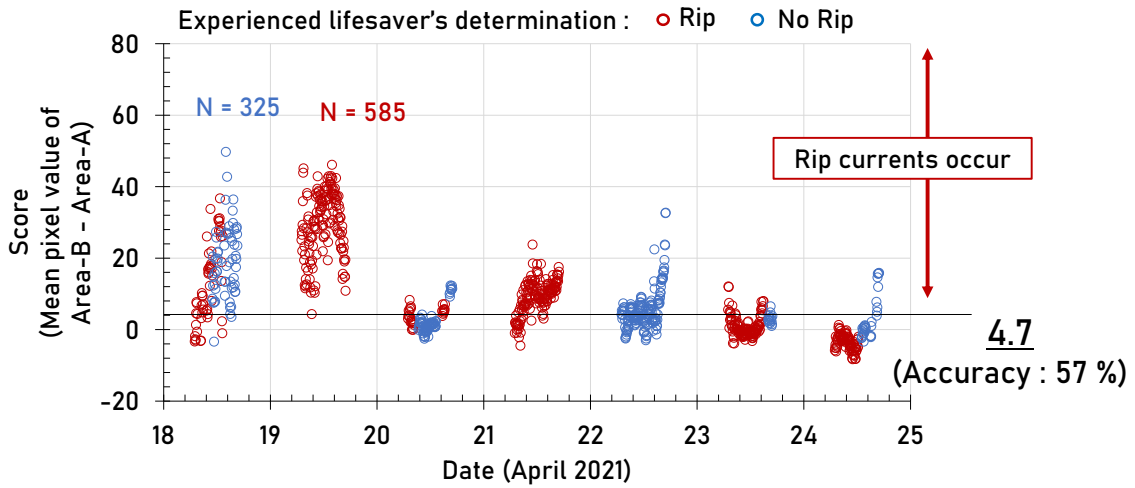
Figure 17. Results of scores of verification dataset (N=910)

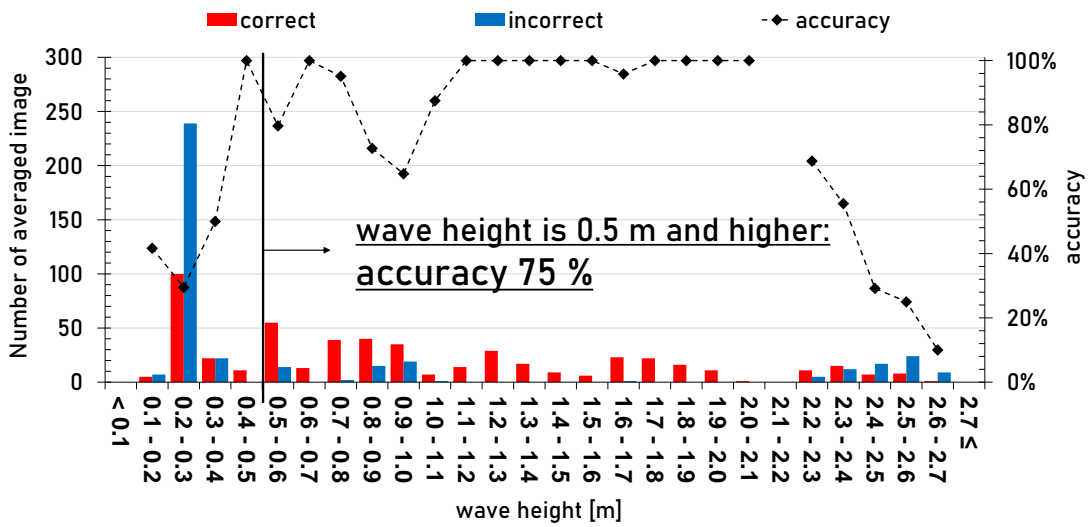
Figure 18. Results of accuracy sorted by wave height

Therefore, we investigated the accuracy sorted by wave heights. Figure 18 shows the results of accuracy sorted by wave height. The red bar shows correct, the blue bar shows incorrect, and the line graph shows the accuracy. As a result, when the wave height was 0.5 m and higher, the accuracy was 75%. According to those results, we suggest that this method can detect the occurrence of rip currents under conditions in which the wave height was 0.5 m and higher.

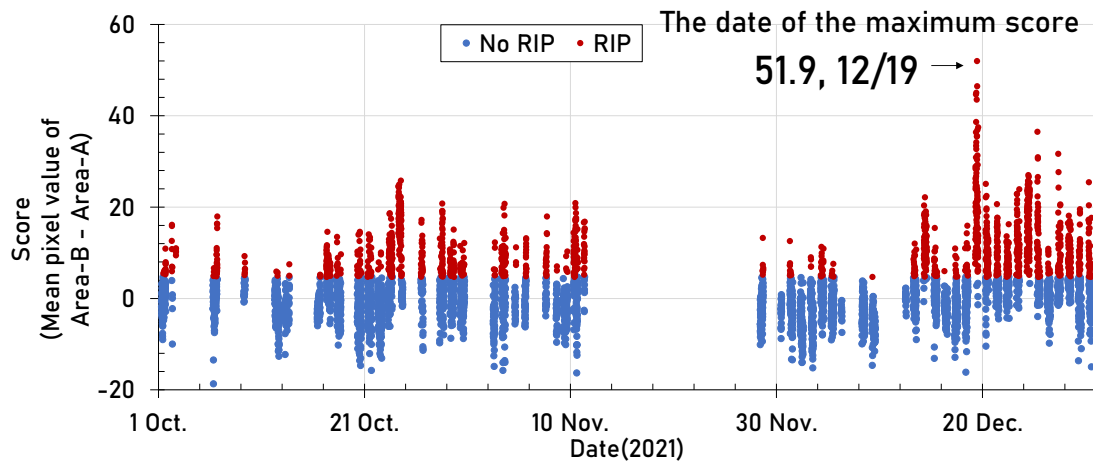
Figure 19. Results of scores of a 3-month image dataset

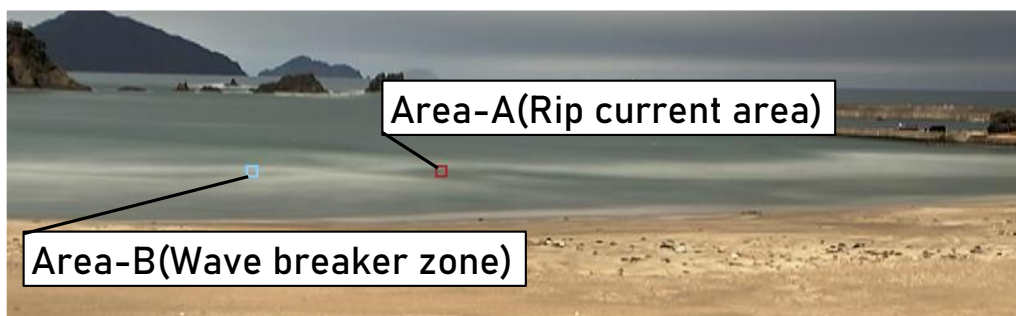
Figure 20. Average image on the date of the maximum score in the 3-month dataset (19th December)

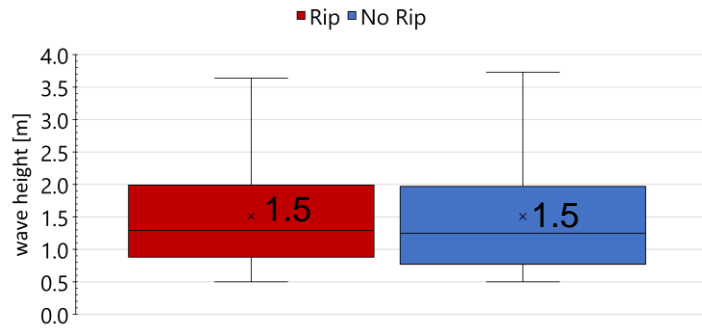
Figure 21. Box plots of wave height with and without rip currents conditions

Figure 21 shows the box plot of wave height with and without rip currents. The mean wave heights were both 1.5 m, so there were not any characteristics in wave height when rip currents occurred. As a reason of this cause was the variation of seasonal conditions between spring when this method was verified and winter when this method was applied. On the other hand, Figure 22 shows the box plot of wave steepness with and without rip currents. The mean wave steepness was 0.007 with rip currents and 0.017 without rip currents. The energy mean waves were $H_E=1.8$ m, $T_E=7.4$ s, wave direction= 309° in rip currents, and $H_E=1.9$ m, $T_E=7.3$ s, wave direction= 312° without rip current shown in Table 1.

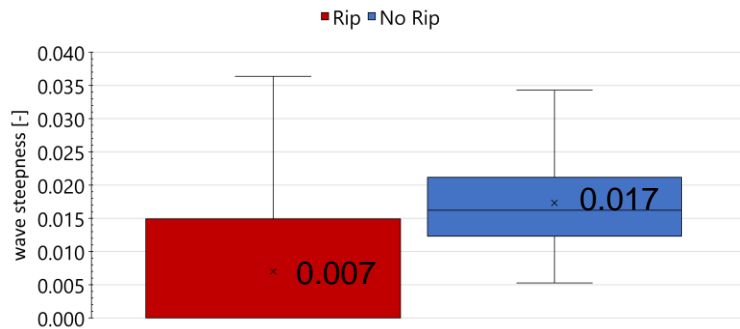
Figure 22. Box plots of wave steepness with and without rip currents conditions

According to those results, it was found that wave steepness was occurring lower under the conditions of rip currents.
