APIA PORT BREAKWATER RECONSTRUCTION

Keywords: Dolosse armored breakwater; design resilience; physical modelling

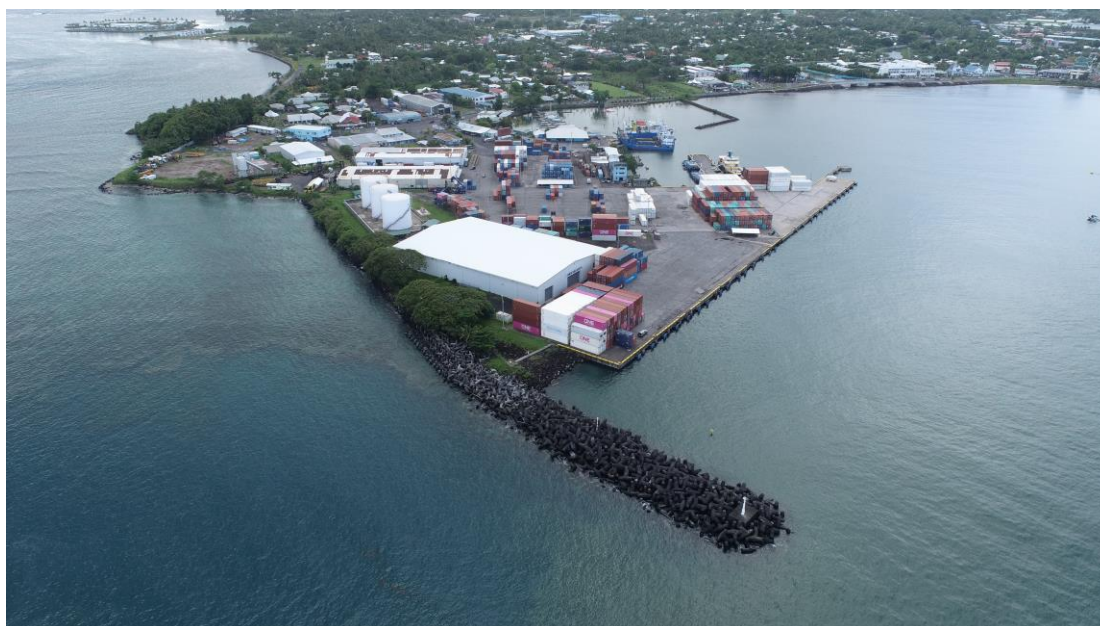
Figure 1. Apia Port, Samoa

Samoa is located in the South Pacific Ocean, about halfway between Hawaii and New Zealand. The country consists of two main islands (Upolu and Savai'i) and several smaller islands and uninhabited islets. Apia Port, on the north coast of Upolu is a commercial port and provides essential transportation links for imports and exports of mixed cargo, bulk petroleum, LPG, fish trans-shipment, liquid bulk storage and warehousing of dry freight [Figure 1]. The port regularly services container and Ro-Ro ships, as well as fuel tankers, gas tankers, fishing boats, interisland ferries and cruise ships.

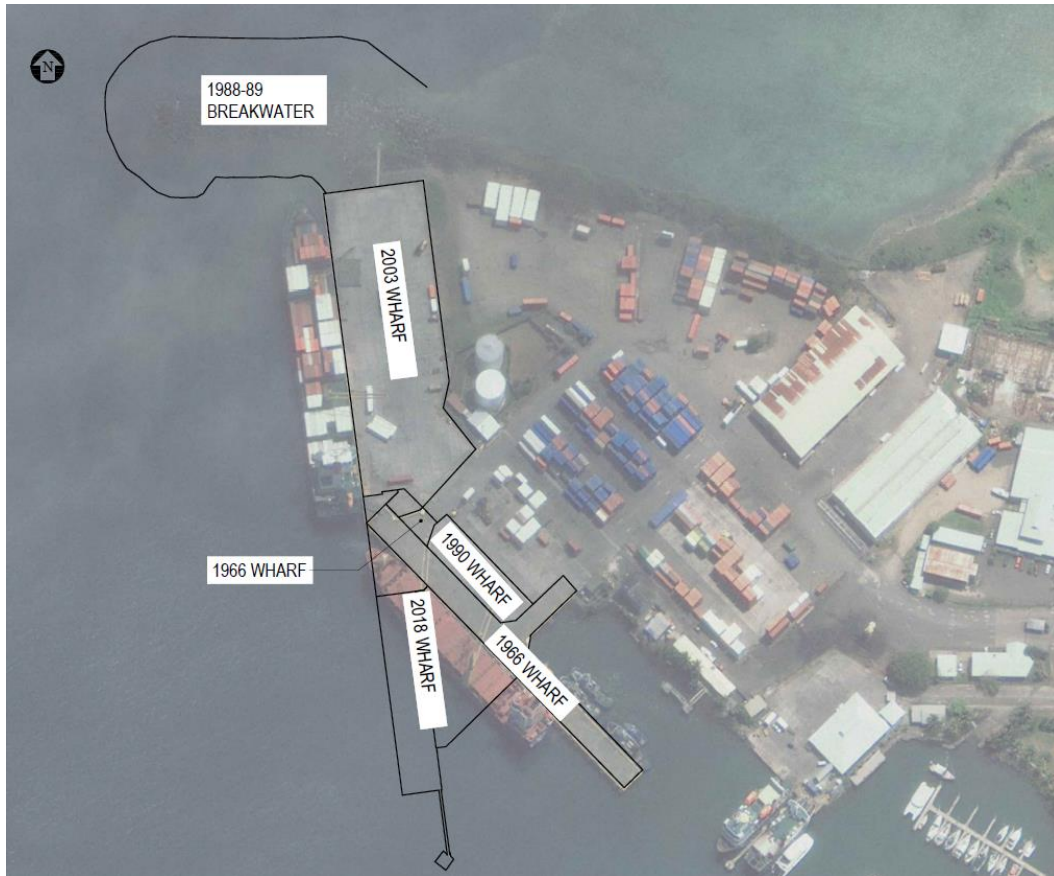
Figure 2. Port Development Timeframes

The first wharf at Apia (185m long) was constructed in 1966. Due to swell waves affecting the harbor, a 100m long breakwater with 8t Dolos armor units was constructed in 1988-89 to provide shelter.

Following large cyclones in the early 1990s, the breakwater was rehabilitated in 1996 with larger 20t Dolos armor units. In 2003, the wharf was extended north by 166m and a 70m solid concrete crown wall added to the breakwater. In 2018 a wharf extension to the south was constructed to accommodate longer ships, multiple ships or a cruise ship. Refer to Figure 2.

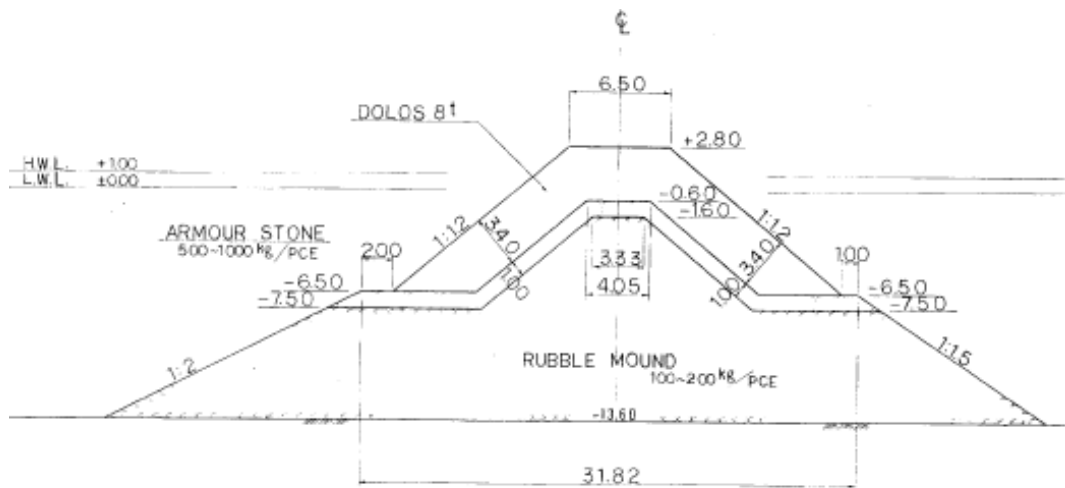
Figure 3. Original 1988-89 Cross Section

The original 1988-89 breakwater extends from a shallow water reef approximately 100m into Apia Harbor to a water depth 14m below Chart Datum (CD). The original breakwater cross section comprised a rubble mound core, rock underlayers and 8t Dolos units at a 1.2H:1V slope with a crest level of 2.8m CD [Figure 3].

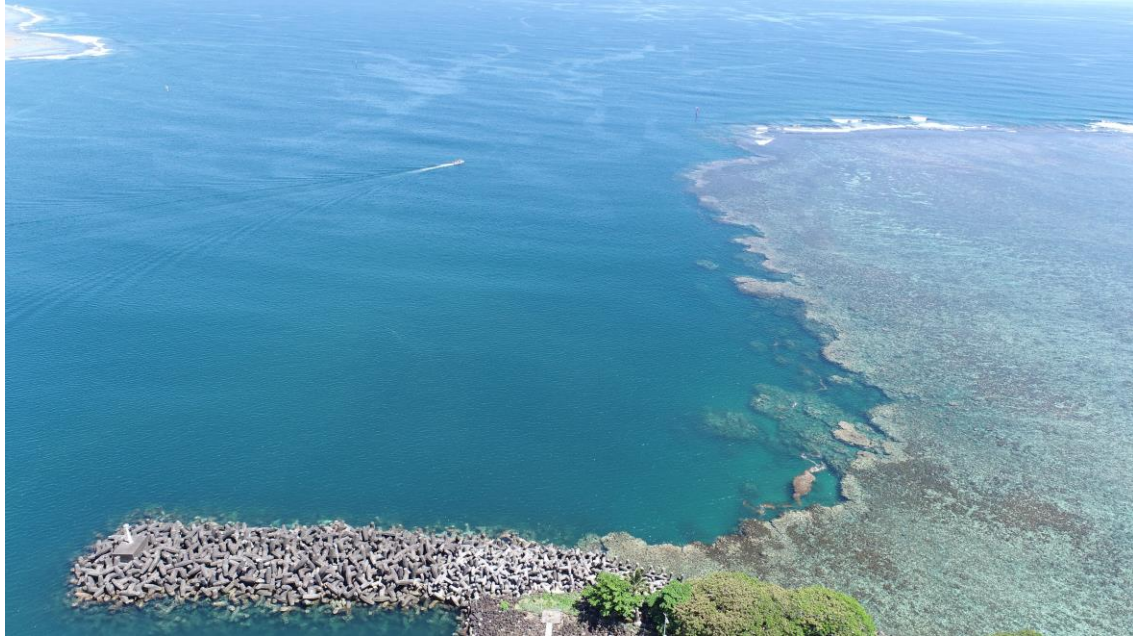
Figure 6. Existing Breakwater and Harbor Approach

Evaluation of the breakwater [Figure 6] was undertaken by review of design drawings, seaborne and walkover inspections, bathymetric survey and side scan sonar. The bathymetric survey and side scan sonar indicated minor reshaping at the lower section of the breakwater, particularly at the roundhead. A diving inspection was not undertaken for the initial inspections and was not pursued once the decision was made for the reconstruction option.

The outer half of the breakwater crest is lower by approximately 1m. This indicated that settlement has occurred in the outer section as the design crest level (4.6m CD) is the same along the breakwater. The concrete crown wall, which was installed in 2003, is in good condition and does not appear to have incurred differential settlement, noting that the crown wall starts at the breakwater root. At the root of the breakwater oceanside the outer slope units are orientated in the same direction which is not desirable. The breakwater is low crested and there is limited toe and scour protection.

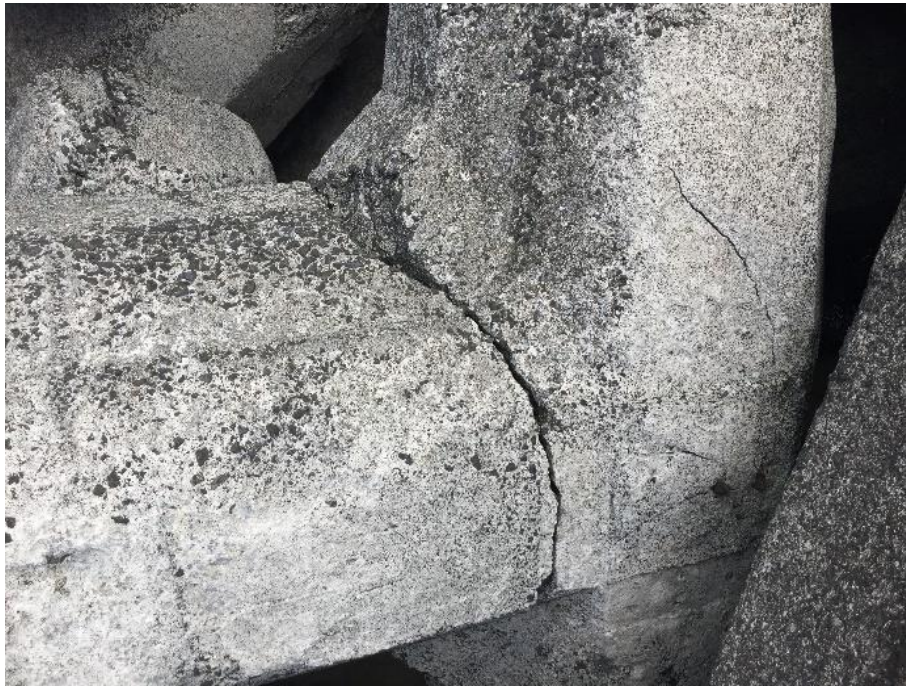
Figure 7. Broken Leg on 20t Dolos Unit

The original 8t Dolos units are predominately placed on the harbor side and the root of the breakwater. The 20t Dolos units are placed elsewhere on the breakwater. Multiple units had broken legs, cracks and rust stains from corroding steel reinforcement. The 20t Dolos units are steel reinforced as evidenced by rusting steel and the 1996 design drawings. There were no signs of steel rusting observed in the 8t units and the design drawings were not available to confirm the presence of steel. From the walkover inspection the estimated number of damaged 20t units above the waterline follows:

- 20-25 units with broken legs [Figure 7].
- 10-15 units with visible cracks.
- 5-10 units with signs of corroding steel reinforcing.

The condition assessment has identified that 35-50 20t Dolos units at the crest to waterline level are broken, cracked or showing signs of steel corrosion. Below water inspection by divers was not undertaken but it would be expected that lower hydraulic loading would mean less damage to units below water. Replacement of damaged units lower down the breakwater slope would involve removal and replacement of many overlying undamaged units. Such an operation would need to be carefully considered due to the risk of further damage occurring during re-handling and replacement. This work would replace the current defective units, however further deterioration of other units could be expected to occur progressively over time which will require further patch repairs. Future repairs at approximately 10-year intervals, or four times over the 50-year design life were assessed to be required.

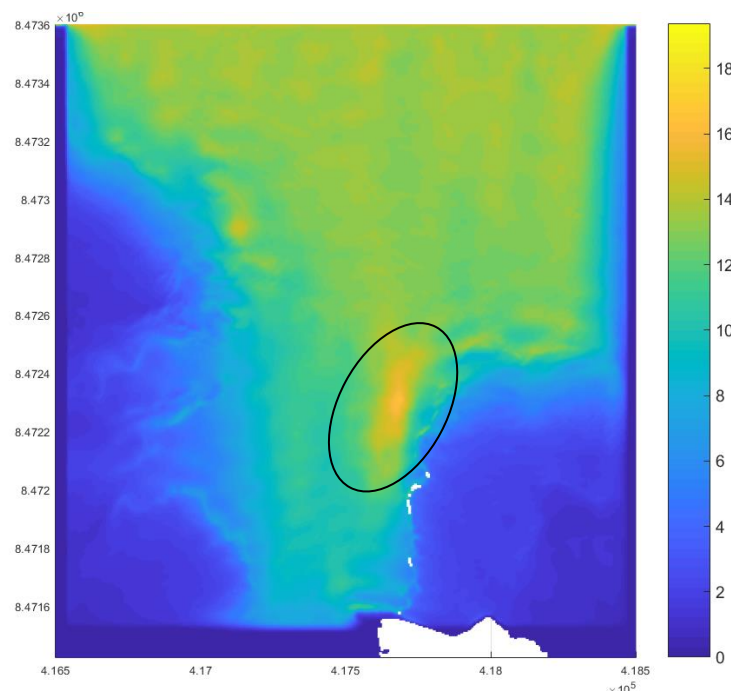
Figure 10. Wave Penetration into Apia Harbor

Figure 10 shows outputs from SWASH with the 1% AEP $H_s = 8.9\text{m}$ at location D off the breakwater roundhead. Note the zone of extreme wave breaking at the eastern reef edge offshore of the breakwater indicated by the ellipse. Excluding wave reflection the 1% AEP $H_s = 8.7\text{m}$ at location D.

The SWASH modelling demonstrated that wave transformation processes within the inner harbor are extremely complex. The distribution of H_s throughout the harbor is significantly affected by wave reflection off the fringing reefs and shallow water wave breaking particularly along the reef edge seaward of the breakwater. The numerical modelling confirmed a zone of high reflected wave energy fronting the breakwater which coincides with a localized bathymetric depression consistent with seabed scour.

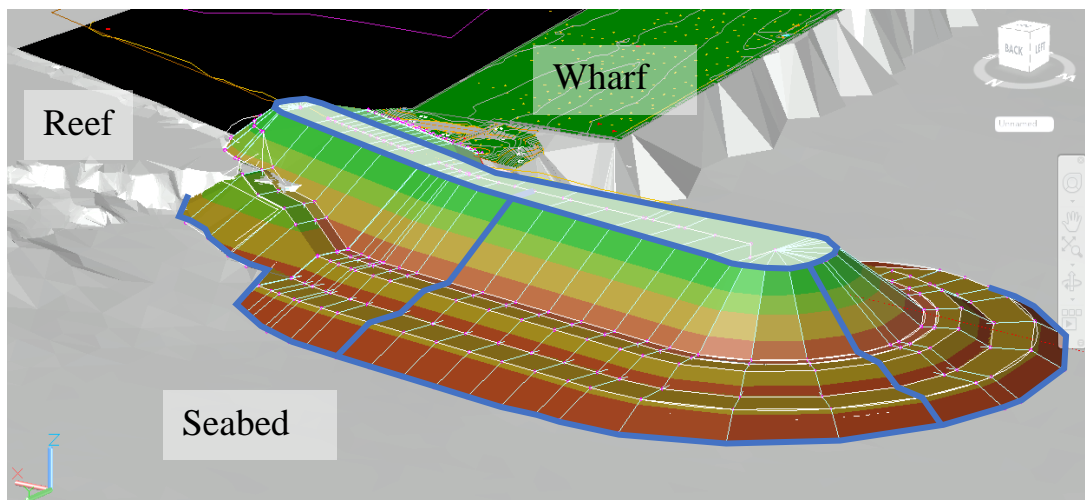
Figure 15. Breakwater Design Model

A 3D graphic of the final design of the reconstructed breakwater outer surface profile is shown in Figure 15.
