## **40 YEARS OF FLEXIBLE SCOUR APRONS: ATLANTIC AND PACIFIC COAST CASE HISTORIES.**

Flexible scour apron mats are sometimes used where seawalls are ‘floating’ in the beach, where firm rock foundations are out of economic reach. This paper reviews the use of flexible scour aprons for the toe protection of seawalls and revetments, based on some 20 to 40 years exposure at sites in NSW, Australia and in Cubut, Argentina. It contains examples of simple and compound revetments, and discusses the problems of design variations driven by cost cutting, and the risks of post-design and post-construction policy changes that critically affect the original design concepts, especially where reliance had been placed on concurrent beach nourishment, and apron elevation had been raised to take the benefit of increased protection offered by the beach nourishment.

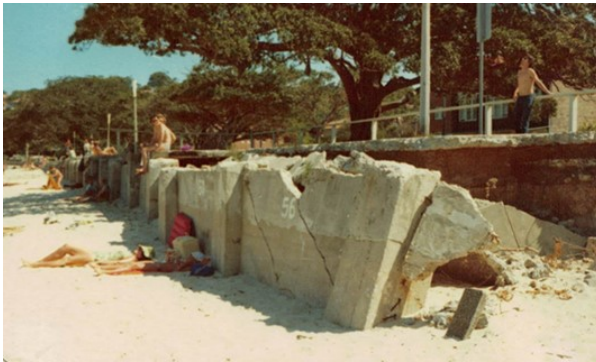
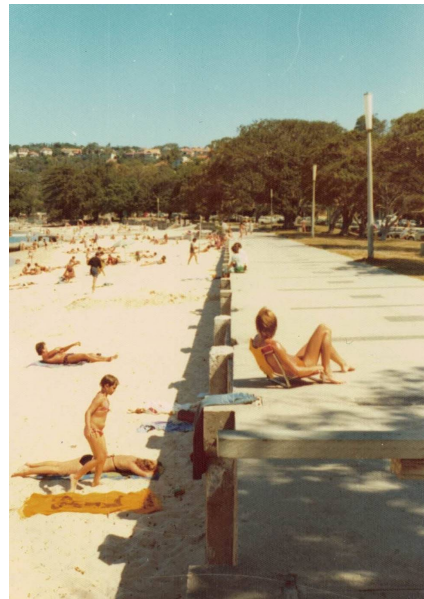
Fig 4a, 4b Balmoral Beach after the storms in 1974

and the wall was knocked backwards. Even in its damaged state, the sheltered ambience of this beach was much appreciated by many Sydneysiders, as can be seen in Figs 4a and b above. .

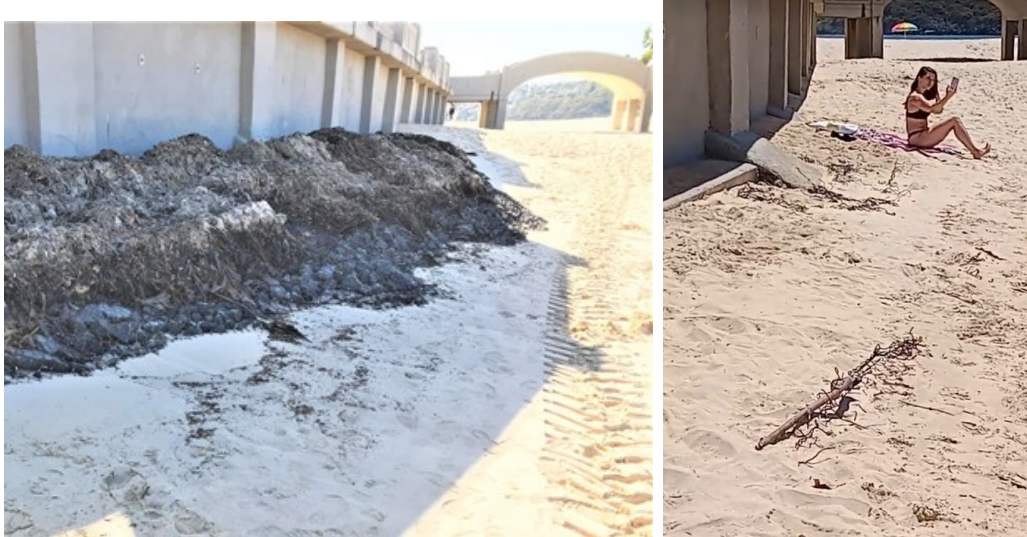
Fig 9 Exposed mattresses overlain by weed, 2021 (Photo courtesy Mosman Municipal Council), and as seen Nov 2022

Durng 2020-21 the mattress were exposed as shown in the photograph below, but had significantly recovered by November 2022 when the author was able to visit the site again.

Unfortunately, rather than renourish, it was decided to re-shape the beach, a much simpler operation, but with the sad result that the mattresses have suffered mechanical damage, as shown in the photos shown in Fig 9 below.

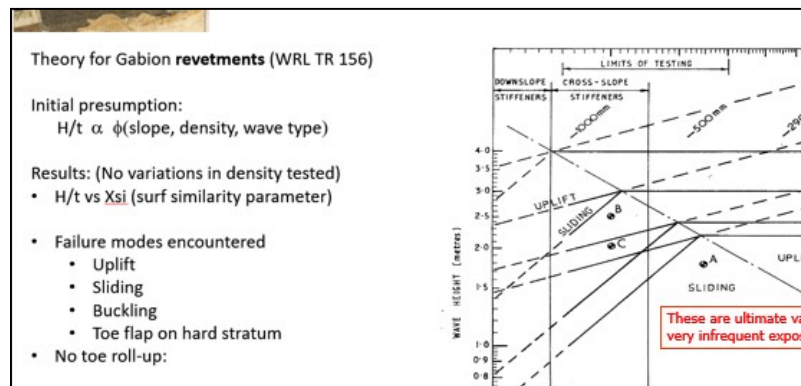
Fig 11 Summary figure of Design Rules, as reported in 1979

These tests found that stability was a function of H/t (wave height and mattress thickness and  $\xi$ , Surf similarity parameter).

At steep slopes, down slope sliding dominated, and for flatter slopes uplift failure/buckling predominated.

Detailed ultimate design chart was published in Brown (1979), and has later been adopted and published by USACE (Hughes, 2006).

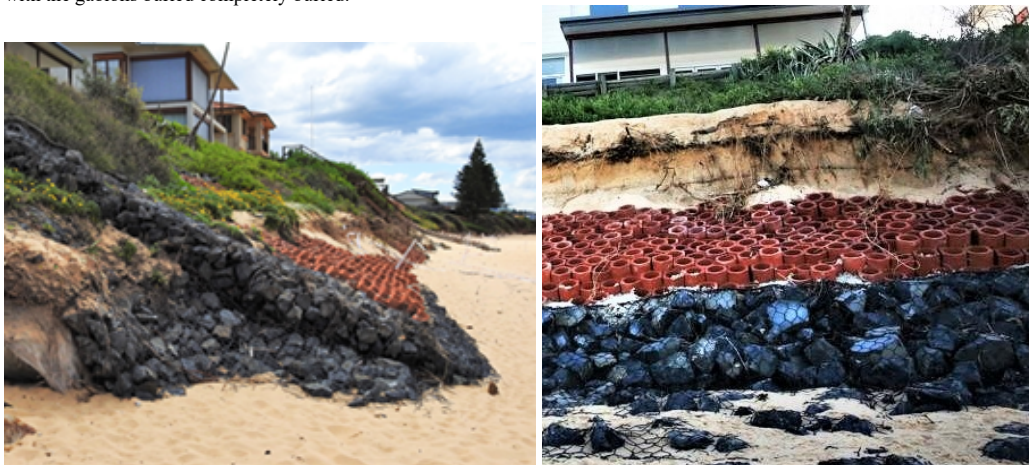
Figure 13a,b June 2016 After design storm (38 years), showing gross deformation of side and toe scour aprons. Note the depth of sand on the revetment above. Photo 13a taken 1 day after the storm subsided, photo 13a two weeks later after author arrived from overseas.

The revetment endured several major storms, including the 2016 event (Fig 13a,b below) without any notified problems until 2020, when scour appeared to descend below the toe reach of the scour apron, which then appeared to fail by down-slope sliding, leaving a gap between it and the revetted upper slope (Fig 14). The filter-cloth membrane maintained a seal on the face for three days, but eventually tore and the revetment was scoured out. The used of double stitched folded seams greatly enhanced the post-failure performance of this membrane

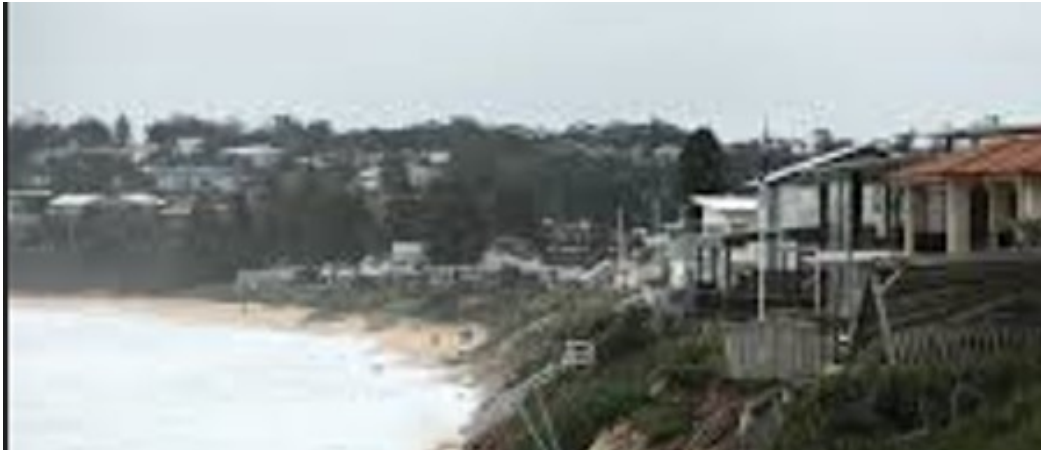
Figure 14 Wamberal prototype, last days 2020 (42 years) Photo courtesy Doug Lord. Note slippage of middle of gabions, and constant slope: compare with Photo 12a above. This gives credence to assumptions about slope angle after scour.

In photos taken before complete failure, it can be seen that the side gabions were anchoring the sides well, but the middle of the slope was unrestrained. It is probable that had a layer of mesh been used under the Seabees, or indeed had gabions been used throughout, this structure would have survived this storm in a more deformed state, but would still have been affected by the problems with adjacent structures. As might adherence to the originally intended extent of the apron.

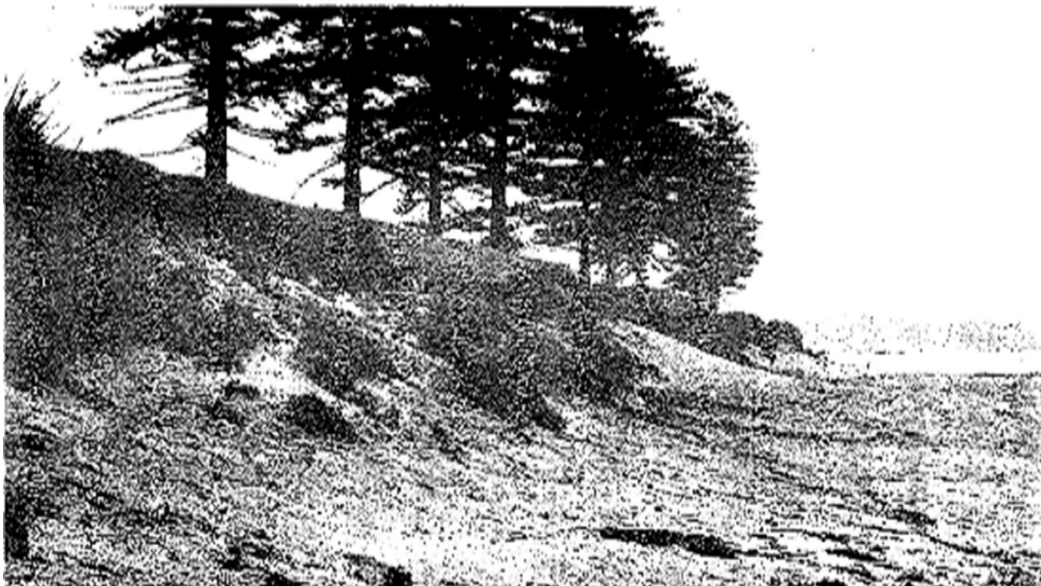
Fig 15 1974 Storm erosion threatens Norfolk Island Pines, Galvin Park (Photo Illawarra Mercury via Report to PWD)

At Galvin Park, the dunes had been badly eroded and were threatening the roots of a stand of Norfolk Island Pine trees, which were to be saved. The dune face was prepared to an agreed stable profile with any arisings being placed on the beach, and filled with blast furnace slag advancing the face of the dunes. A two stage mattress revetment with gabion wave absorber at beach berm elevation was constructed, with a flatter wave absorbing lower section. The two were separated by a 1m gabion, to provide an uprush absorber to protect the vegetated sand cover placed over the upper slope.

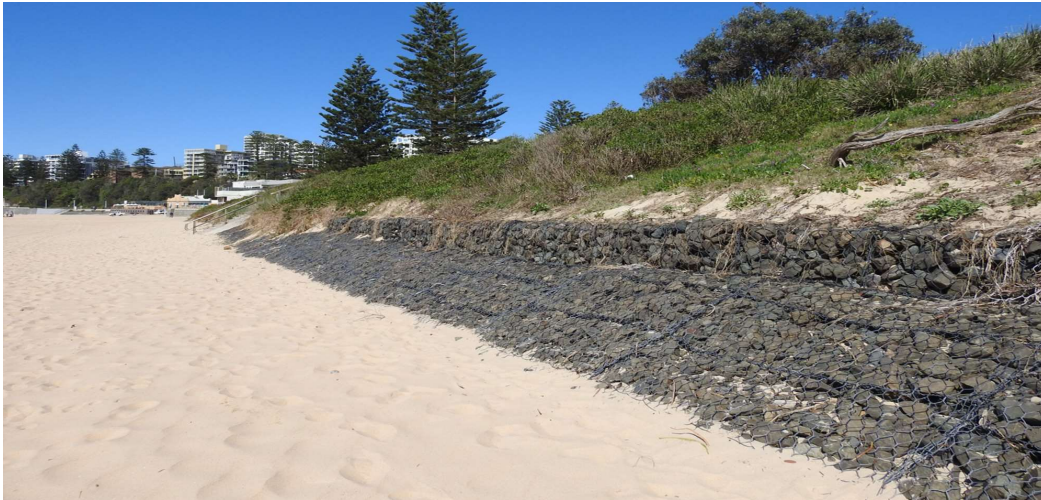
Figure 17 Galvin Park revetment October 2016. (Author's photo)

With the advent of Google Earth, the author was able to monitor this structure from UK, but never succeeded to establish any communication with those responsible. This structure was inspected by Author in 2016, and found to be in acceptable condition with some surface mesh repairs apparent. Inspected again in 2020 in the week before the conference, it was found to be in excellent condition

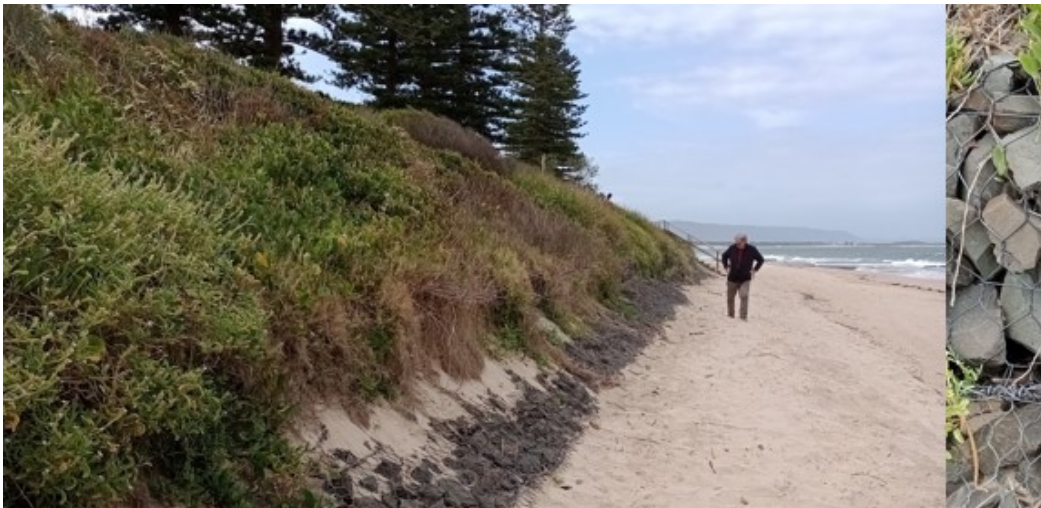
Fig 18 Author's inspection November 29 2022, with detail of exposed mesh. Not the perching of the foredune, and healthy vegetation, including many of the species originally specified before client change to spinifex! R.B Waite accompanying.

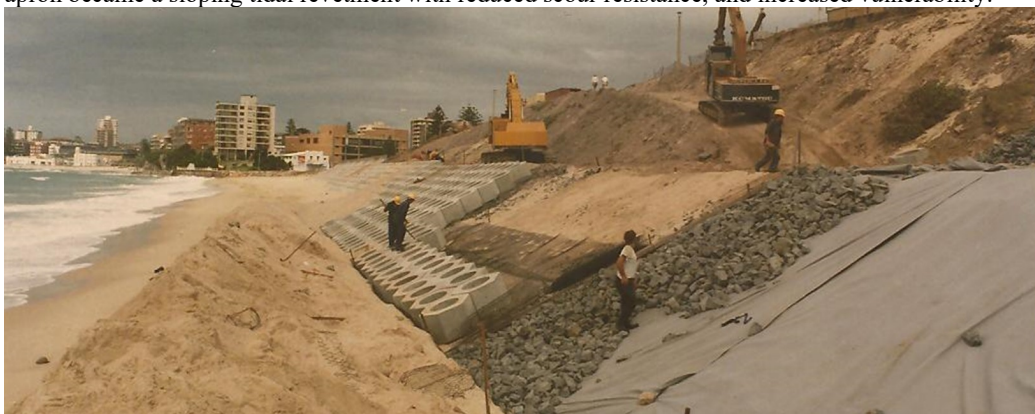
Fig 21 Cronulla seawall during construction. Underlayer blinded with sand to get an aesthetic appearance. Note the Netlon mesh, which served A) to prevent theft of underlayer and B) was to link the gabion toe to the crest wall as a tension link.

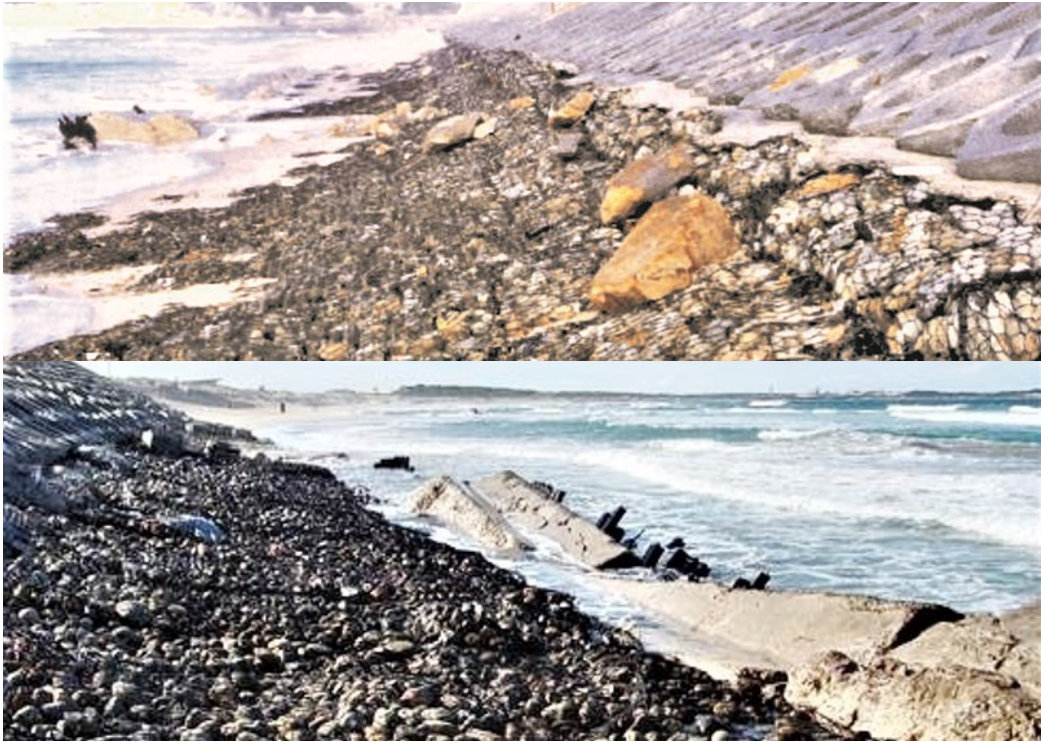
Figure 22a Gabion exposed: photo dated 14 August 1986! This is not the way to treat gabions

22b The end of the line after a severe storm in early 2000s. Note the disruption at the downdrift end.

It was finally constructed in 1986 and exposed by storms almost immediately in August of that year (Fig 22a), with large boulders being thrown up on the gabions. What was to have been a scour apron became a sloping tidal revetment with reduced scour resistance, and increased vulnerability.

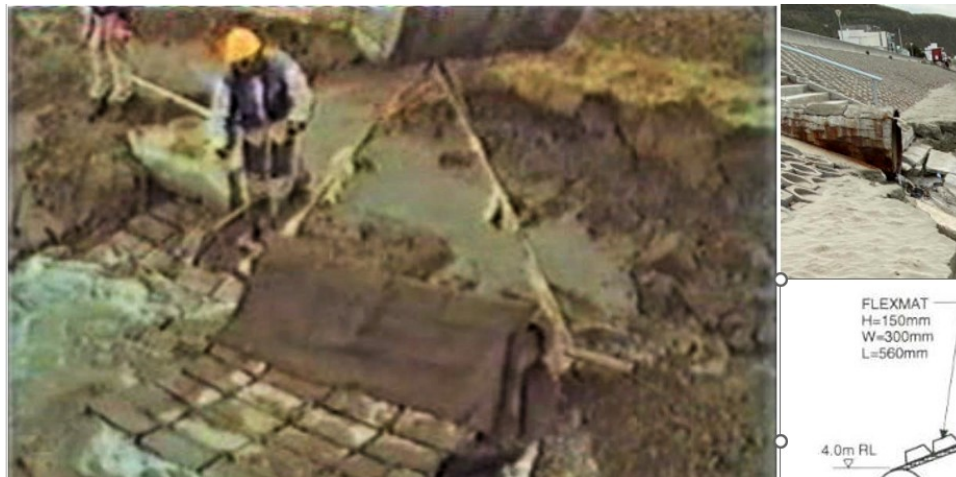
Fig 25 Flexmat – Design details, installation, and problems at a stormwater outfall.

This project is included for comparison, as the concept is similar, but used a short articulated block apron, sited high in the beach above mid tide level. Rada Tilly beach is very flat and has a high tide range of almost 6m. The seawall was designed to harden the face of an existing dune. The seawall s constructed using geotubes filled with beach sand, overlain with a geotextile and a rock underlayer, protected by a carapace of small extruded concrete Seabees at a flat slope of 1:2.5. The toe of the revetment is supported by a horizontal row of toe blocks, protected from scour by a Flexmat apron, a proprietary Argentinian system using precast concrete blocks cast on to the geomembrane, to which they are attached by raised fabric loops around which the blocks are cast. This system is supplied to site in truck-wide panels, with geomembrane overlaps on two sides. Field stitching of the overlapping joints has not been observed.

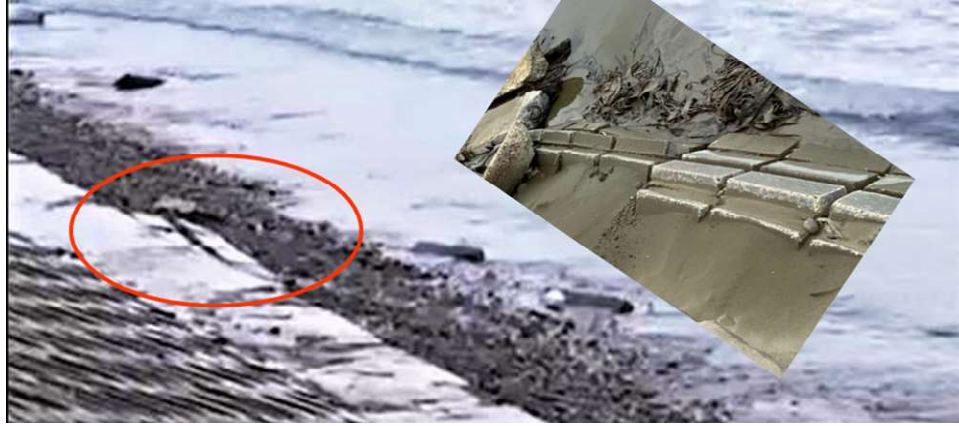
Figure 26 – Disturbed Flexmat toe at Rada Tilly, before rotation of toe blocks occurred. Those look like loose blocks in this photo. Note also the ringed section showing the scour apron being pulled away seawards. These and 200 other photos from searched from facebook & Instagram following a chance observation on Google Earth in January 2021, allowed the date of onset and following history on inaction to be documented from UK..

This design was tested at the WRL (WRL 1998), and some effort was expended to provide a solution that ensured that the toe of the apron fell down during wave attack and did not curl up, and to this end a tubular toe gabion was advised, having a mass in excess of 1 tonne/m. Site video footage of the construction details all phases of the work, except for the installation of the toe gabion. It also
