MORPHOLOGICAL CHANGES TO THE PORTSEA (VICTORIA) COASTLINE FOLLOWING SHIPPING CHANNEL DEEPENING

Andrew McCowan, Water Technology Pty Ltd, andrew.mccowan@watertech.com.au
Ida Brøker, Independent Consultant, broker.warren@mail.dk

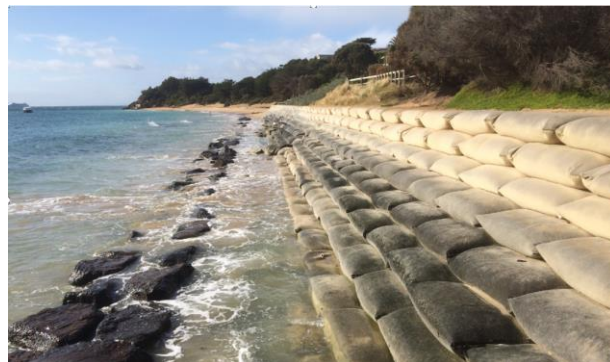
Figure 3 - The sandbag wall at the western end of Portsea Beach

A sandbag wall was constructed in 2010 to protect the

western end of the beach from further erosion while a more permanent solution was developed (Figure 3).

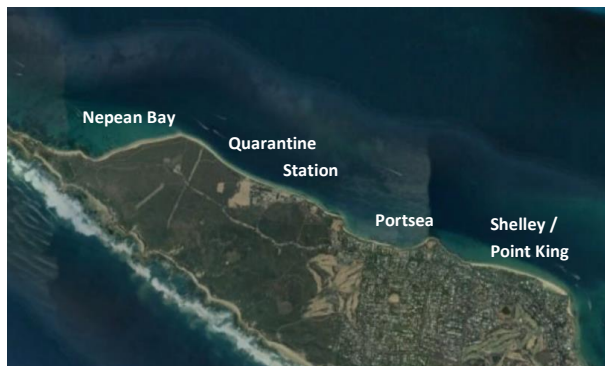
Figure 5 - Sections of coastline under consideration

Four main sections of coastline have been considered, as shown in Figure 5. These are: Nepean Bay Beach; Quarantine Station Beach; Portsea Beach; and Shelley / Point King Beach.

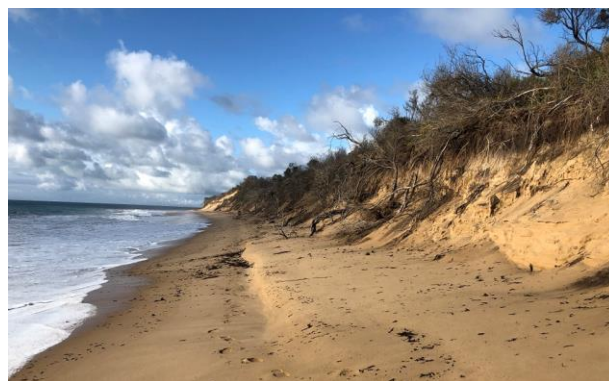
Figure 6 - Dune erosion along Nepean Bay Beach

Nepean Bay Beach: is the highest energy beach under

consideration. Here, the swell wave heights are typically around 50% of those offshore. A pre-existing trend to erosion along this beach has continued, with the higher swell waves resulting in higher wave set-up and wave run-up. This has resulted in more wave action attacking the base of the dunes. Sand from the dunes then collapses onto the beach where it is transported offshore by cross-shore processes. The dune sand is then transported away by longshore processes and the strong tidal currents in the area. Between 2007 and 2018, dunes up to 7m high have receded by 15m to 20m, with a total loss of 135,000 m³ of sand removed from above mean sea level. Most of this sand has been lost to the system.

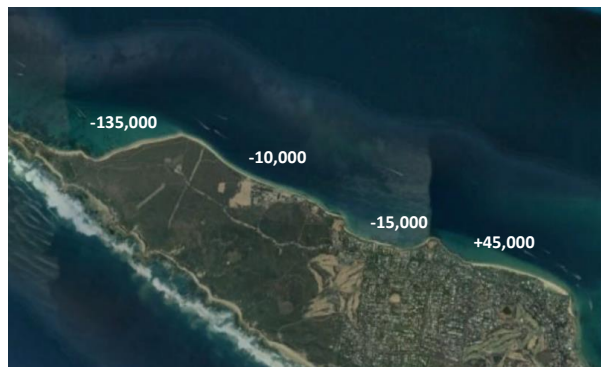
Figure 10 - Changes in volumes of beach sand in m³ between 2007 and 2018

The changes in volume of beach sand above mean sea level have been summarized in Figure 10. Overall, there has been a net loss of 115,000 m³ from the beaches between Point Nepean in the west to Point King in the east.

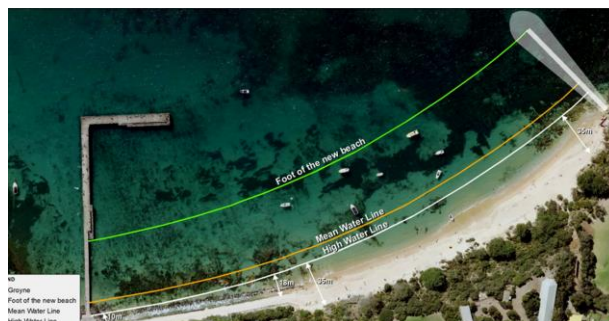
Figure 11 - Schematisation of the proposed groyne and renourished beach.

As an alternative, the present authors have evaluated the effects of the construction of a relatively short 65m at Point Franklin. It has been found that, in conjunction with beach nourishment, the groyne would allow the beach to build-out approximately 35m from the currently stable alignment of the beach. This approach will provide the most cost-effective approach to restoring Portsea Beach.
