SHELL HASH: A NATURE-BASED SOLUTION FOR BEACHFRONT COASTAL RESILIENCE?

William Dally, Brynna Bartlett, Camden Dean, and Zachary Scott
 University of North Florida, 1 UNF Drive 3/3201
 Jacksonville, FL 32224 USA w.dally@unf.edu

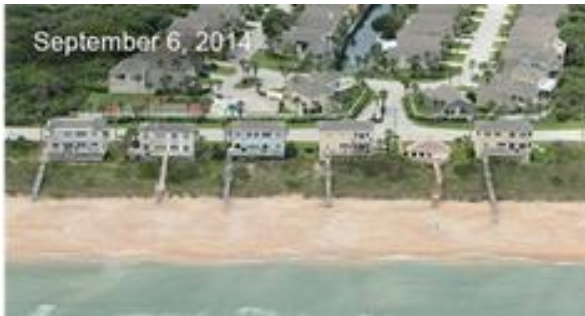
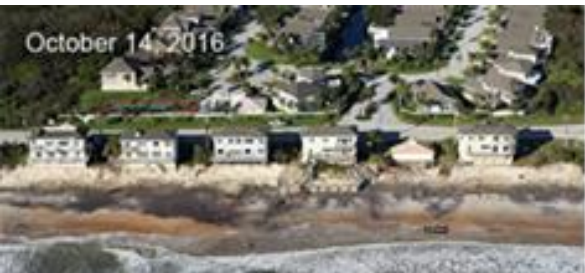
Fig. 1 - Oblique aerial photographs of a section of South Ponte Vedra Beach (a) pre-Hurricane Matthew, and (b) post-Matthew. (R-104).

Based upon examination of beach profiles measured in June, 2016 (*i.e.* pre-Hurricane Matthew), November, 2016 (post-Matthew), and in September, 2017 (post Hurricane Irma) it was found that the 6.8 km of natural beaches in the Guana, Tolomato, Matanzas National Estuarine Research Reserve (GTM), extending from State range monuments R-46 to R-67 in St. Johns County, FL, experienced essentially no erosion of the primary dune, whereas dunes and bluffs in the developed beaches further south in St. Johns County were severely eroded and many beachfront homes experienced heavy damage - see Figs. 1 & 2.

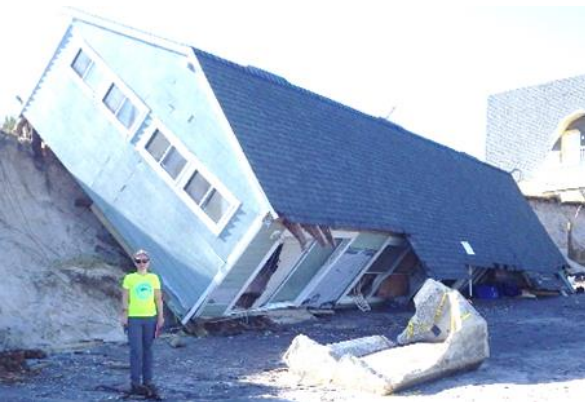
Fig. 2. - Post-Hurricane Irma photograph of slab-on-grade house destroyed by bluff erosion (R-110).

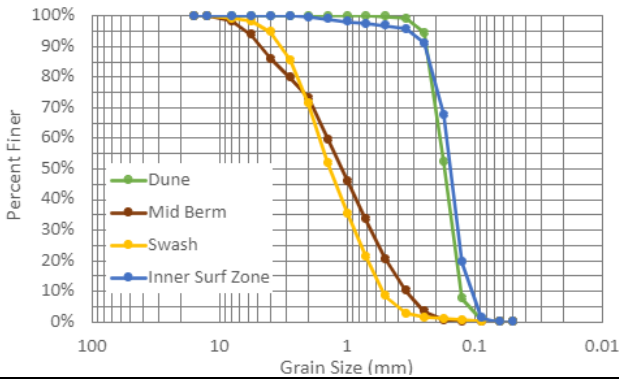
Fig. 5 - Example grain size distributions of the sediments found on the beaches of the GTM (R-57).

Students from the University of North Florida have been collecting and analyzing sediment samples along the shoreline of St. Johns County from R-1 (Ponte Vedra Beach) to R-123 (the north side of St. Augustine Inlet) since February of 2020 to test this hypothesis. Samples are taken every third R-monument (*i.e.*, 57, 60, 63, etc.), with four samples taken at each - one sample taken in the dune, a second from the mid-berm, the third at the toe of the swash zone, and the fourth from the inner surf zone. These samples are being subjected to standard sieve analyses, seeking any correlation of the mean grain size to the beach profile behavior at that location. Sample results are presented in Fig. 5 from R-57. Note 1) the remarkable similarity between the grain size distribution of the dune and that from the inner surf zone, 2) the similarity between that from the toe of the swash and the mid-berm, and 3) the marked *dissimilarity* between the two populations, both in terms of mean grain size and sorting characteristics.

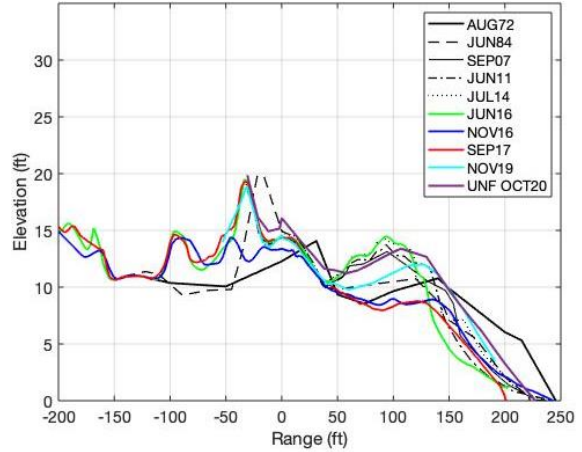
Fig. 6 - Beach profiles at R-57 (dirt access road in the middle of the GTM’s pristine beach), indicating post-storm recovery.

Because shell hash does not collect in a natural primary dune due to its resistance to Aeolian transport, it is hypothesized that the naturally fronting features present before the hurricanes struck were formed by extreme, yet constructive run-up, probably associated with spring high tides and long-period swell events. As evident in Fig 6, beach profiles surveyed after the hurricanes indicate that it required nominally three years for the frontal feature to rebuild itself. It is especially intriguing that the fronting feature grew back to its pre-Matthew shape, and remarkably to the same maximum elevation of nearly +14 ft NAVD88 that existed before the storms (ref. Fig. 1).

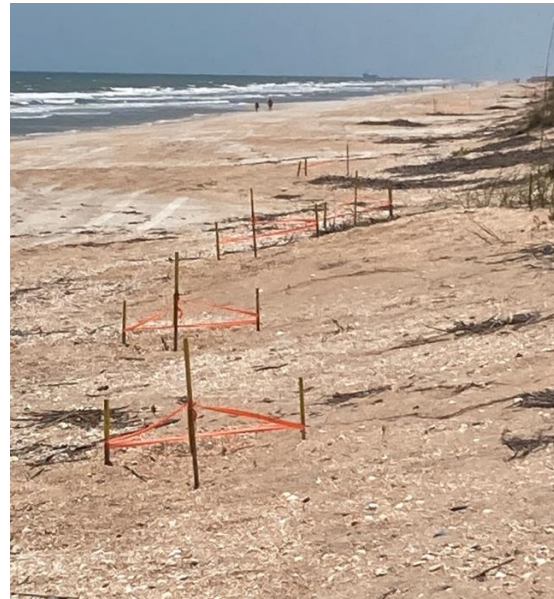
Fig. 7 - Sea turtle nests along the shell hash beach of the GTM (R-58).

Based upon these observations and findings, it appears that the design of “engineered” dunes, and particularly artificial berms, could be significantly improved by utilizing larger-grained sediment such as shell hash, as opposed to attempting to match the native fine-grained quartz sand, as is conventional practice. It is common knowledge that coarse material is not only more resistant to erosion, but is the first material to recover after a storm. As importantly, the naturally rebuilt feature in the GTM is now covered with grasses and other vegetation (see Fig. 7) and is thriving with coastal fauna. Based upon ongoing monitoring, it is also clear that shell hash does not impede the ability of sea turtles to dig nests.
