PERFORMANCE OF A TERMINAL GROIN - FOLLY BEACH, SC USA

Timothy W. Kana, PhD, PG, Coastal Science & Engineering, USA, tkana@coastalscience.com
Steven Traynum, Coastal Science & Engineering, USA, straynum@coastalscience.com

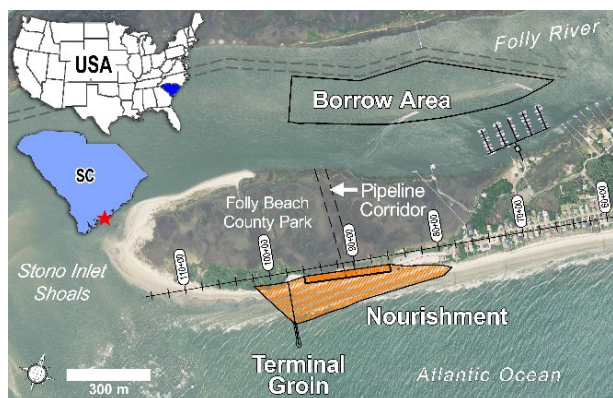
Figure 1 - Project area at Folly Beach County Park (SC).

A terminal groin was designed by the authors and constructed at Folly Beach County Park (South Carolina) in June 2013 to restore and stabilize a highly eroded spit (Figure 1). Groins are rarely permitted in the Carolinas and require extensive monitoring to assess impacts. In the case of the Folly Beach project, permits prescribe groin removal or periodic downcoast nourishment if erosion rates exceed pre-project rates. The common expectation is that groins will accelerate downcoast erosion because of sand trapping by the structure. Annual surveys have been performed by an independent surveyor, GEL Engineering (Charleston), and provide source data for the present analysis.

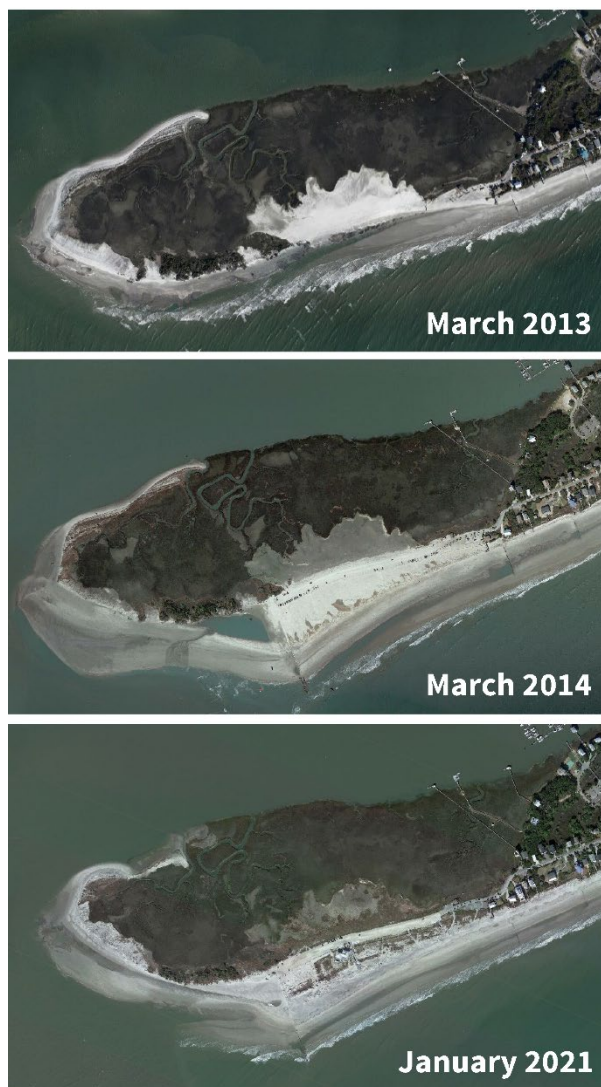
Figure 2 shows a sequence of pre- and post-project conditions. Before construction in March 2013 (top image), the project site was highly eroded with a broad washover fan extending across the marsh landward of the prior parking area for the County park. Marsh outcrops (dark patches on the image) were exposed along the outer beach, confirming recent high erosion rates. The middle image shows post-construction conditions (March 2014), including reclamation of the parking area and beach fillet on the upcoast side of the groin. The lower image shows conditions in January 2021, eight years after project completion. The site has experienced several tropical storms and another out-of-project area nourishment since 2013.

Figure 2 - Aerial images showing the pre-project condition (March 2013), one year post-project (March 2014), and nearly eight years after project completion (January 2021).

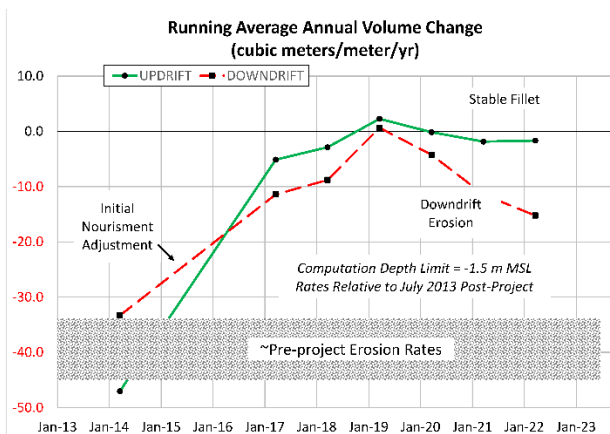
Figure 3 shows the results of the present volume analysis and annual loss rates. The graph in Figure 3 shows high initial losses due to fill adjustment. This includes offshore transport beyond the inner surf zone calculation boundary as the nourishment sand spreads into deeper water; and losses to longshore transport as the construction salient receded rapidly. By four years after construction, erosion rates diminished to under 10 cm/m/yr, and continued to slow through Year 6 (2019). Over the past three years, the fillet has stabilized with negligible change, confirming equilibrium has been reached on the updrift side of the groin.

Figure 3 - The results of the present volume analysis and annual loss rates for the Folly Beach terminal groin. Initially, there were high sand losses due to fill adjustment, but erosion rates steadily diminished four years post-construction. Over the past three years, equilibrium has been reached on the updrift side of the groin.

The downdrift spit tracked with the upcoast fillet over the first seven years but has begun to erode at accelerating rates in Year 8 and 9. Despite the recent increase in erosion, the downdrift loss rates remain well below pre-project rates, as shown in Figure 3. Thus, the project has not reached a point where downcoast erosion exceeds threshold conditions for mitigation. Based on the data in Figure 3, the authors project that mitigation in the form of downcoast nourishment will not be required for at least three more years (Year 12 of the project). Figure 2 shows the downcoast spit remains largely similar to the pre-project condition. Recent oblique aerials (Figure 4) further confirm sand is freely bypassing the groin over the cap, which follows the natural profile, or around the end.

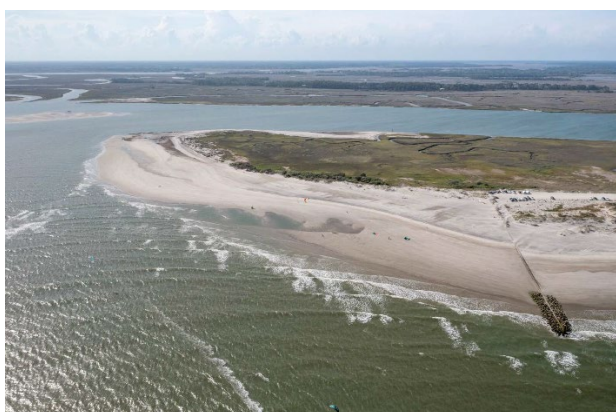
Figure 4 - Downdrift spit at Folly Beach County Park on 3 May 2022, nine years after groin installation. Note the continuous dry sand beach. Photo courtesy of GEL Inc, Charleston, SC.
