# UPDATE ON THE STABILITY OF FOUR ESTUARIES ON THE AUSTRALIAN SOUTH-EASTERN SEABOARD

Angus Gordon, Coastal Zone Management and Planning, [angusczmp@icloud.com](mailto:angusczmp@icloud.com)  
Alexander (Lex) Nielsen, Advisian Worley Group, [lex.nielsen@worley.com](mailto:lex.nielsen@worley.com)

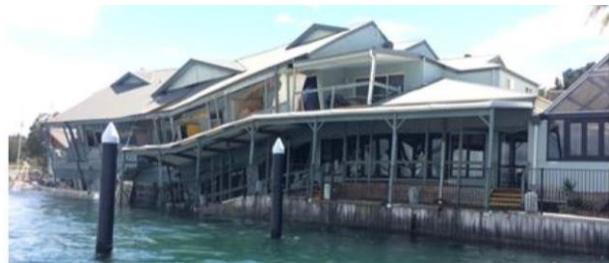
Figure 3 Collapse of Foreshore Buildings due to entrance channel scour at Lake Macquarie 8 February 2016 (photo: Fire & Rescue NSW)

To further investigate the phenomenon a similar channel/lake system with twin breakwaters on the NSW central coast was studied. At Lake Macquarie, the data. For 100 years following jetty construction (1888-1988) the available data suggested the bay/ocean spring tide range ratio had reached 0.080 at an average rate of 0.00080/a. However, for the 18 years following commencement of tidal data acquisition (1988-2006) the average rate was 0.00093/a. But for the past 18 years (2003-2021) the rate rose to 0.00135/a indicating that the rate of increase in the bay/ocean spring tidal range ratio is accelerating (Figure 5.2). At Lake Macquarie not only was the main road bridge undermined but the scour of the lake's connecting channel had compromised the stability of a building, eventually resulting in its collapse into the channel (Figure 3). Low-lying area flooding also is increasing.

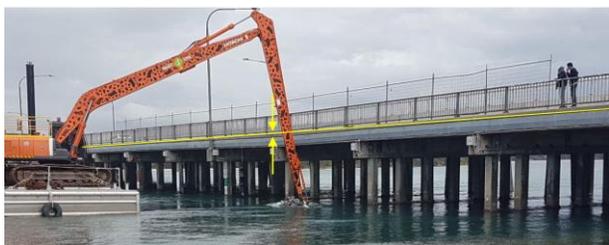
Figure 4 Placing scour protection around piling at the subsiding Windang Bridge February 2020 (Photo: Phil Hollis)

As could have been easily anticipated the channel to the Lake immediately began to scour. The first casualty was the road bridge near the entrance which began subsiding (Figure 4). The next was the progressive loss of the foreshore holiday park. Now there are several dwellings under threat. As Figure 5.3 demonstrates, the rate of change in tidal amplitude in the Lake is far greater than seen elsewhere. However, this is possibly due to the early stage of adjustment. Again, the increased tidal range is progressively impacting on low lying areas around the lake and changing the ecological systems.
