EROSION HOTSPOTS AND BAR DYNAMICS ON THE DANISH WESTCOAST

Nikolai Heath Sørensen, Danish Coastal Authority, nihes@kyst.dk
 Per Sørensen, Danish Coastal Authority, ps@kyst.dk

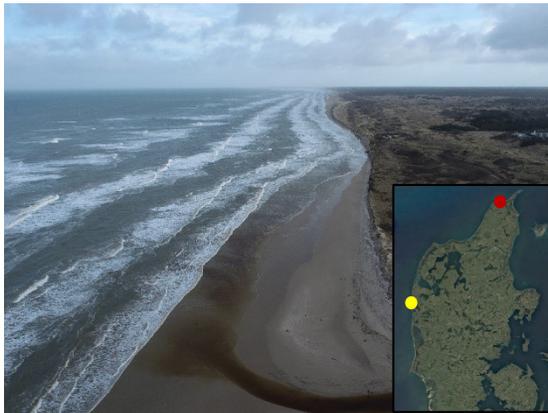
Figure 1 - Location of, and drone image from Tversted (red) and Ndr. Thorsminde Tange (yellow).

Focused local beach and dune erosion hamper coastal safety in certain vulnerable areas. Erosion hotspots are observed as 300-500 m stretches of coastline with greater levels of erosion than adjoining coastlines (Figure 1). Two erosion hotspots, with different wave climates, are observed and analysed to better understand their controlling mechanisms. Forecasting erosion hotspots' location and behaviour could be valuable for coastal safety in these areas.

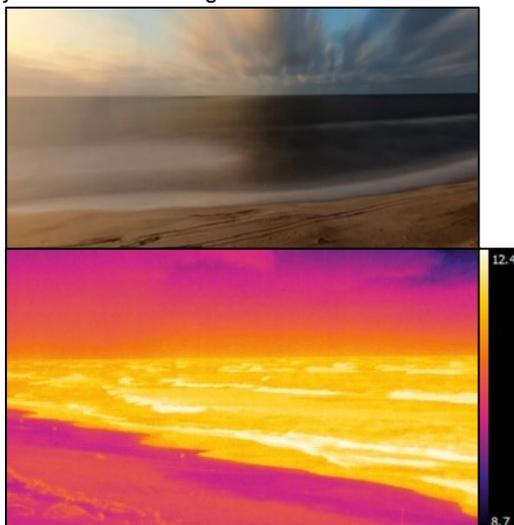
Figure 2 - Top: averaged image. Bottom: TIR image (°C).

Two erosion hotspots are identified, one on the mid Danish west coast (Ndr. Thorsminde Tange) and one on a north-facing beach in northern Jutland (Tversted). A rip current system and an erosion hotspot is identified and monitored for 43 days, at Ndr. Thorsminde Tange, via averaged time-lapse images (Figure 2 top), thermal infrared images (TIR) (Figure 2 bottom), photogrammetric surface models, bathymetric surveys and satellite images.

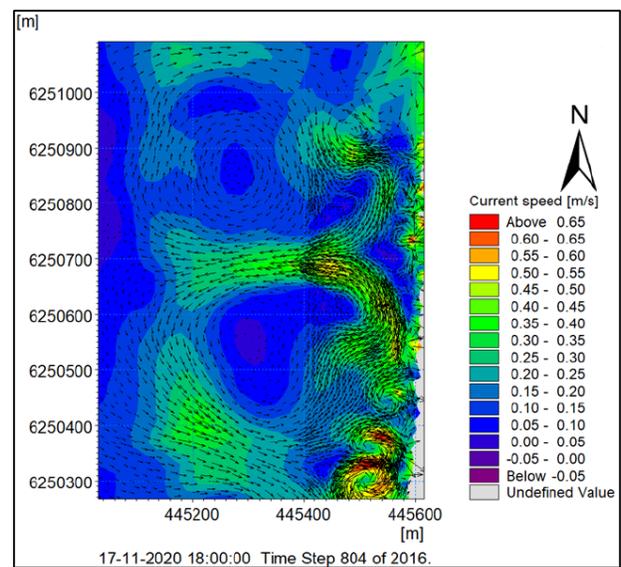
Figure 3 - Simulated rip current under the following hydrodynamic conditions: $H_{m0}=2.4$ m, $T_p=7.7$ s, $Dir=257^\circ$ N.

The dimensionless fall velocity (Ω) is often applied to describe and categorise the nearshore morphology into beach types. A time series of Ω indicates that the beach type is dominantly *intermediate* throughout the 43-day monitoring period. A Ω parameter considering a response lag by a 10 day averaged Ω previous to an observed beach type describes the beach type more accurately than the instantaneous Ω . The integrated coupled MIKE 21/3 model simulates greater water levels at the beach, stronger seaward flowing currents (Figure 3) and larger waves in, and in lee of the rip channel compared to neighbouring coastlines.

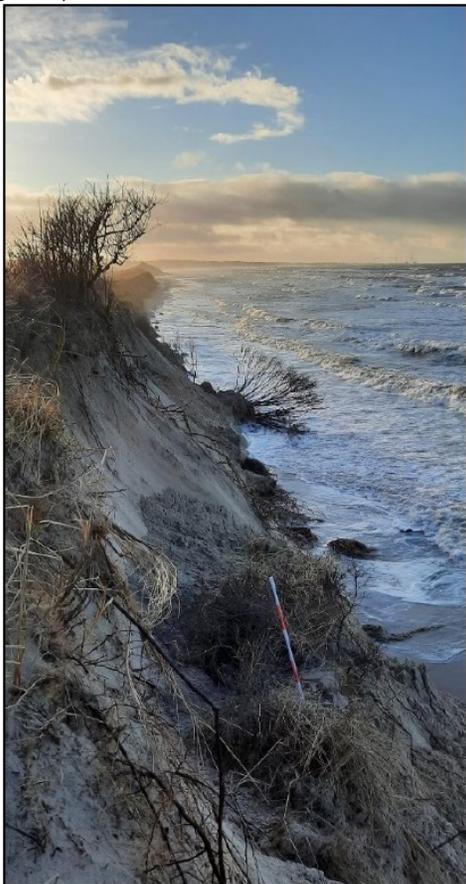
Figure 4 - Photo of a dune after sand dune landslide. The fallen measuring rod was placed on top of the dune two hours prior to the photo.

Besides rip current systems, erosion hotspots can also be a consequence of migrating alongshore sandwaves and/or migrating seabed sandwaves. Alongshore- and seabed sandwaves can exist when the incident wave angle is towards $0/180^\circ$ relative to shore, which is the case at Tversted. Shore orthogonal seabed sandwave crests and troughs could possibly cultivate beach salients and embayments, respectively. The wavelength of the seabed sandwaves are similar to the extend of the erosion hotspot, which calls for further analysis. Several meters of dune erosion was observed within a few hours at a high-energy event in the trough of the alongshore sandwave at Tversted (see Figure 4).
