SURVEY OF STORM SURGE DUE TO TYPHOON RAI IN DECEMBER 2021 IN THE PHILIPPINES

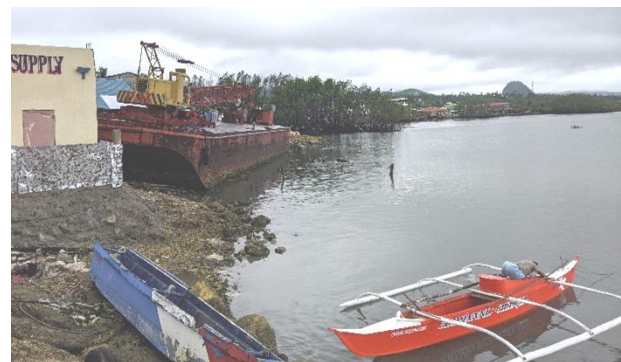
Figure 2. Barge slammed into houses, Tubigon port.

The measured storm surge inundation and run-up heights are summarized in Figure 1, showing that a total of 23 points were surveyed. The maximum storm surge height (4.24 m) was recorded at Tubigon port, in Bohol (See Figure 2). At this town, barge was carried by the surge and

slammed into houses next to the port, though many of them were subsequently rebuilt. At a house next to this barge, the inundation level reached 1.07 m above the floor, though there was substantial run-up that reached the main church of the town (situated around 430 m from the shoreline). Nearby low-lying coral islands, such as Isla Batasan or Ubay, were completely flooded, with up to 90% of houses washed away (see Figure 3).

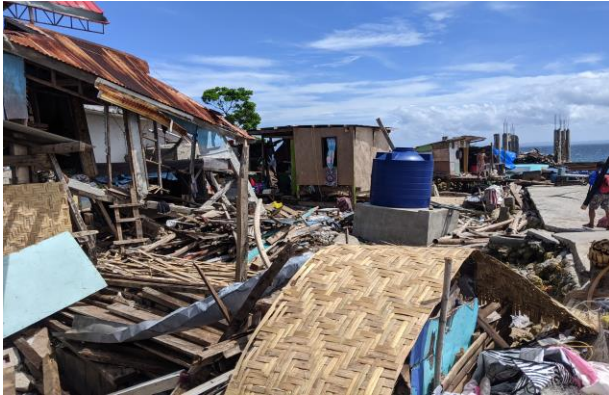
Figure 3. Small islands offshore of Tubigon where badly hit, with 90% of houses destroyed. At the time of the survey some improvised constructions had been rebuilt using materials that were left after the passage of the typhoon.

The measured storm surges at Bohol were generally higher than at Cebu, possibly due to the stronger wind speed and shallower bathymetry surrounding the former island. This was more evident at the islands surveyed near Tubigon, which were originally small sand banks with some vegetation situated on top of a double reef system - and hence the water around them is very shallow-, and which were already submerged during high tides following the land subsidence that took place during the 2013 Bohol Earthquake (Jamero et al. 2017, 2018).

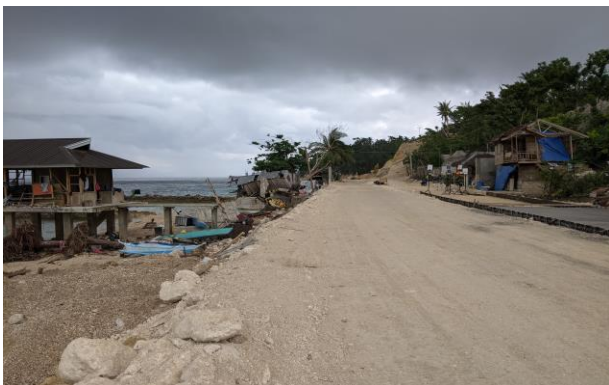
Figure 4. The road between Malabuyoc and Alegria suffered severe scour damage and in some places was completely removed, with recovery activities underway at the time of the survey.

In some areas in the west coast of Cebu, large stretches of roads were eroded, which were partially rebuilt at the time of the survey (see Figure 4). At several locations[,] a boulder ridge had been created by the typhoon by transporting coral stones from deeper within the reef (see Figure 5).

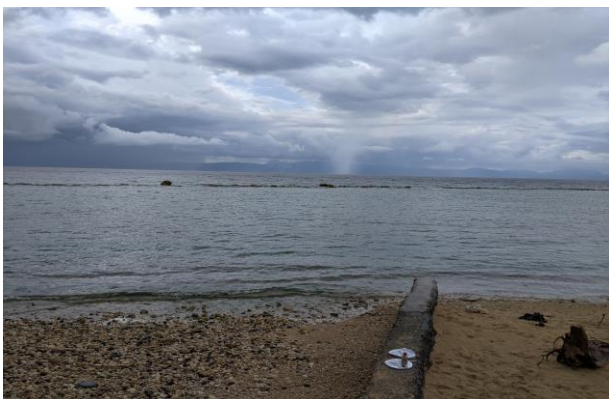
Figure 5. Boulder ridge created by the typhoon offshore Badian.
