INNOVATIVE COASTAL CLIFF STABILISATION - THE SCARBOROUGH CLIFFS STABILISATION PROJECT

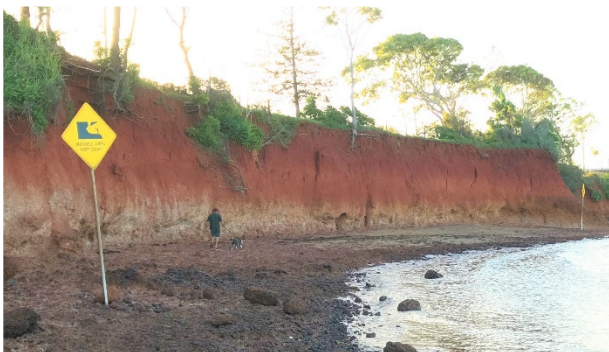
Coastal cliff erosion and retreat is a common problem worldwide. Long-term erosion due to natural coastal processes have caused the iconic vibrant red cliffs of the Redcliffe peninsular (Scarborough, Queensland, Australia), to retreat landwards, which posed a potential risk to public safety and infrastructure (Figure 1).

Figure 1 - Image of the iconic Scarborough Cliffs (pre-works)

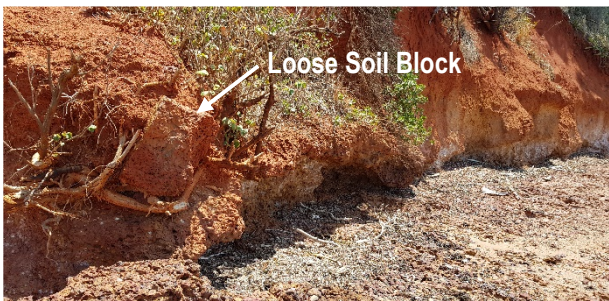
Investigations into coastal processes and geotechnical conditions at the site found that the retreat of the 320m long section of cliffs was largely driven by the slow notch erosion of the cliff base resulting in translational block failure of the overlying laterized cliff face and rotational collapse of the weaker cliff crest soils (Figure 2).

Figure 2 - Typical example of notch erosion along the base of the cliffs

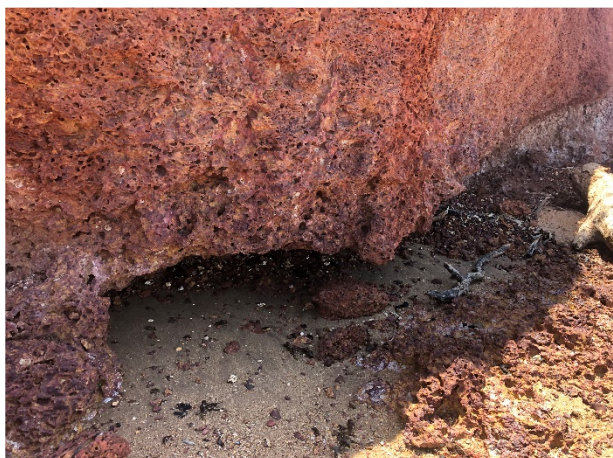
Severe notch erosion was observed in two sections along the cliff extending up to 1.6m into the base of the cliff (Figure 4). Treatment including removal of the overlying material, shotcrete filling of the remaining notch and incorporation into the shotcrete erosion protection wall.

Figure 4 - Severe notch erosion observed at the base of the cliff prior to commencement of works

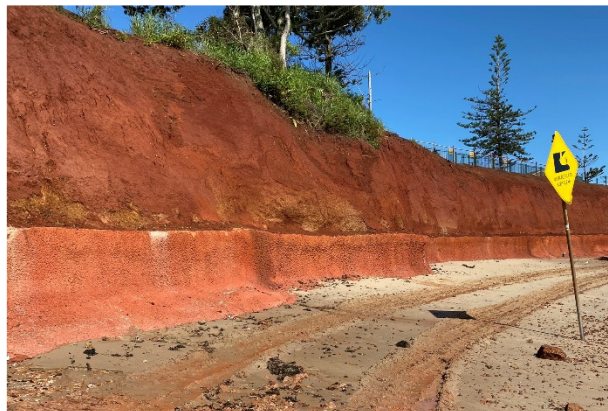
The construction works were staged as follows: Preliminary works to make safe the site, including removal of near-vertical, negative slopes and undermined vegetation; Re-profiling of the cliff base where the shotcrete erosion wall is to be constructed; Installation of grouted GFRP soil nails, drainage and GFRP mesh reinforcement; Removal of any loose materials, such as sand, gravel and vegetation; and Layered application of shotcrete to design wall profile. The completed structure achieved a colour and texture

similar to that of the existing cliff, whilst retaining the beach width and iconic aesthetic of the cliffs (Figure 5).

Figure 5 - Image of the completed works

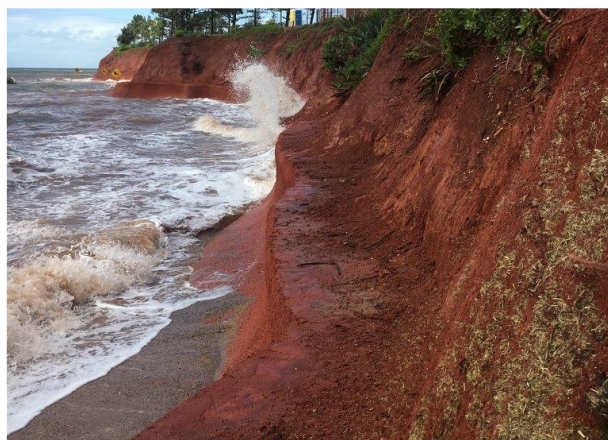
Several storm events have occurred since construction of the works was completed, which has provided an opportunity to observe the performance of the structure against wave conditions that would have previously contributed to notch erosion at the base of the cliff. (Figure 6). Post-construction monitoring shows the works are performing well and are successful in protecting the lower cliff from further erosion to date. The shotcrete wall remains well integrated with the cliff face. The design and construction challenges of this project, including detailed discussion of the adopted design solution, and the performance of the completed works, are presented within this paper.

Figure 6 - Reflection of wave attack during a spring tide event (March 2020)
