## ASSESSMENT OF ALTERNATIVE BEACHFILL PLACEMENT ON SURFING RESOURCES

Jon K. Miller<sup>1</sup>, Alicia M. Mahon<sup>1</sup>, and Thomas O. Herrington<sup>1</sup>

In February 2009, a 700,000 cy, \$9 million beach nourishment project was completed in Long Branch, New Jersey. The beach fill was constructed using an innovative feeder beach design, rather than a standard linear fill template. The feeder beach design was adopted to address the concerns of local surfing groups by initially burying fewer structures, and by potentially creating additional surfing opportunities through enhanced bar formation during the equilibration process. Nine months of monitoring results show that roughly 84% of the placed material can be accounted for within the project area and on the downdrift beaches. The immediate impact of the fill on the local surfing conditions was negative within the project area as steep slopes, violent plunging breakers, and narrow surfzones limited the use of the feeder beach area; however traditional surf spots to the north and south were unaffected by the nourishment due to the concentrated nature of its placement. More recently, as the post-nourishment slopes have begun

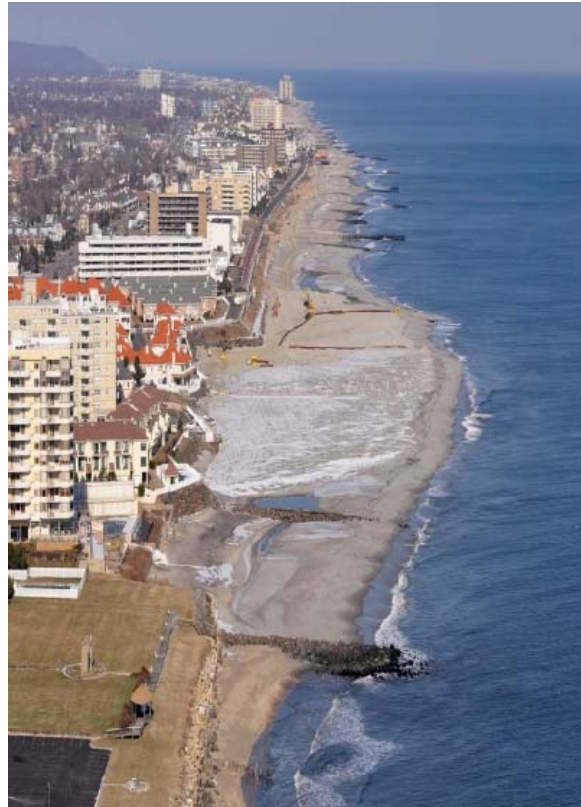
**Figure 1. Construction of the feeder feature.**

Construction on the project began in November 2008 and continued through February 2009. An aerial view of the project during construction is given in Figure 1. The modified design template consisted of a trapezoidal center section with berm extending approximately 500 feet from the seawall, flanked by a traditional linear fill extending 300 feet from the seawall. The toe of the fill within the feeder section was designed to extend approximately 900 feet from the seawall and to tie in with the existing grade at a depth of approximately 29 feet. Due to complications encountered with placing the material in water depths greater than 25 feet, the feeder beach was actually constructed 300 feet shorter (at the toe) than the design template.

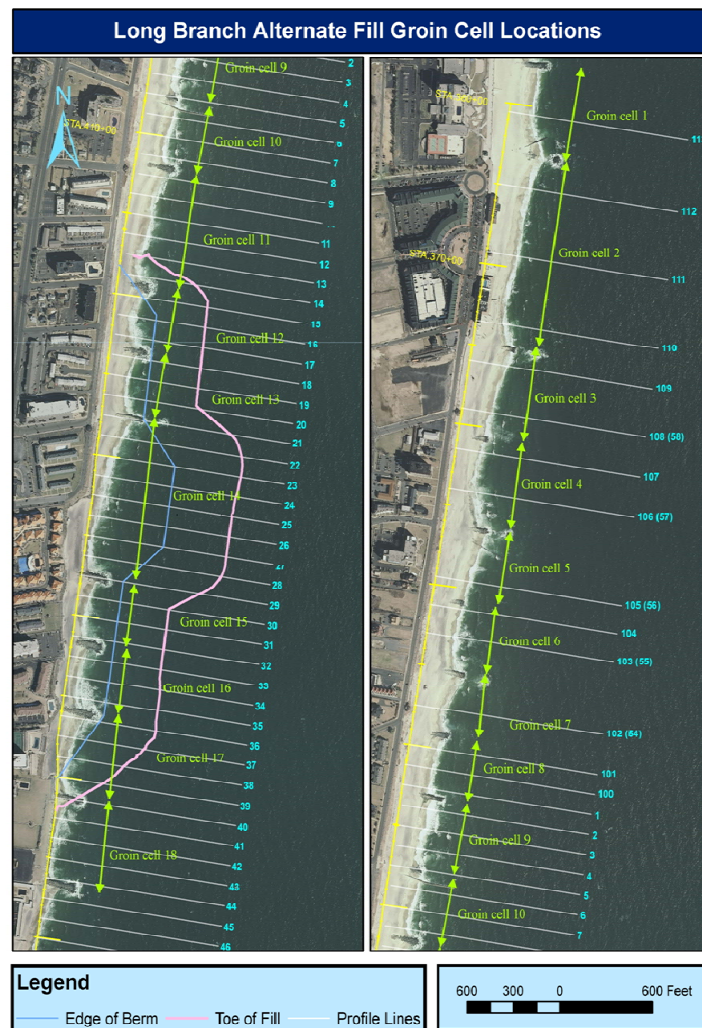
Figure 2. Profile lines and groin cell numbering system.

(Miller, *et al.* (2009a). The majority of the profiles remain spaced 125 ft; however the spacing between some of the added profiles ranges up to 400 ft. Surveys were conducted weekly during the first two months of monitoring, biweekly during the third month, and approximately monthly thereafter through the first year. Each profile extends from the landward-most accessible point on the dry beach (typically adjacent to the seawall or dune) out to an offshore depth of approximately 30 feet NGVD (National Geodetic Vertical Datum of 1929). Land based measurements of the dry beach are collected during periods of mid to low tide, with the offshore data collected during periods of mid to high tide. This ensures the highest likelihood of achieving an overlap between the two surveys. A site plan showing the profile lines, the project baseline, and the original feeder beach design is shown in Figure 2.

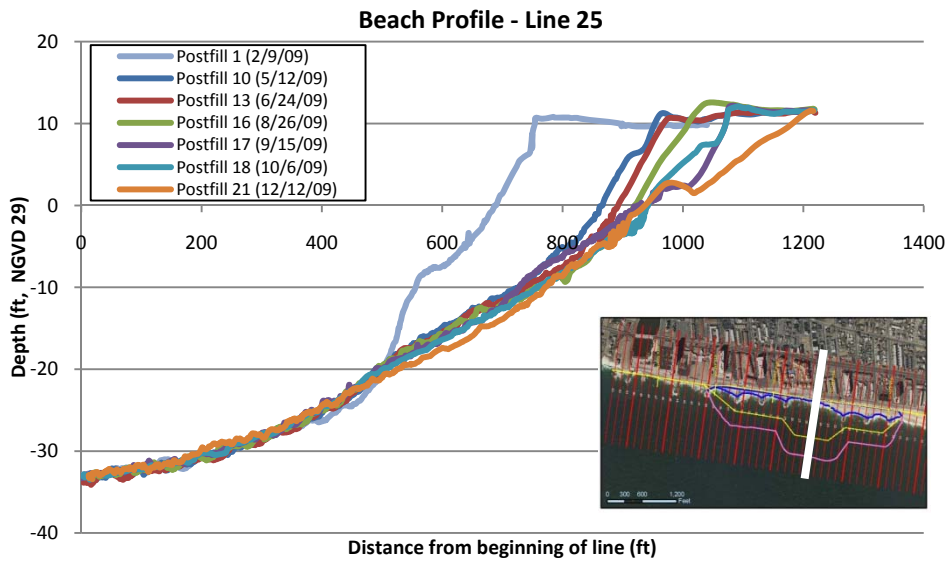
**Figure 3. Beach profile along Profile 25 (center of feeder feature)**

Profile 25 located in the center of the feeder region, is shown in Figure 3. Initially slopes within this region remained stable and close to the placed slope (~1:15). Beginning in June 2009 (Postfill 13), the slopes finally began to flatten; however the natural slope equilibration was significantly influenced by summer beach maintenance activities which included smoothing the nearly vertical scarp at the run-up limit. The most recent surveys (Postfill Surveys 18 and 21), reflect the impact of the winter storm season. In contrast to the gradual, uniform slope modifications experienced during earlier periods, these two surveys exhibit prototypical winter/storm profile response with material being removed from the subaerial beach and deposited in a bar. The bar is particularly pronounced in Postfill Survey 21. As of December 2009, the MHW shoreline (+3' contour) had retreated approximately 345 ft from its post construction (Postfill Survey 1) position.

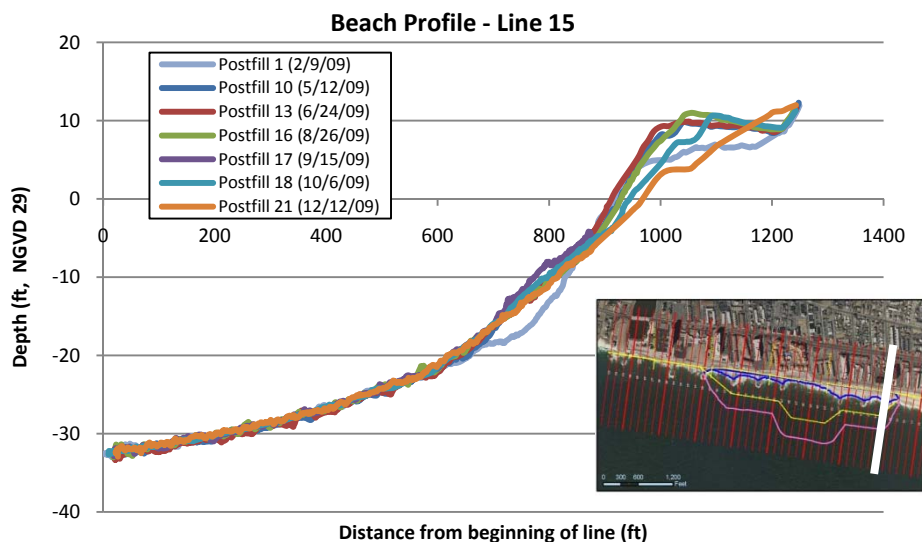
**Figure 4. Beach profile along Profile 15 (within fill template, downdrift of feeder beach)**

Moving north along the project site in the direction of the predominant littoral drift, many of the features of Profile 25 are preserved although the impact of the initial fill is lessened outside of the feeder region. Profile 15 which is shown in Figure 4 exemplifies the types of changes observed along Profile Lines 10-17. Profiles in this region experience significant gains in volume both along the upper beach face and at depths between 10 and 20 ft below NGVD29. In both cases, the material comes from the neighboring feeder beach region. The sediment influx along the beach face is somewhat typical of beach nourishment evolution; however the deposition of material in deeper water is less common. A detailed analysis has not been performed, however the current hypothesis is that the combination of an extremely steep beach face combined with the extra sharp initial shoreline gradient associated with the feeder feature resulted in sediment moving alongshore and sliding into the trough or pocket measured during the initial Postfill Survey.

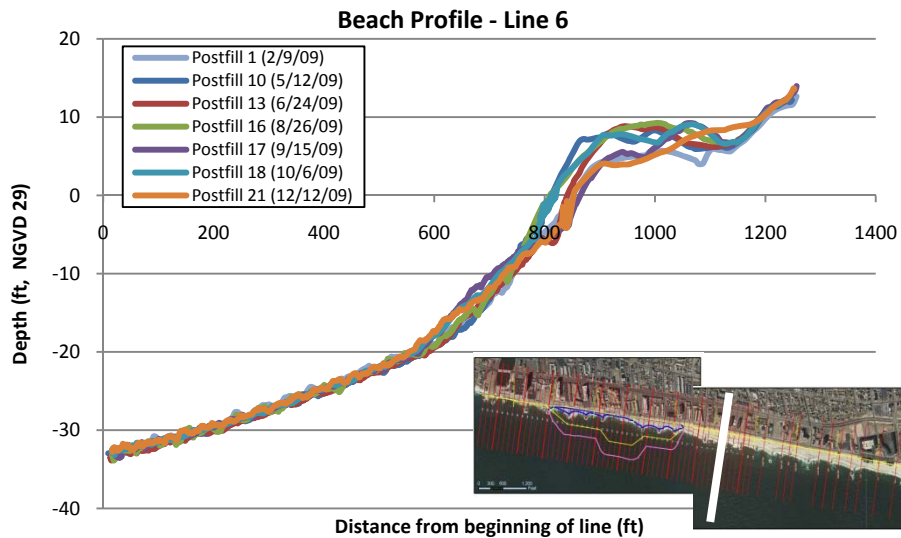
Figure 5. Beach profile along Profile 6 (downdrift of fill area, updrift of outfall pipe)

Further to the north some interesting behavior is observed at Profiles 5 and 6 associated with a 78" diameter outfall pipe that initially acts as an oversized groin, effectively limiting transport to the north. As the beaches updrift of the pipe built up in response to the impoundment of the fill material moving north, the pipe was eventually bypassed. For comparison, Profile 6 located just updrift of the pipe is shown in Figure 5, and Profile 5 located just downdrift of the barrier is shown in Figure 6. The broad flat-crested berm exhibited by Profile 6 is reflective of the dominant northward littoral drift which has caused the downdrift beach to accrete both vertically and horizontally. The maximum beach width achieved during Postfill Surveys 10 and 18 occurs when the updrift beach builds out to the tip of the outfall pipe and significant bypassing occurs. In general the downdrift profile is less stable as the beach width and elevation is regulated by the amount of bypassing that occurs. Even during transport reversals associated with storms, the amount of sediment within the system is insufficient to build the downdrift beach out to the tip of the pipe.

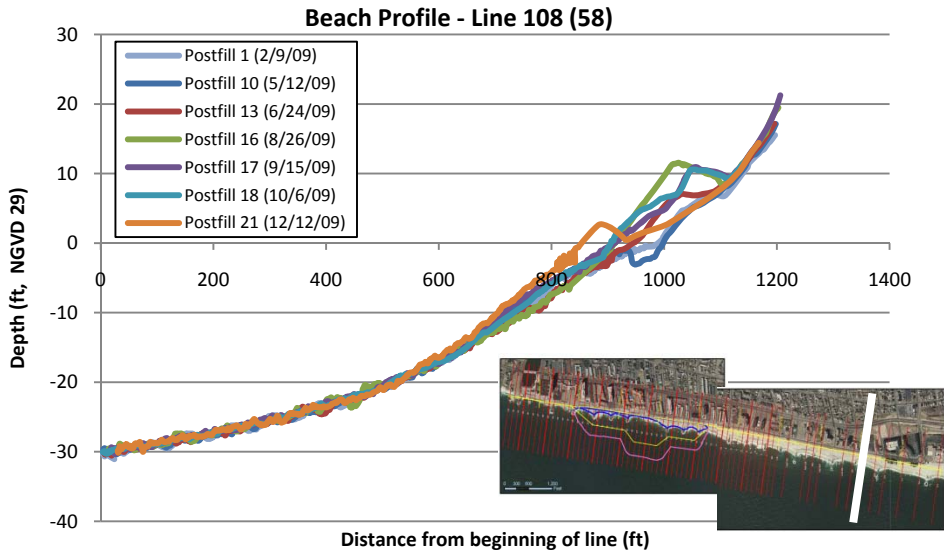
Figure 7. Beach profile along Profile 108 (58) (downdrift of fill area)

Further downdrift, the impact of the fill is being felt as well, although to a lesser extent. Profile 108 (shown in Figure 7) is the northernmost profile collected throughout the monitoring period and as such represents the limit for comparisons/calculations of elevation and or volume change. Only minor differences exist between the first two surveys shown on the plot (1 and 10). Beginning with Postfill 13 however, the beach berm begins to build in elevation. The reason for the delayed response is attributed to the large outfall pipe between Profiles 5 and 6, a smaller outfall near Profile 105, and the series of notched and unnotched groins between Profiles 6 and 108. Initially much of the sediment was deposited near the shoreline on the subaerial beach; however most recently, winter storms have reworked the profile into a typical winter/storm configuration complete with a subaqueous nearshore bar.

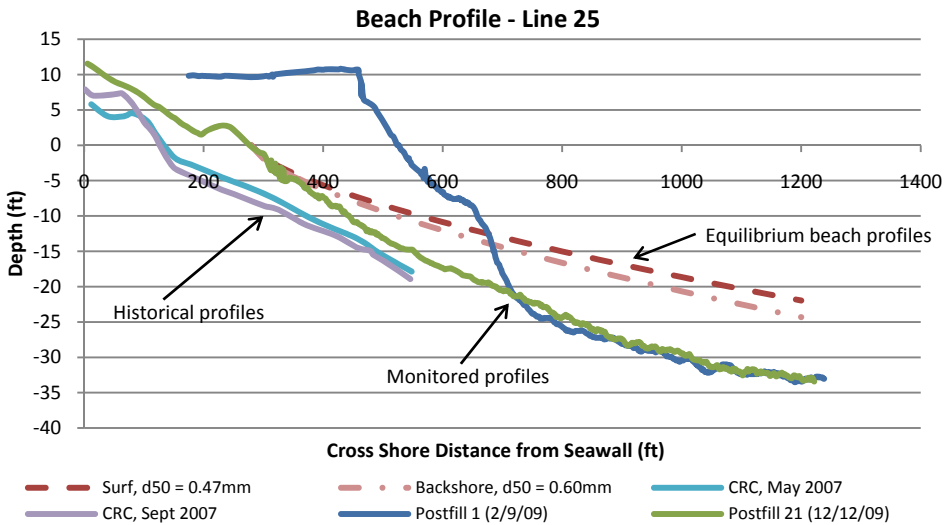
Figure 8. Comparison of the initial and most recent observed profile at line 25, with historically measured, and equilibrium beach profiles.

One of the more interesting and most significant facets of the profile changes that have occurred relates to the nearshore beach slope. To illustrate the extent to which the beach nourishment project altered the nearshore slope, a comparison was made between the measurements collected along Profile 25, historical data collected nearby by the Coastal Research Center (CRC) at The Richard Stockton College of New Jersey and two sets of Equilibrium Beach Profiles (EBP) (Dean, 1977). Figure 8

shows the comparison. Previous calculations (Mahon, *et al* 2009) have indicated that the offshore slopes of the CRC profiles (~1:25) approximately match those associated with the equilibrium beach profiles (EBP). By comparison, both of the measured post-construction profiles are dramatically steeper.

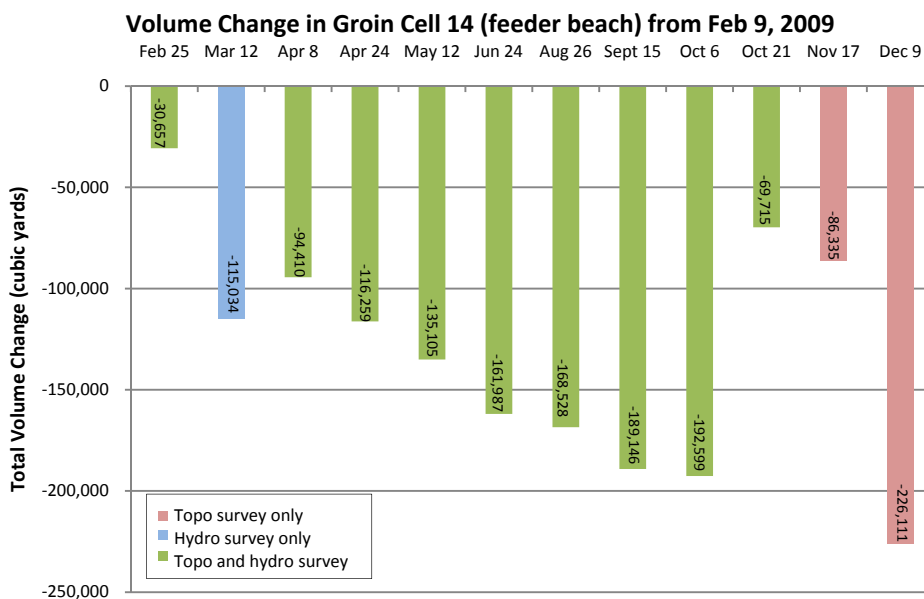
Figure 13. Volume change in groin cell 14 (feeder beach)

Volume changes in three specific groin cells are shown below in Figure 13 through Figure 15. Figure 13 shows the volume change in groin cell 14, which is the feeder beach region. Note that the color of the bar is reflective of the type of comparison being made, i.e. full survey, topographic only, or bathymetric only. The graph is somewhat skewed by the fact that the x-axis is categorical rather than

quantitative, such that each bar takes up the same amount of space even though the last six bars represent a time period twice as long as the first six. Considering this, it's obvious that the rate of volume change has slowed considerably

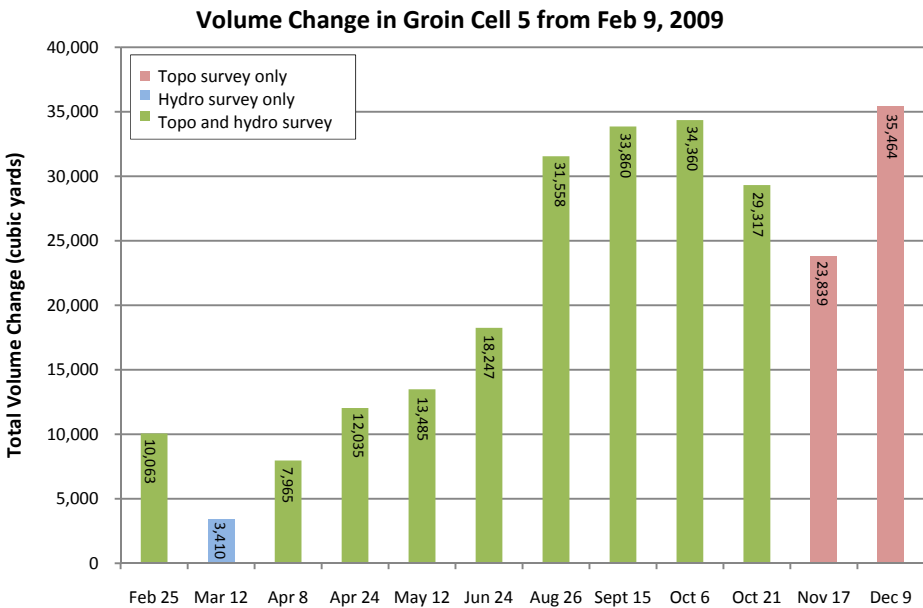
**Figure 15. Volume change in groin cell 5 (downdrift)**

The changes in Groin Cell 5 (downdrift of the fill placement area) are shown in Figure 15. As with each of the groin cells downdrift (north) of the project site, significant accretion is observed. Cell 5 is located immediately downdrift of a small outfall pipe/groin combination which impacts the local

morphology although not to the same extent as the large pipe discussed previously. The sharp increase in volume observed between the June 24 and August 26 survey is potentially related to the updrift cell filling to such a capacity that bypassing of the pipe/groin system is enhanced. Subsequent surveys indicate that minimal changes have been observed within the cell subsequent to the abrupt jump.
