THYBORØN HARBOUR – STUDY OF WAVE AGITATION AND SEDIMENTATION

Keywords: tidal inlet; sediment transport modelling; wave agitation; wave modelling

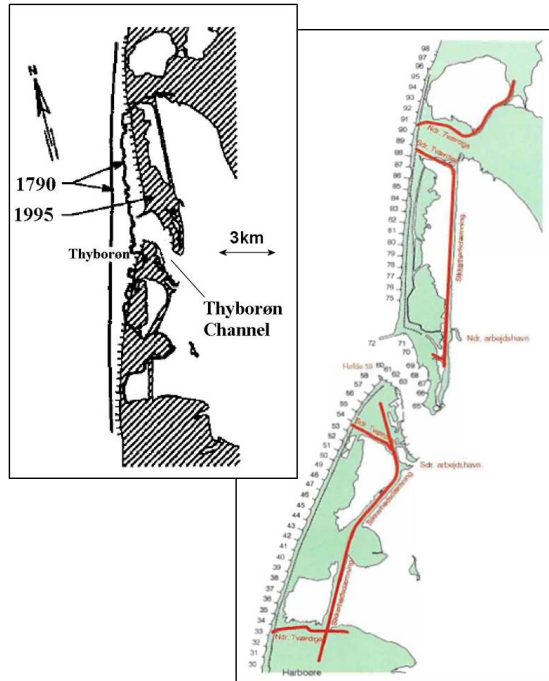
Figure 2. The coastlines before the breach and the present protection works.

coastline, but a steepening of the coastal profiles outside the tips of the groynes was observed and led to a fear that an uncontrollable coastal erosion could be caused by a series of severe storms, Sørensen et al. (1996), Jacobsen et al (1998). In the 1940-ies it was therefore decided to close the channel and construct sluices and a navigation lock. Subsequently an extensive technical investigation was carried out at the initiative of Professor Lundgren after the publication of Per Bruun's (1954) doctoral thesis. The technical investigation led to the conclusion that the conditions were sustainable without closing the channel, and following this monitoring and management of the protection works have been carried out by the Danish Coastal Authority. The steepening of the profile has continued at a reduced pace and the position of the coastline is maintained by regular nourishment of about 750,000 m³/yr.

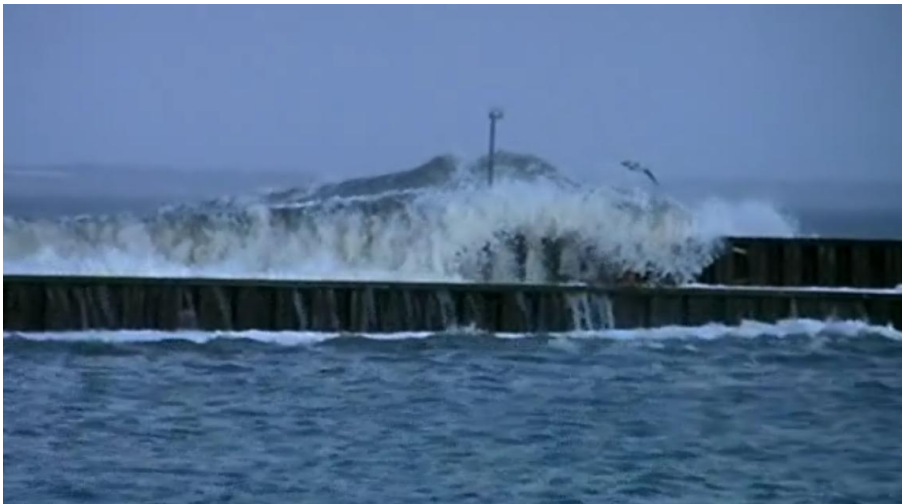
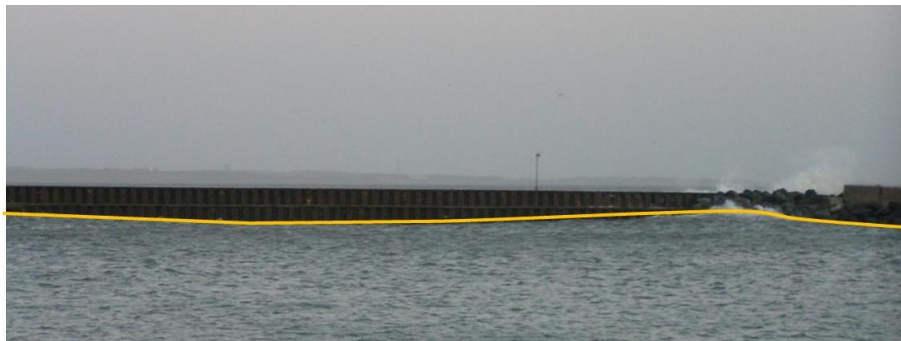
Figure 3. Severe overtopping of the breakwater just south of the harbour entrance (upper figure) and wave disturbance inside the harbour basin.

As a remedy the protective breakwater south of the harbour mouth, which had a vertical sheet pile front, was reinforced by a rubble mound slope at the breakwater front. This removed the immediate threat to the structures of the harbour, but it did not solve the difficult navigational and mooring conditions at and in the harbour.

According to the harbour users the problematic events occur during and shortly after events with strong wind/waves with offshore directions between W and NW. Several events were documented by video and photos. Fig. 3 is showing an example from one of the video documented events with severe overtopping. From the observations, it was assessed that the wave heights were locally amplified – a so-called Mach Stem effect. This effect occurs when the direction of the incoming wave is close to the direction of the reflective breakwater front.

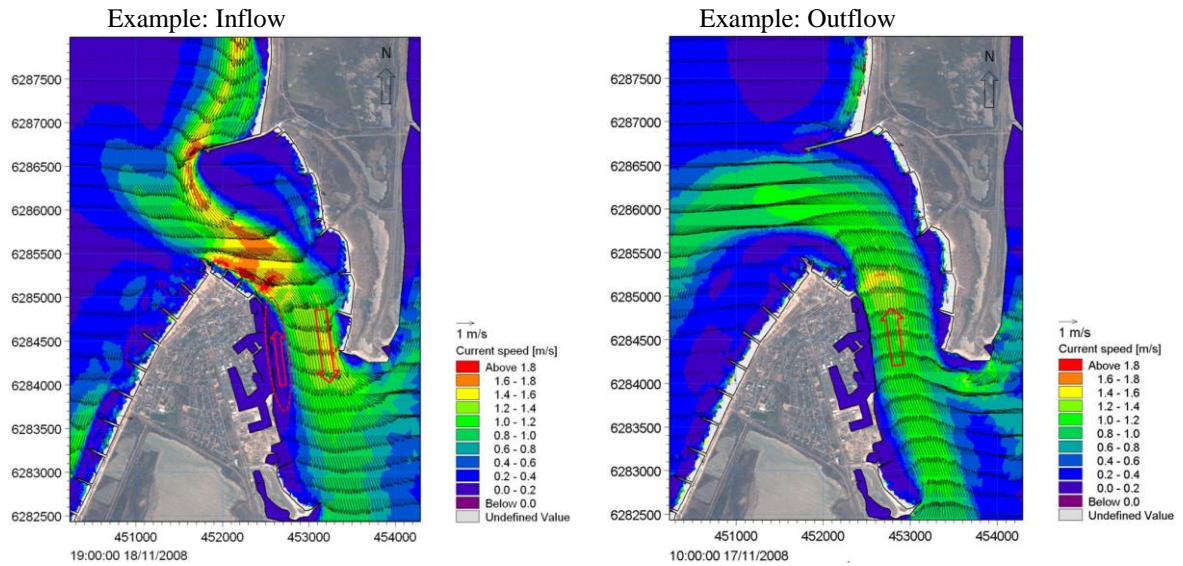
Figure 7. Examples of simulated instantaneous flow fields for an inflow situation (left) and an outflow situation (right), respectively.

An understanding of the flow and sediment transport conditions in the channel was obtained through analysis of results from numerical simulations. A flow model was set up with MIKE21-FM HD (hydrodynamics) and calibrated based on ADCP-measurements carried out as part of the study by the Danish Coastal Authority. The model includes meteorological forcings, tides, wave radiation stresses and bottom friction and the model settings were in general based on earlier experience (Brøker et al, 1996). The new measurements carried out in the harbour approach area, approximately 100 m from the southern breakwater, however, called for a recalibration of the bottom roughness to be able to reproduce the presence and strength of a circulation/eddy cell in front of the harbour entrance during inflow situations, see Fig. 7. Fig. 8 shows a comparison of the measured and modelled current speeds and directions for a period in Nov. 2008.

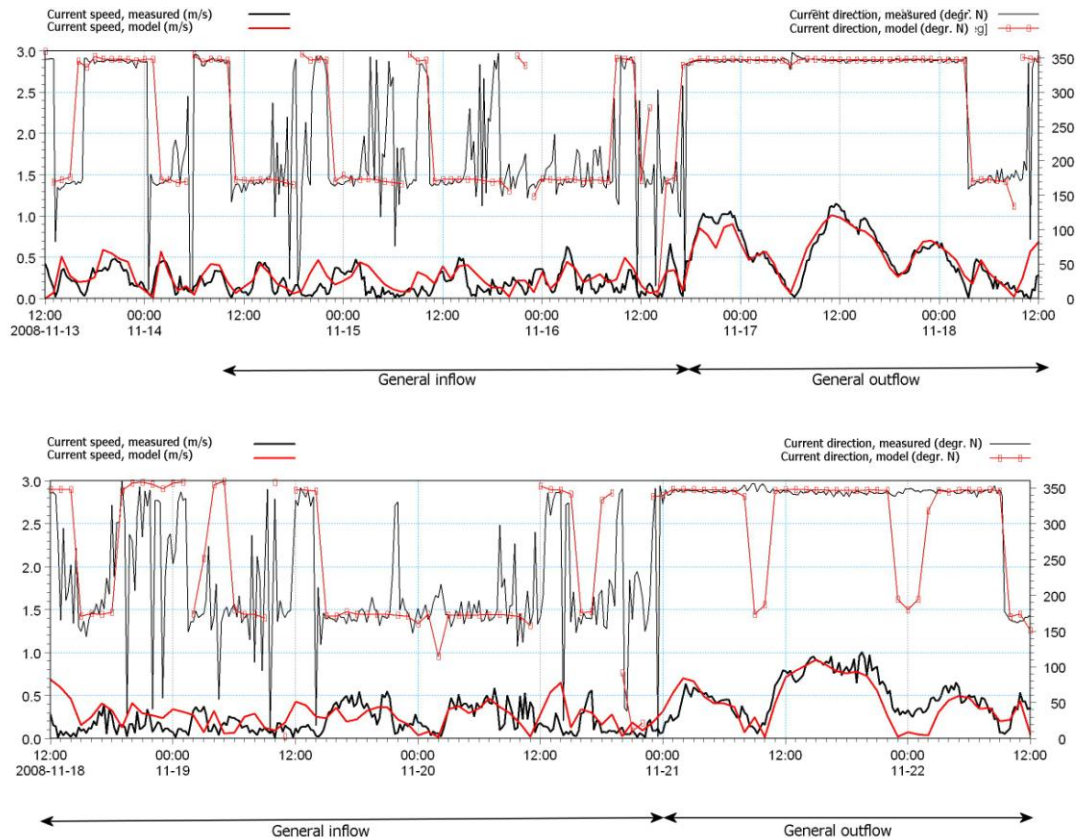
Figure 8. Measured and calculated current speed and direction in front of the southern breakwater, Nov. 2008. Measurements by the Danish Coastal Authority.

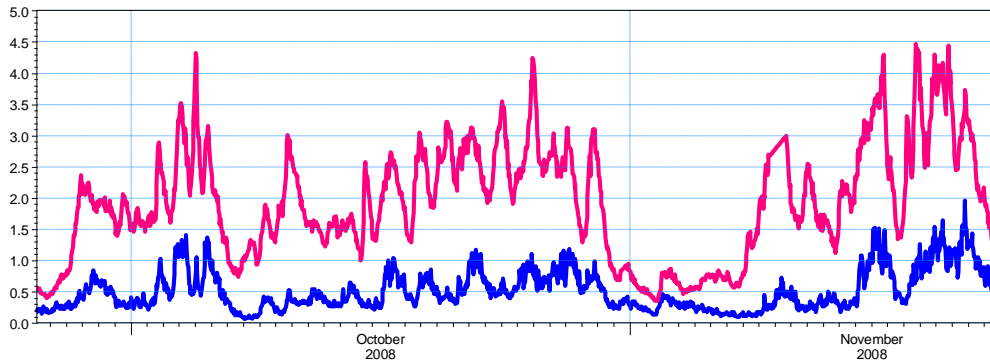
Figure 10. Measured wave heights at the harbour (blue) and offshore (red). H_{m0} (m).

Over a 4-month period wave measurements were carried out at the harbour entrance. At the same time measurements were carried out outside Thyborøn Channel at 16 m of water depth. Figure shows the measured wave height offshore and at the harbour for a two-month period. During the measuring period the maximum wave height (H_{m0}) at the harbour was measured to 2 m.

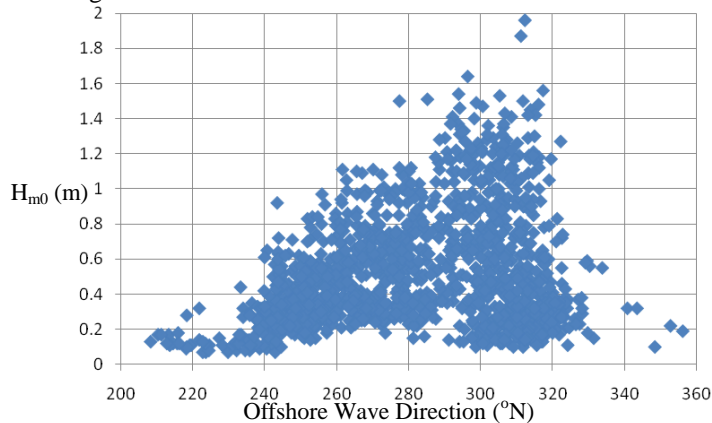
Figure 11. Wave Height, H_{m0} (m) at the harbour as function of the offshore wave direction.

Fig. 11 shows the wave height at the harbour as function of the offshore wave direction. It is seen that the largest waves at the harbour occur for waves with offshore directions between $290-320^\circ\text{N}$. The wave period for the larger waves at the harbour was 8-12 s.

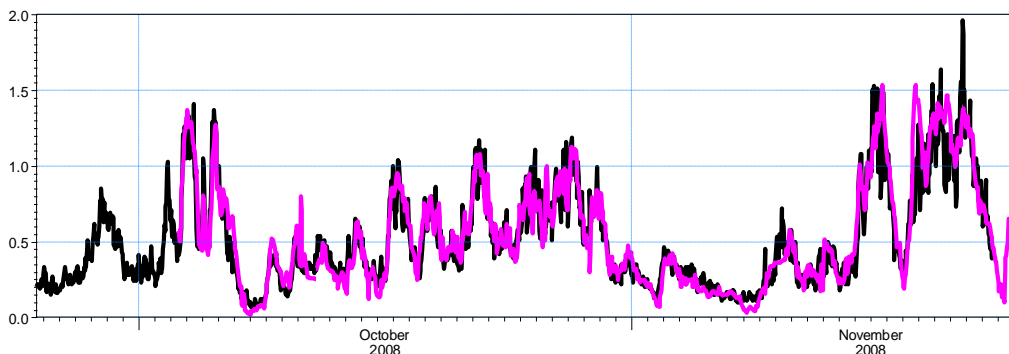
Figure 12. Measured (black) and modelled (pink) wave height (H_{m0}) at the harbour. Model : MIKE 21 SW.

A wave modelling complex including MIKE21-FM SW, MIKE21 BW and MIKE21 PMS was set up. MIKE21-FM SW, being a spectral wave transformation model, was applied to model the wave transformation over a longer time period and included the effect of the varying water level and current conditions on the wave conditions. This model was primarily applied for the sediment transport modelling. Fig. 12 presents results from the MIKE21-FM SW model, showing the measured respectively the modelled wave height at the harbour. For the modelling the measured offshore wave conditions were applied as boundary conditions.

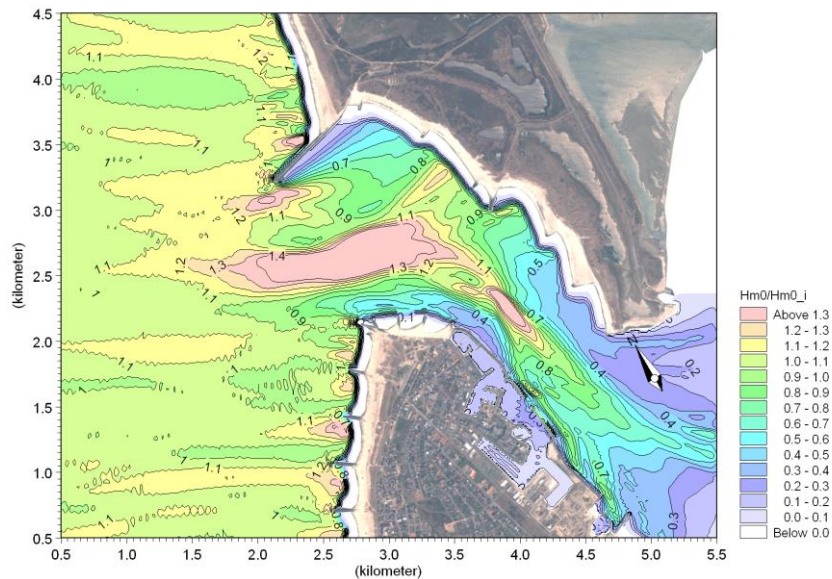
Figure 13. Relative wave heights. Waves from 300°N, with $T_p = 10$ s.

MIKE 21 BW is considered the most accurate of the wave transformation models. It reproduces the bathymetry and structures in great detail. The model was applied for selected stationary wave conditions. Fig. 13 and Fig 14 show results from a MIKE21 BW simulation for waves from 300°N with a wave period of 10 s.

It was found that a pronounced focussing of the waves occurs at several locations in the channel. This is mainly due to wave refraction caused by the complex bathymetry. For the wave conditions at the harbour entrance the bathymetry north of the harbour plays an important role as the bathymetry here is very complex with a shoal with minimum depths of 5 m close to a deep natural channel with depths of 15 m. This focusses the waves and changes the wave direction towards the harbour entrance.

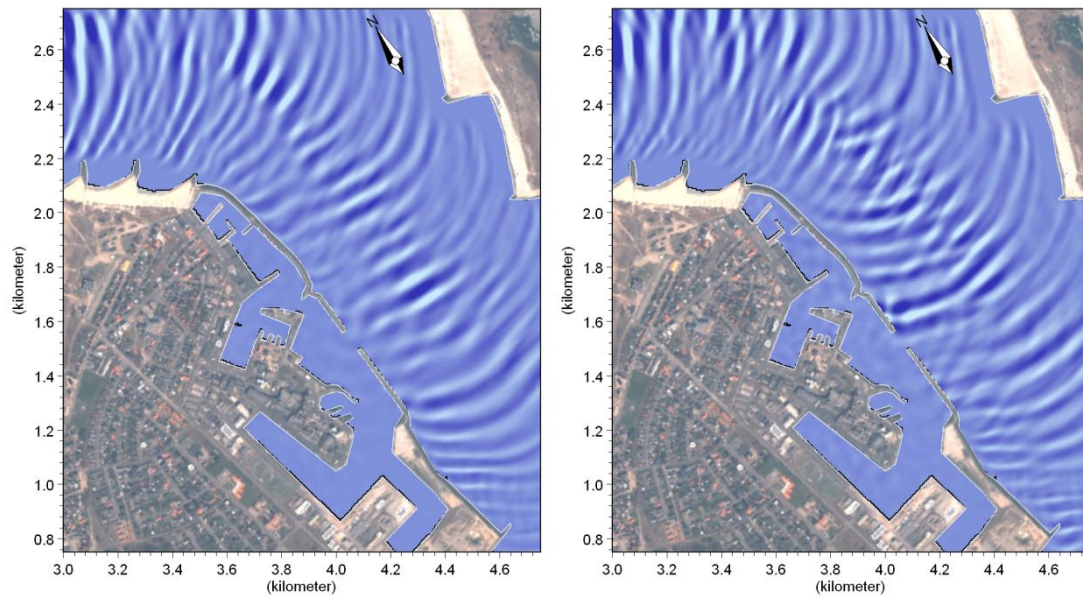
Figure 17. Snapshot of surface elevations. Left: With 2004 Bathymetry. Right: 2008 conditions.

Examples of simulation results are presented in Fig. 16, showing the relative wave height for waves from 300°N and $T_p=10\text{ds}$. Examples of instantaneous surface elevations are presented in Fig. 17. The simulations in Fig. 16 and Fig. 17 are made with identical time series for the wave boundary conditions. The two snapshots are taken at the same instant in the simulations and the differences in the wave conditions just outside the harbour mouth are obvious. From the simulations it is clear that bathymetry changes in the period 2004-2008 have caused the problematic wave conditions at the harbour to develop. In general it was found that the wave height at the harbour entrance had more than doubled from 2004 to 2008 for the critical events.

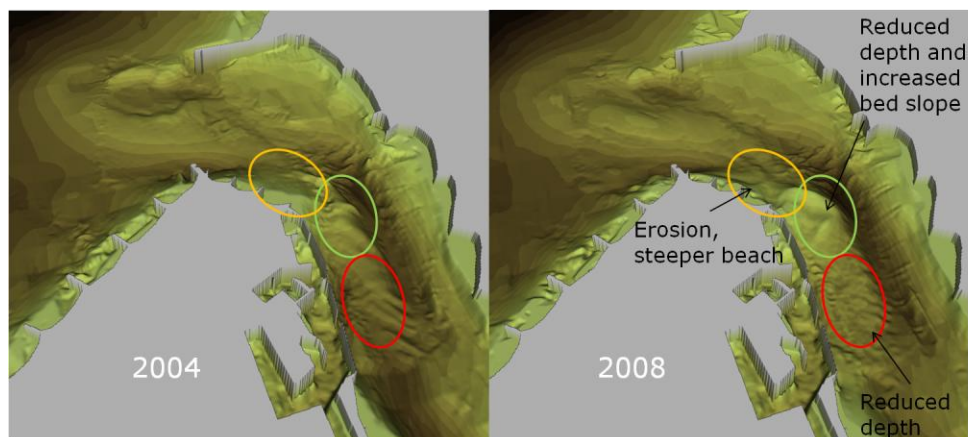
Figure 18. Main areas, where the changes in the bathymetry between 2004 and 2008 are important for the wave conditions at the harbour.

Looking at the bathymetry changes from 2004 to 2008 and the changes in the wave transformation, three main areas were found to be important for the changed wave transformation, marked in Fig. 18. In the orange area it has become deeper from 2004 to 2008 towards land meaning that more wave energy passes this zone instead of refracting towards land. In the green area the slope towards the deep part of the channel has become steeper and more pronounced. This means that the waves refract towards the harbour entrance earlier and stronger than before. In the red area the depths are reduced and the bathymetry has become more equally sloping from the harbour towards the deep parts. This also increases the waves at the harbour. The changes are thus a result of the long-term morphological development of the channel.

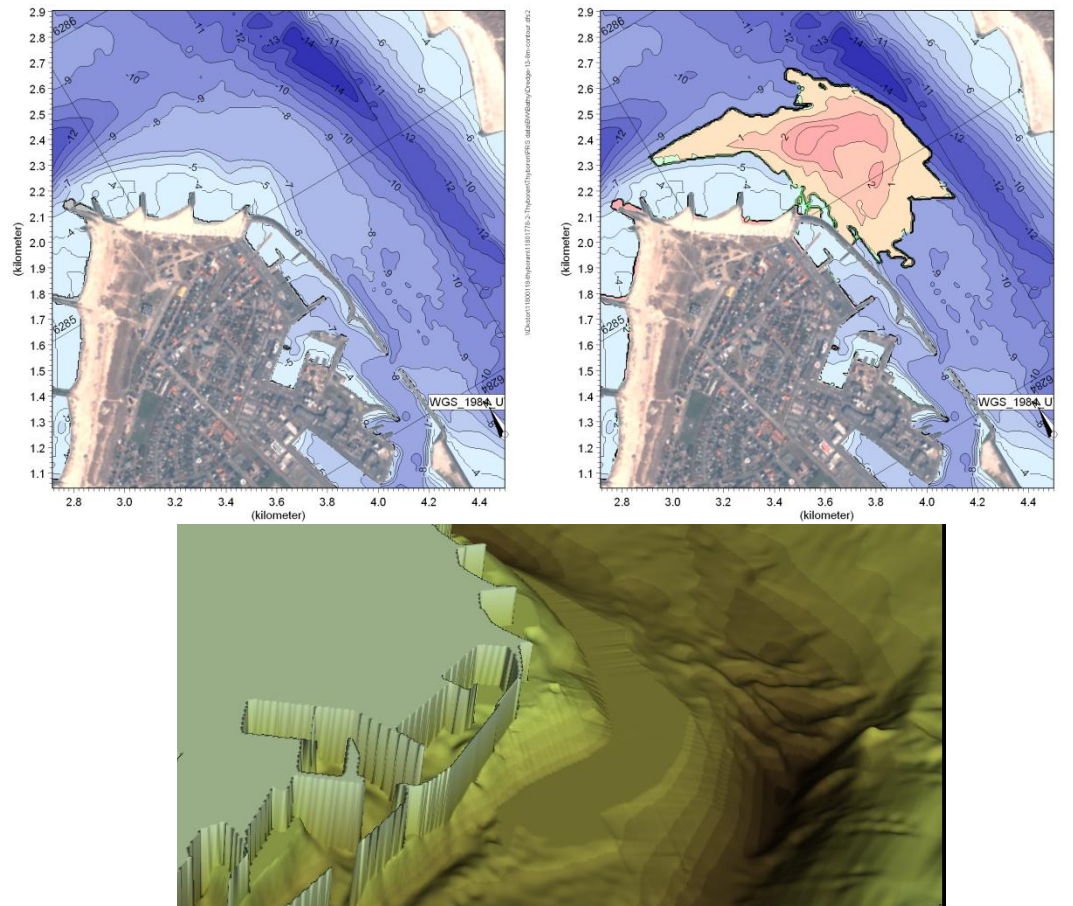
Figure 19. Proposed deepening scenario. Upper left and bottom: Bathymetry after deepening. Upper right: Dredging zone with dredging depths (yellow/orange).

As the increased waves at the harbour have been caused by bathymetry changes it is logical to consider the possibilities of mitigating the problems by actively modifying the bathymetry in the channel. Re-establishing the 2004-bathymetry completely was, however, not considered feasible. Different alternatives were investigated and it was concluded that a deepening scenario as shown in Fig. 19 was feasible and would eliminate the problematic waves at the harbour. The deepening scenario includes dredging of 400,000 m³ sand at the shoal NW of the harbour to reduce the wave focusing and refraction towards the harbour entrance.

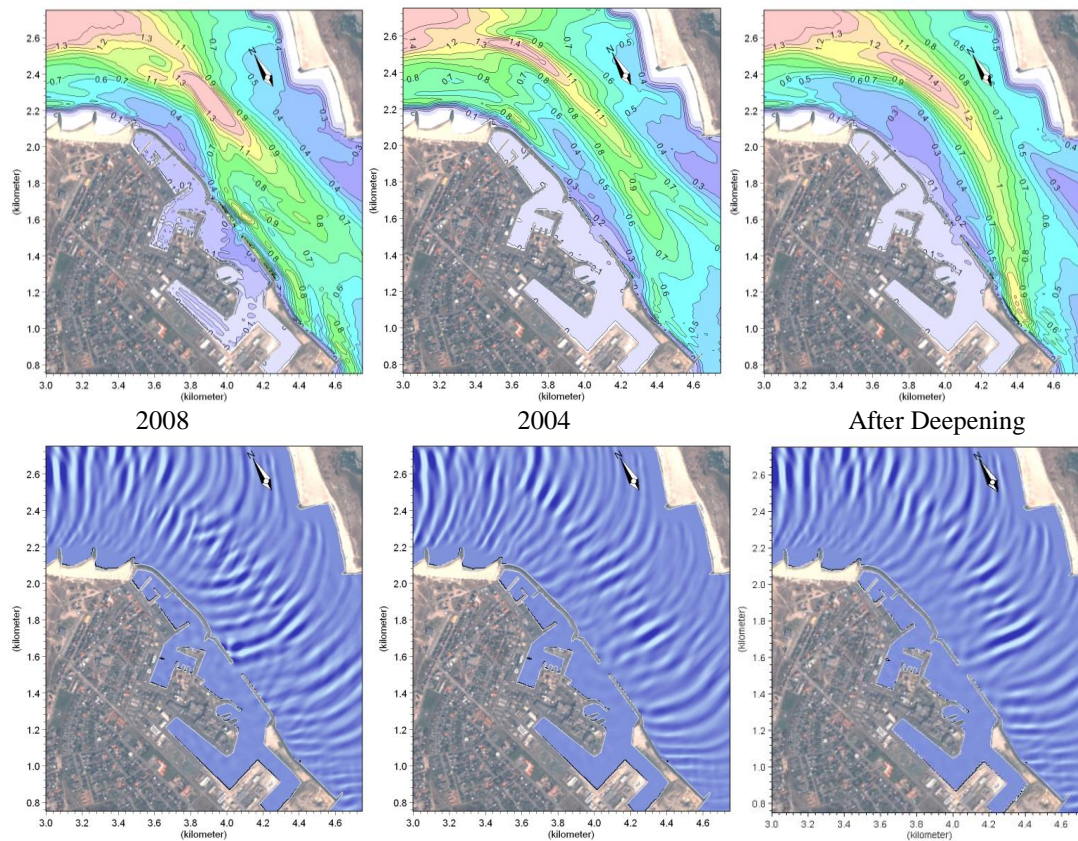
Figure 20. Upper: Relative H_{m0} . Lower: Surface elevation snapshots.

The deepening scenario was optimized through the wave modelling. Figure 20 shows a typical result from the simulation with the deepening scenario, compared with the results for the 2004 and 2008 bathymetry.

With the proposed deepening scenario, the wave heights at the harbour entrance are generally reduced to a level close to the 2004 conditions i.e. a reduction in wave height for the critical events by around 50%. Generally, the wave energy entering the channel is not reduced but due to the changed bathymetry the wave energy is spatially redistributed also meaning that other parts of the channel will experience larger waves after the dredging has taken place. This was, however, not considered to be critical by the harbour authorities.
