CHAPTER 15

LOW COST SHORE PROTECTION USED ON THE GREAT LAKES

E. F. Brater

Professor of Hydraulic Engineering
University of Michigan, Ann Arbor, Michigan

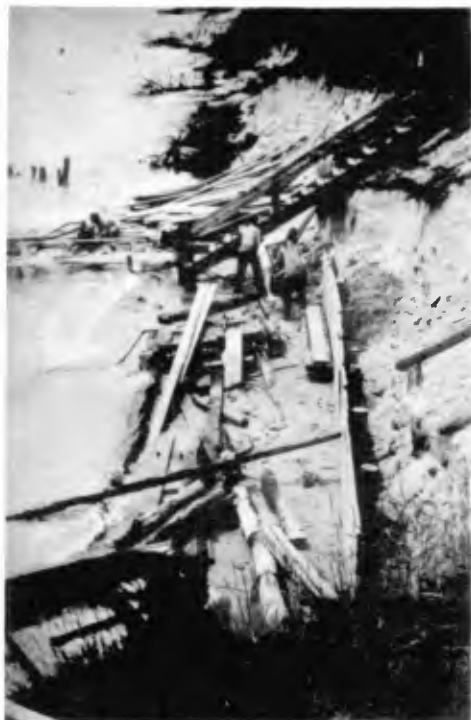
Fig. 1. An example of inadequate sea wall construction.

It was apparent from the beginning of these studies that much money was being spent by property owners on structures which were inadequate structurally and that often times the methods used were ineffective or even harmful hydraulically. Sea walls were used where groins would have been more effective. Many sea walls were being built with insufficient strength to withstand the back pressure of the saturated soil or without cut-offs to prevent seepage from the shoreward side which ultimately undermined the walls. Efforts were being made to hold banks at slopes much steeper than the natural angle of repose. A typical example of completely inadequate and incorrect wall construction is shown in Figure 1. This wall has no tie backs, the sheeting is on the wrong side of the piles, the sheeting does not penetrate into the ground a sufficient distance to prevent seepage and provide strength, a double row of sheeting should be used rather than a single row and, finally, the angle of the bank is much too steep to be stable. Many walls were built without provision for preventing long shore currents from developing behind the wall as the result of overtopping by waves. The use of permeable walls and groins was widespread. Groins were often not extended far enough inshore to prevent by-passing. An example of groin and wall construction which embodies some of the errors mentioned above is shown in Figure 2. Many walls were being built parallel to shore in off-shore locations where they were ineffective and easily damaged. Revetments were frequently constructed of such coarse material that erosion continued at nearly unhampered rates between the stones.

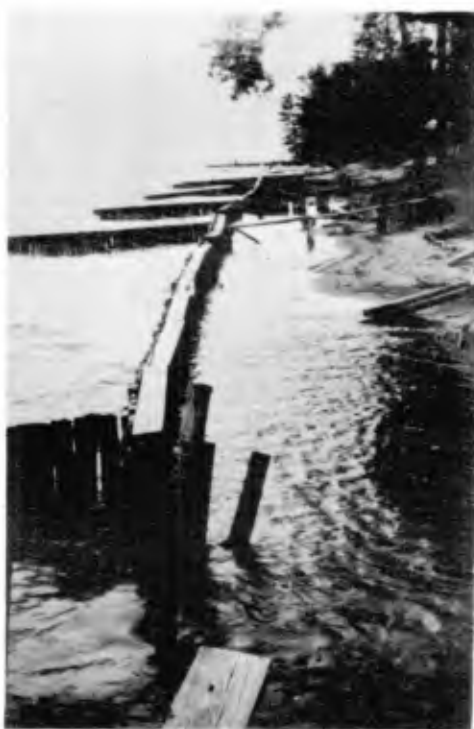
Fig. 2. An example of ineffective sea wall and groin construction.

It has been found that groin systems provide excellent protection in the majority of locations studied. This is because of the generous supply of sand which is available along most of the Michigan shore line. Groins temporarily hold some of the littoral drift, thus raising the beach sufficiently to break the waves before they are able to attack the steeper banks. Protection by means of groins has the great advantage, in recreational areas, of not destroying the bathing beach as is the case where sea walls are built. Typical examples of beach building by low cost groins are shown in Figures 3, 4, and 5. Figure 3 shows a series of timber crib groins on Lake Huron. In Figure 4, the entire beach outside of the cement block wall was built up after the construction of a series of concrete groins. This beach, located in the Saginaw Bay area, has been maintained in the present condition for two years. A beach in the Little Point Sable area on Lake Michigan is shown in Figure 5. Timber sheet piling groins were used in this case. Water several feet deep occurs on the lake side of the timber sea wall shown in the background of Figure 5. The observations indicate that groins should extend from 50 to 70 feet into the lake from the shore line and should extend well back into the bank at their shoreward ends. Good results have been obtained by constructing the groins so that their top edges are located one foot above highest lake levels to be expected. It has been found that groins must be of tight construction to be effective. Only in locations where wave action is mild or where the beach material is very coarse do permeable groins hold beach material. Examples of ineffective permeable groins are shown in Figure 2.

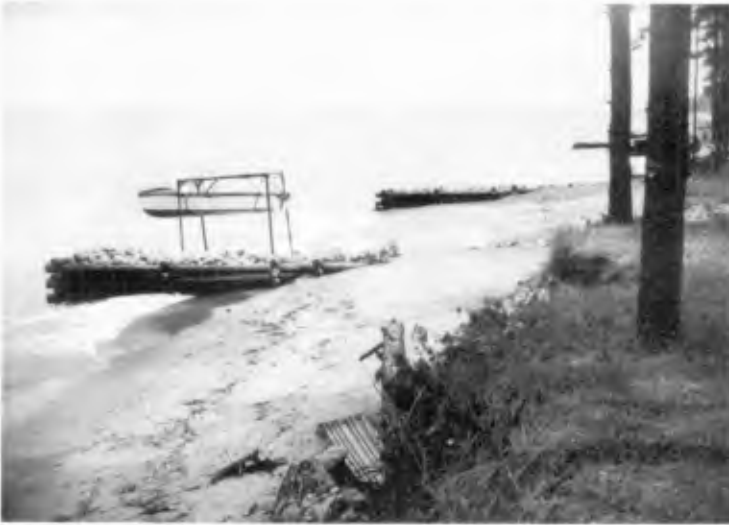
Fig. 3
Beach resulting from the use of rock filled
timber crib groins.

Where it is impossible to jet in timber sheeting, because of the presence of large stones or hard clay, rock filled timber crib or concrete groins are built. Timber crib groins are shown in Figures 3, 6, and 10. They are constructed by building log cribs in shallow trenches and filling with large stones after placing a layer of brush. The logs are fastened together with steel pins.

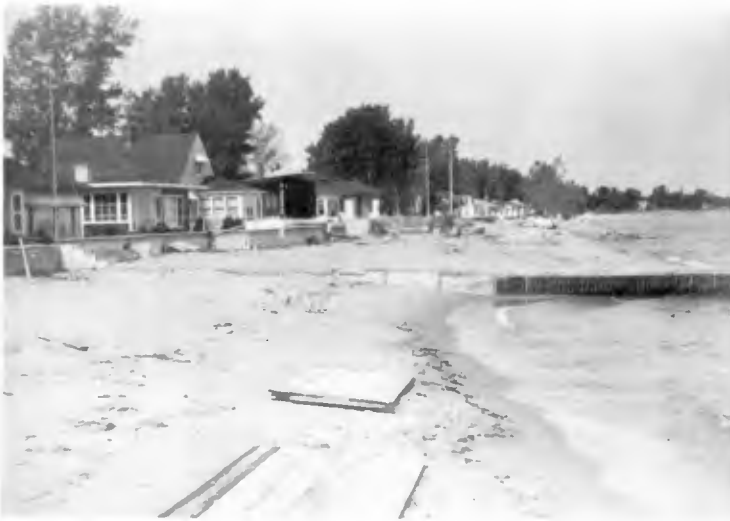
Fig. 4.
Beach resulting from the use of concrete
groins.

Figures 4 and 11 show concrete groins. They are built in shallow trenches and must be sufficiently massive to resist the overturning effect of the waves.

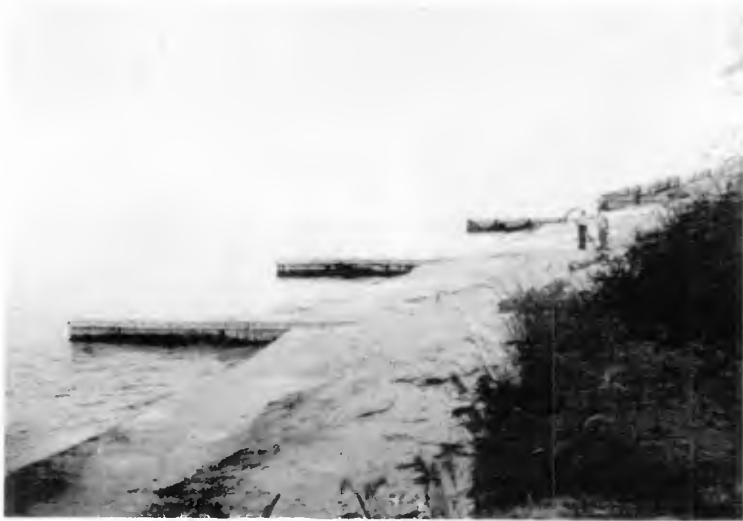
Fig. 5
Beach resulting from the use of timber
sheet piling groins.

Groin Construction - Three types of groin construction have been found to give good results upon the basis of the observations carried out to this time. Timber sheet piling groins are the most widely used. Groins of this type are shown in Figures 5 and 9. As previously mentioned, these are modifications of the type of construction recommended by the Corps of Engineers (1947). Credit for the original design belongs to them. They consist of two rows of white oak plank sheeting with joints overlapping, walers on both sides, and round piling spaced at approximately 8 foot intervals on one side. The piles and sheeting are installed by jetting with a stream of water from a small portable pump. It is recommended that the sheeting be driven twice as far beneath the ground as it will extend above the ground, however, many timber groins which do not quite meet these specifications have been standing for several years.

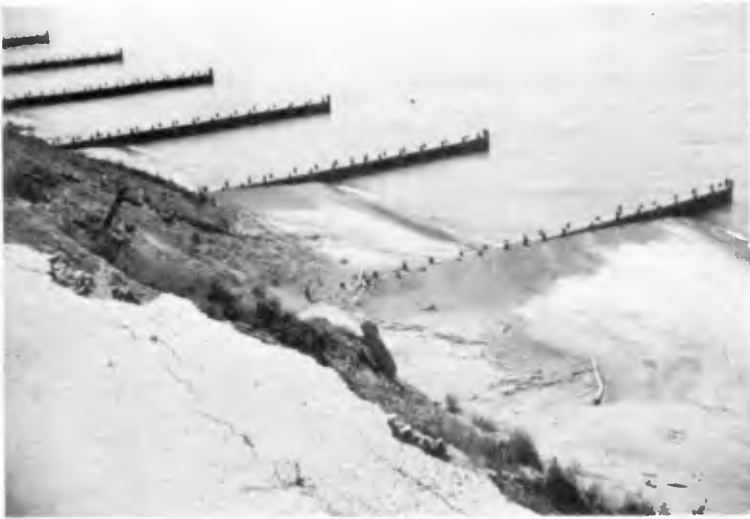
Fig. 7
Examples of groins that are longer than necessary or desirable.

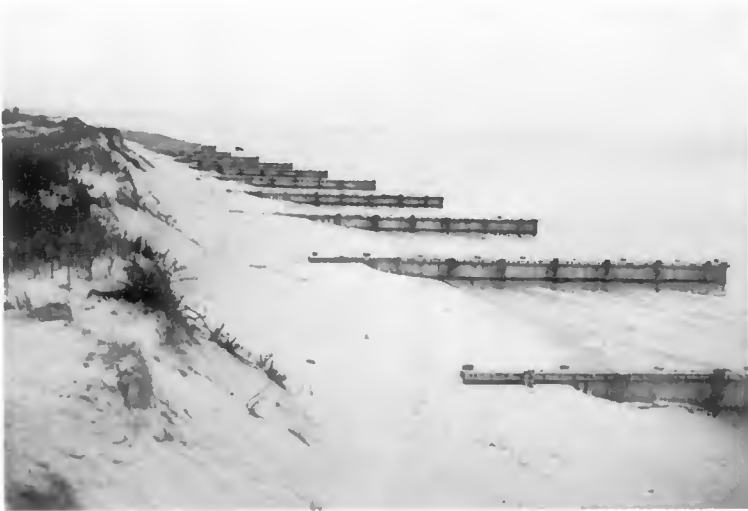
Fig. 8
Examples of groins which do not extend into the bank a sufficient distance.

shoreward direction. An extensive groin system, such as is shown in Figure 8, usually requires artificial nourishment not only to supply beach material to the groin area but to keep from starving down drift locations.

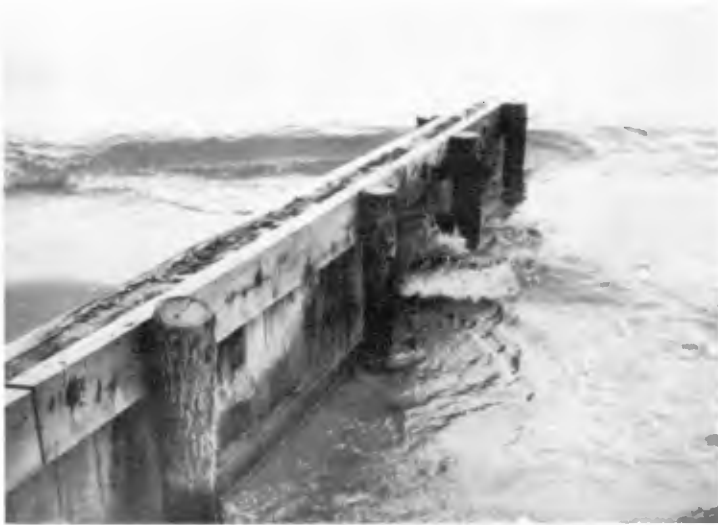
Fig. 9
Timber sheet piling groins.

Sea Wall Construction - The most successful type of inexpensive sea wall construction is timber sheet piling. The walls are constructed in the same manner as the groins illustrated in Figure 9, except that ties to anchor piles must be installed at least every eight feet. The sheeting should be jettied six or eight feet below the lake bottom to insure that seepage will be cut off and that piping will be prevented. Groins must be placed on the inside of the walls to prevent erosion behind the wall, due to long shore currents fed by overtopping waves. The walls must be tight to prevent the leaching out of the back fill. Whenever possible, groins should also be constructed on the lakeward side of sea walls to minimize the erosion that would otherwise occur in front of the wall.

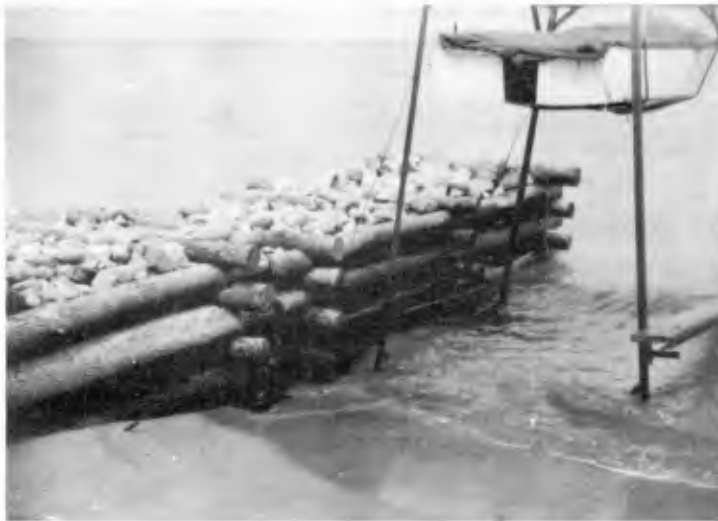
Fig. 10
Rock filled timber crib groins.

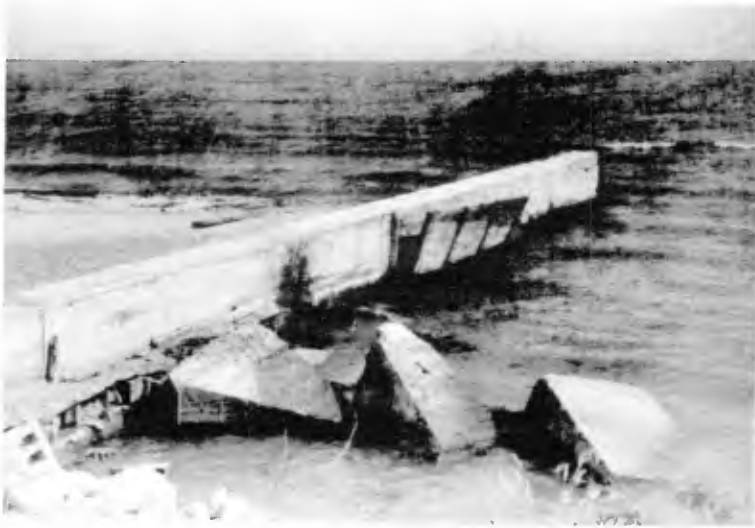
Fig. 11
Concrete groin.

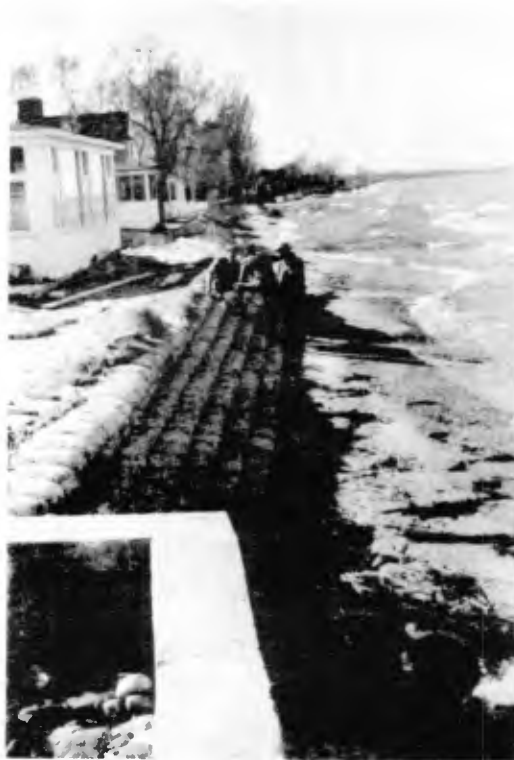
An interesting type of revetment built in the Saginaw Bay area is shown in Figure 12. This construction consists of concrete poured into

Fig. 12
Concrete revetment.

canvas bags and placed as shown. Each bag is connected with the one below by means of a short piece of reinforcing steel. The toe of the revetment is placed in a trench several feet deep. The revetment is "four bags thick" at the toe and tapers to a thickness of one bag as it rises against the bank. Although the revetment shown in Figure 12 is two years old, it has not yet been subjected to the severe ice conditions which sometimes occur in that area.
