#### CHAPTER 39

USE OF MODEL EXPERIMENTS IN SOLVING QUESTIONS OF NAVIGATION WITH SPECIAL REFERENCE TO THE ENTRANCE OF ST. ANNA BAY, CURACAO, NETHERLANDS ANTILLES

#### J. J. Leendertse Coastal Engineering Laboratory University of Florida, Gainesville, Florida

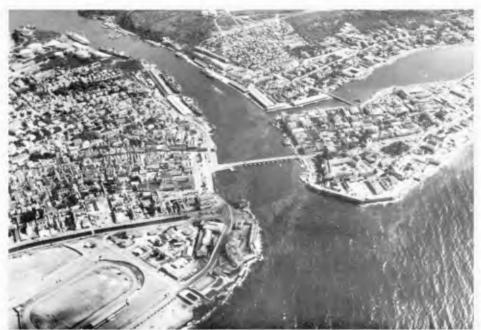
Fig. 3. Survey St. Anna Bay. In the foreground the harbor entrance, on the right-hand side of the entrance Waterfort, on the left-hand side Riffort.

The entrance to the harbor, the mouth of St. Anna Bay, lies in the center of Willemstad, the capital of Curacao. This narrow entrance is bounded by two old fortresses (Waterfort and Riffort). Over a range of 800 ft. the entrance channel narrows from 650 to 300 ft. near the portlights (measured between the drop lines of 30 ft. below low water) (Figs. 2, 3, 4). The underwater slopes of the channel are very steep.

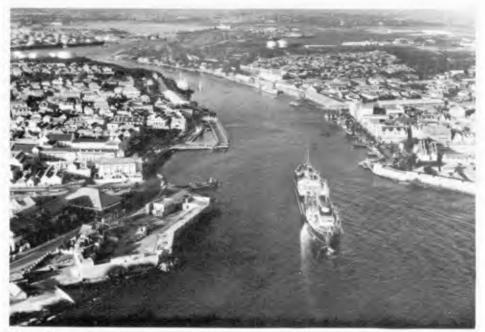
Fig. 4. Entrance St. Anna Bay. The bulkhead of the bridge which runs far into the entrance channel is clearly visible. On the left top the Shell refineries.
