CHAPTER 105

CHANGES IN INLET OFFSET DUE TO STABILIZATION

Dennis K. Hubbard

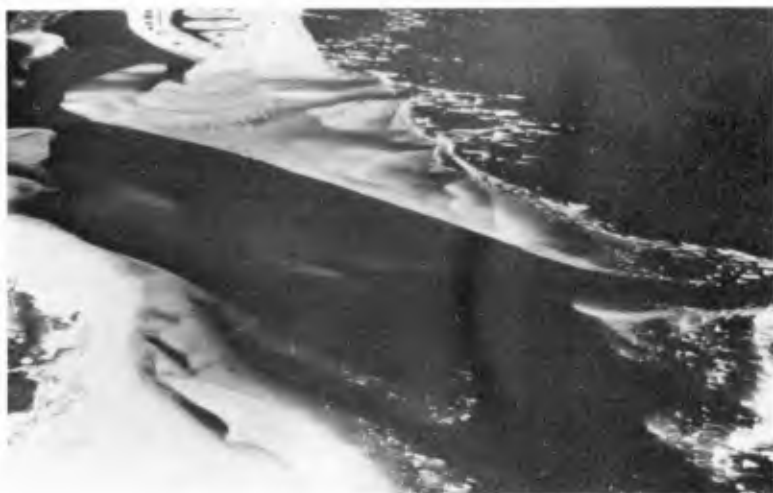
Figure 1. Low tide photograph of Murrells Inlet, S. C. Note the large shoal occupying the channel cross-section. This is a result of the near balance of sand moving in and out of the inlet.

At Murrells Inlet, S. C., (Fig. 1) net longshore transport rate is small and sand tends to reside in the inlet system. The near balance between sand entering and leaving the inlet causes it to be choked with sand. In this case, bar bypassing dominates at the expense of local navigation. At Kiawah Inlet, S. C. (Fig. 2) another type of bypassing, channel abandonment, occurs. Over a period of 10 months, the sand that had accumulated on the updrift side of the inlet was bypassed as the main channel was closed and a path further updrift was initiated (Fig. 2).

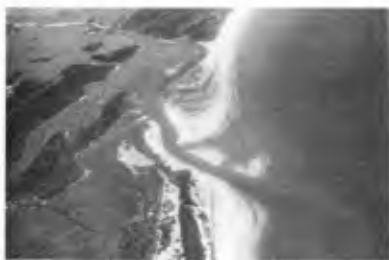
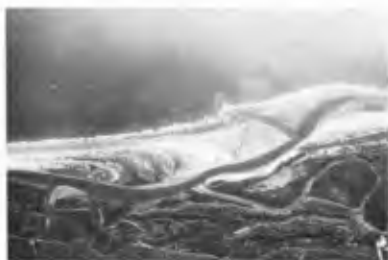
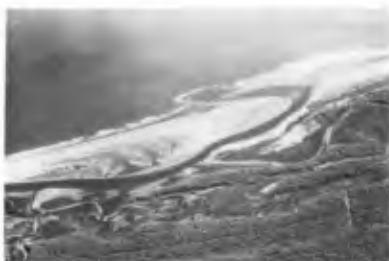
Figure 2, Bypassing at Kiawah Inlet, S. C. These photographs show the configuration of the inlet in April, 1975 (A), November, 1975 (B) and February, 1976 (C). Note the abandonment of the main ebb channel between April and November, 1975 followed by swash bar development in February, 1976.

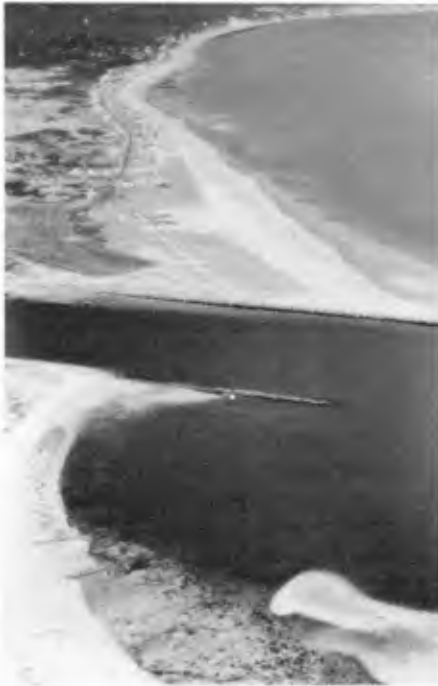
Figure 3. Low tide aerial photograph of the Cape Cod Canal entrance. Note the erosion-deposition pattern resulting from interruption of littoral transport. Sand is moving toward the viewer. Photo by Miles O. Hayes.

modification of the bypassing process. In most documented cases, the resultant pattern of erosion and deposition is similar to that shown in Figure 3; that is, accretion along the updrift beach at the expense of the eroding downdrift beach.

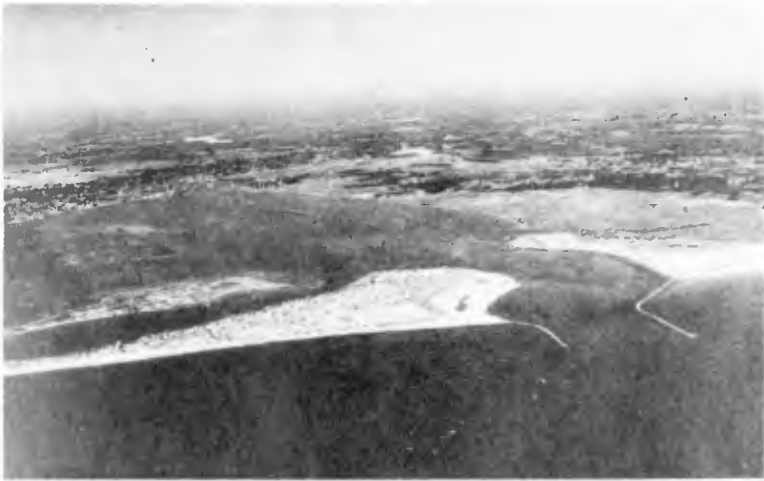
Figure 7. Aerial photograph looking westward across Merrimack Inlet. Note the similarities between this photo and Figure 9. From Chute and Nichols (1942).
