CHAPTER 124

RESISTANCE OF GRASSMAT TO WAVE ATTACK

Jan Willem Seijffert¹ and Leo Philipse²

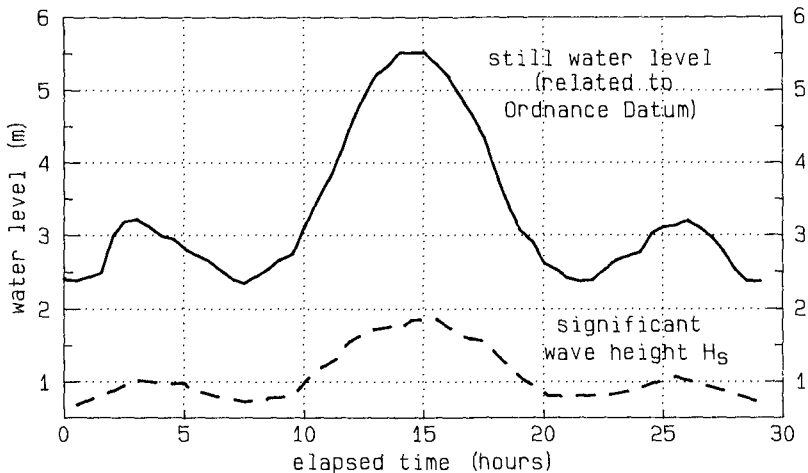
Figure 5. Realized loading conditions (water level and significant wave height) in course of time

The hydraulic loading was realized by generating irregular waves with a Pierson-Moskowitz spectrum, with varying water level and wave height (fig. 5), with a peak wave period between 5.2 and 5.6 s. This stands for a plunging breaker type, falling on water cushion. The variation of the water level reproduced a storm surge superimposed on a tidal cycle, during 29 hours, reaching a maximum level of O.D.+ 5.50 m and a maximum significant wave height $H_s = 1.85 \text{ m}$. In total the experiment lasted 48 hours, because of two stops between times for lowering the water-level, visual inspection and measuring the erosion level.

The water velocities, measured at 0.05 m above the surface, were at maximum 2.2 m/s, at 4% of the waves a speed of 2.00 m/s was exceeded and the mean of the peak velocities was $\pm 1.00 \text{ m/s}$, upward as well as downward, appearing at $H_s = 1.85 \text{ m}$. Run-up and overtopping were measured and were in good accordance with the design values.

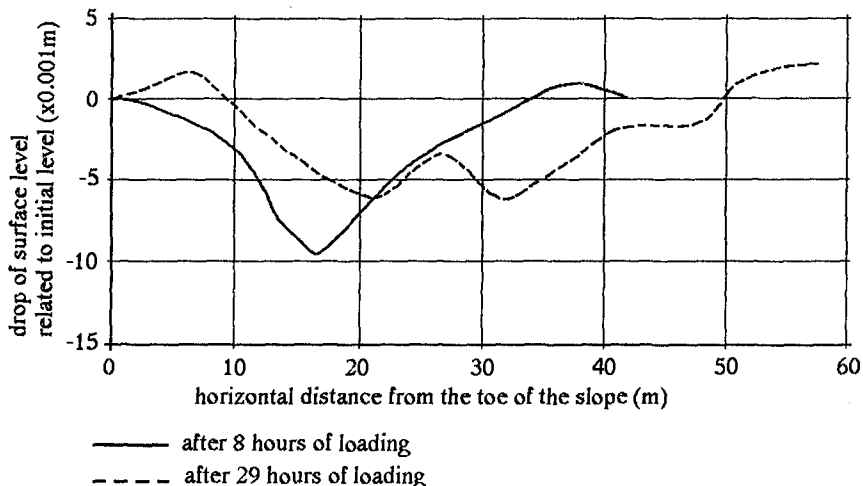
Figure 6. Averaged drop of surface, due to erosion

Besides the still water level and wave characteristics being measured during the experiment, the amount of surface erosion was measured during breaks of the execution, by sounding the surface of the turf with a vertical rod in a fixed pattern. Because of the standard deviation of 0.005 m in measuring a single point, the results are presented as a difference between before and after wave loading, of the mean of 30 points in an area of 5 x 5 m (fig. 6). In this way the largest erosion, of about 0.005 to 0.010 m, was measured at levels of about O.D. + 2.45 m and O.D. + 4.25 m as well. In the first mentioned area a wave height of $H_s = 0.85$ m (as a mean) has worked out during 18 hours approx. (fig. 5) and in the second one $H_s = 1.65$ m (as a mean) lasted during 6 hours. Although most of the grass leaves had vanished, the turf was in exceptional good condition without any

visual holes or cracks, caused by erosion. In general it was found that the erosion resistance originated from the upper layer of soil and roots, much more than from the grass leaves. The erosion of the clay surface occurred in a rather even way, without forming obvious cracks or holes. While eroding, a fine root structure of the grass remained on top of the clay. This root structure reduced further erosion rather effectively.

Because of the minute erosion after the storm surge simulation during 29 hours, it was decided to restart the experiment after cutting 4 holes in the grass surface. The dimensions of the holes were 0.50 m (width) x 0.20 m (length) x 0.07 m (depth). The wave height was established at $H_s = 1.57$ m and the water level at O.D. + 5.00 m. In the vicinity of the breaker impact the holes eroded progressively, by scouring the soil underneath the upper layer of the turf. The first visible erosion appeared after 5½ hours of loading. After 7 hours two holes were scoured out to the depth of the underlying, very resistive, clay layer. Conclusive can be stated that the soil material of the grass sods itself was not very resistive to erosion, in contrast to the top layer with roots (of 0.03 m to, at maximum, 0.10 m) which appeared very resistive to erosion under the given loading.

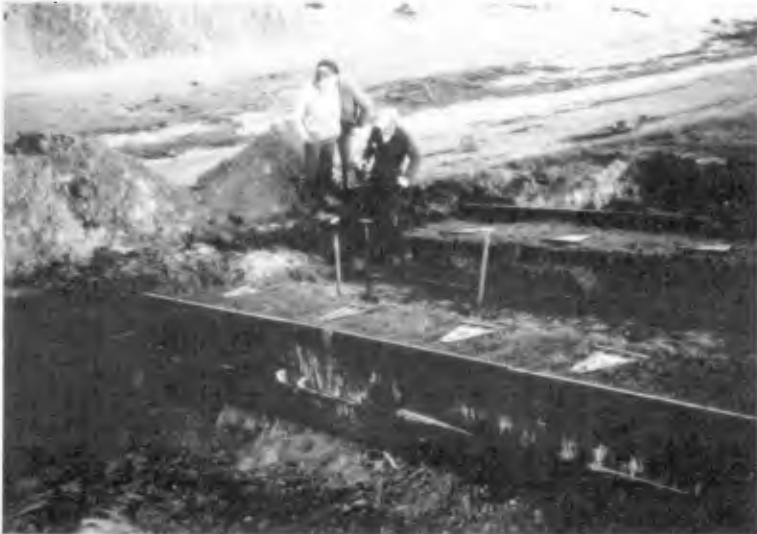
Figure 7. Two grass sods for Test 2. being dug out

In Test 2, a grass sod of 0.5 m thick, 1 m wide and 10 m length was dug out as a whole from a sea-dike as follows. An I-girder of 10 m long and 1 m high with one flange cut off was placed with its web horizontally, in a groove, dug out next to the sod to be taken out. The sharp edge of the web was pressed horizontally by hydraulic pistons at 0.5 m below the grass surface underneath the sod. Then the other side of the 1 m wide sod was dug free and the I-girder functioned as a bearer during the take up, the transport as well as during the whole test (fig. 7).

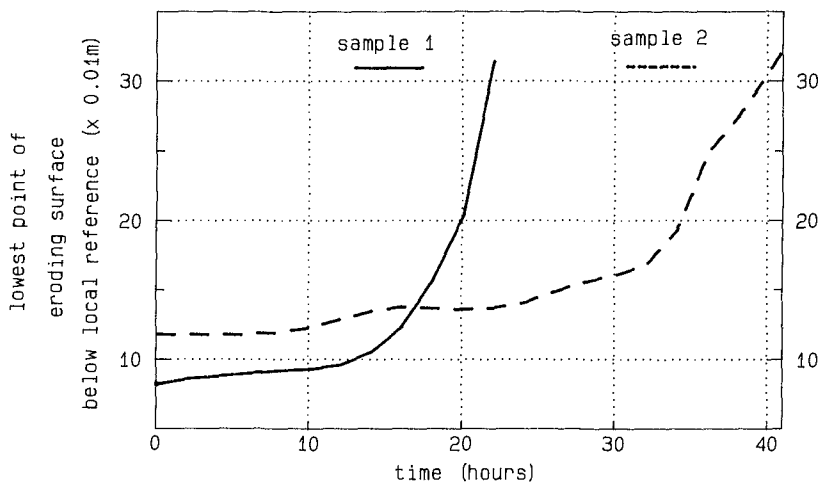
Figure 9. Maximum erosion depth in course of time

The amount of erosion was gauged by vertical rods touching the surface in a fixed pattern, during breaks of the simulated wave loading. The erosion at the point of maximum damage at the end of the test of each sample is given in fig. 9. During the first 3 hours of loading hardly any erosion was visible. In the next period from 3 to 10 hours, in the lower 5 m along the slope the grass leaves eroded away. In general it was established that the upper 0.03 m of the turf eroded in a rather even way, without obvious cracks or holes. Thereafter, (between 10 to 15 hours with sample 1, 15 to 25 hours with sample 2) cracks developed.

In sample 1 after 16 hours the rate of erosion increased. After 18 hours, when at 0.6 m from the lower rim the erosion is 0.08 m deep and 0.60 m long, lumps of soil started breaking away and after 22 hours the bottom of the turf was reached.

In sample 2 the increase of the erosion rate appeared after 25 hours at 2.5 m from the lower rim of the turf. After 40 hours the hole was 0.20 m deep and 0.40 m long and the bottom was reached after 41 hours.

As said sample 2 hold out longer than sample 1. Partly this may have been caused by a somewhat better condition of the grassmat as a whole, but it is important to

mention that sample 1 had a bold patch in the heaviest loaded zone, caused by lack of sunlight during the two months before test by a wall sustaining wooden lath at 0.20 m above the grass. Although 20 hours for sample 1 is significantly shorter than the 40 hours lifetime of sample 2, the top layer caused mainly the total resistivity, even at the bold patch. This confirms the lesser importance of the grass leaves, and shows that the resistivity of the upper root layer can sustain a period of weak growth of the grass, which is likely to be important for the condition of the sea-dike grass in the winter and early spring.
