## CHAPTER 210

### RECENT PERFORMANCE OF LINKED CONCRETE MAT ARMOR UNDER WAVE AND ICE IMPACT

P.E. Gadd, M. ASCE and C.B. Leidersdorf, M. ASCE<sup>1</sup>

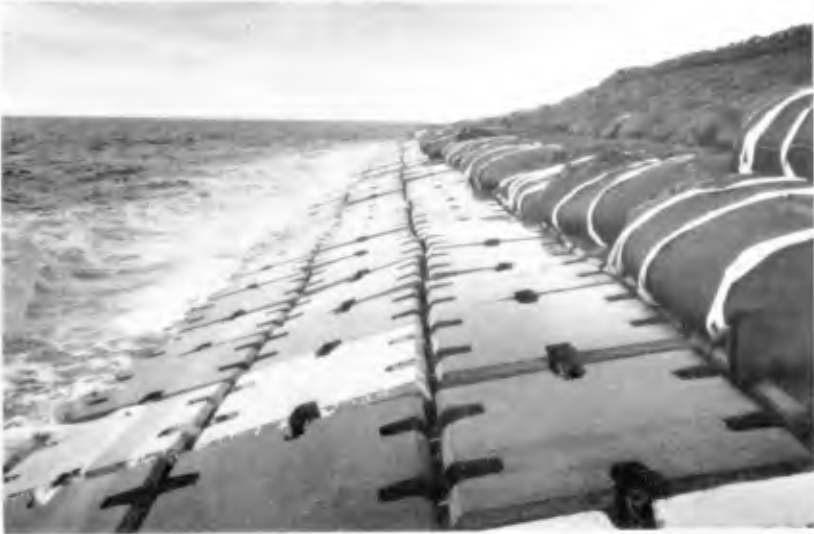
PHOTO 1: POST-STORM CONDITION, NORMAL ANGLE OF WAVE INCIDENCE

During a strong northwest storm accompanied by wave heights in the three to four meter range that occurred in late September 1986, significant uplift and undulation of the concrete mat at Northstar Island first occurred. It was clearly noted, however, that the extent of mat uplift was not uniform around the island circumference. Photo 1 is presented to show the condition of the island sector that received the incoming wave impact at a normal (i.e. wave ray approach = 90° from waterline) angle of incidence. The undeformed nature of this slope suggests that mat uplift did not occur along this island sector.

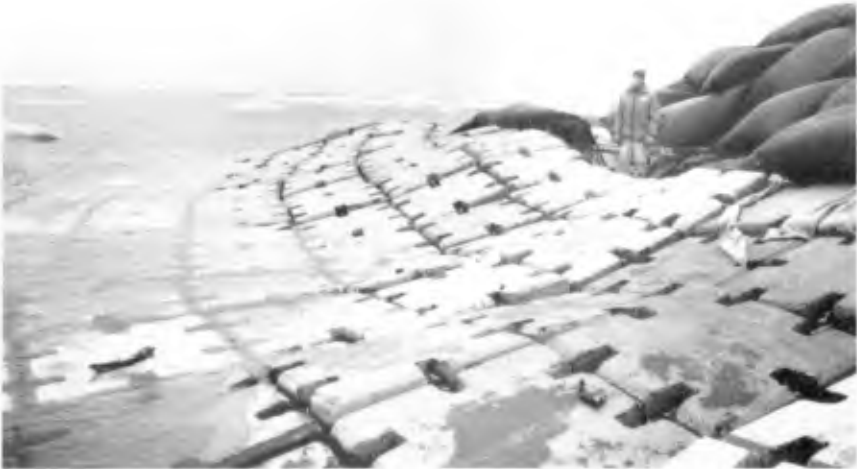
PHOTO 2: POST-STORM CONDITION, OBLIQUE ANGLE OF WAVE INCIDENCE

Conversely, along the sides of the island which experienced wave passage at highly oblique angles of incidence, mat uplift and the resulting mat undulation was severe, as shown in Photo 2. Wave-induced mat instability was noted along the island slopes on the lee side of the island as well, where wave crests did not detach from the island slopes, but proceeded along the slopes at angles of incidence greater than 45°.

We believe that the reasons for the destabilizing effect of oblique wave passage over the concrete mat at Northstar Island is based both on hydrodynamic effects that impose negative wave pressures on the mat, and as a consequence of asymmetrical mat linkage tension imposed during the construction process. The

Asymmetric block linkage tension within the mat was caused as a result of the construction process, undertaken during August-September, 1985. In placing the mat upon the island slopes, narrow mat segments were used incorporating 22 blocks in the upslope-downslope direction by two blocks across. As the placement crane lowered the mat to its above-water anchorage position and boomed the mat offshore, high tension was achieved in the upslope-downslope mat direction. Successive mat sections were placed closely side-to-side to allow divers to easily connect the mat beneath the water. Consequently, substantial slack resulted in the side-to-side block linkage. The resulting lack of side-to-side restraint in the mats surrounding the island promotes mat instability in response to oblique wave attack. Conversely, the lack of alongslope linkage tension would seem not to affect mat stability given a normal angle of wave incidence where side-to-side restraint would be less important. This indeed appears to be the case, given the visual observations of the effects of wave-induced uplift at Northstar Island.

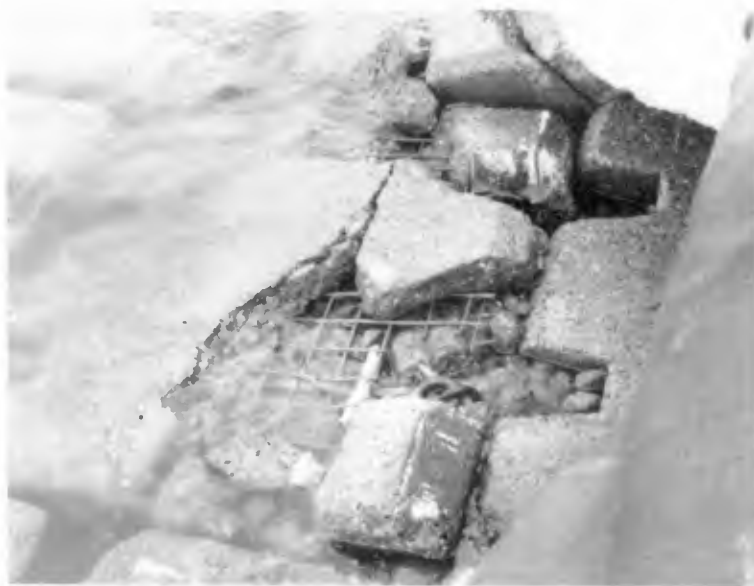
PHOTO 4: BLOCK BREAKAGE CAUSED BY ICE IMPACT

Concrete mat breakage has proven to be impressive at Northstar Island, primarily affecting blocks located above an elevation of -3.7 m (MLLW). Block breakage has occurred, in which cracks propagate through the block without substantial loss of concrete volume. In addition, blocks have been stripped of concrete cover, leaving only the steel reinforcement where the concrete mass had once been. Photo 4 is presented to show an example of excessive block damage of this type.

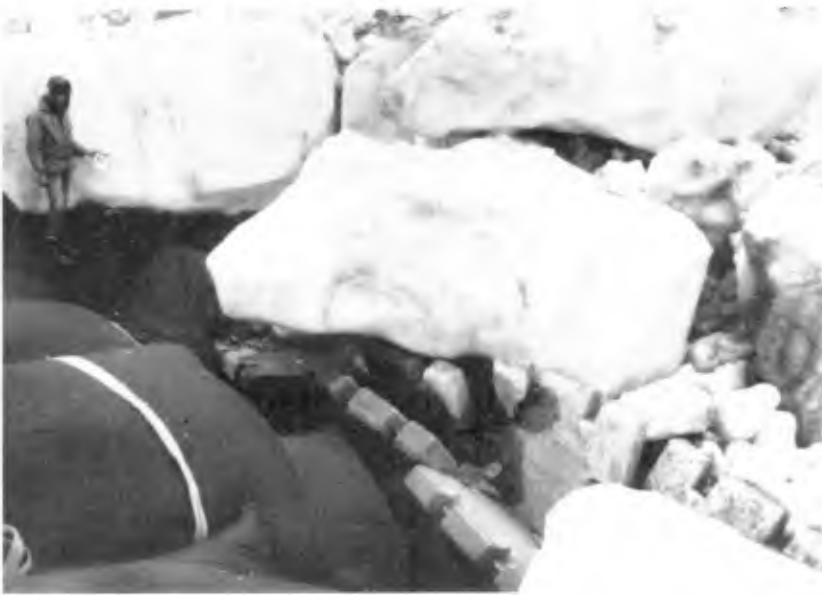
**PHOTO 5: BLOCK DISPLACEMENT BY LARGE ICE IMPACT, AUGUST 1988**

When the slopes of Northstar Island were pristine and free from irregularities and undulations, the early winter ice would collide with the concrete and form ice piles that would build seaward from the waterline. These ice piles would form a barrier providing protection from the larger ice features that might impact the island later in the freeze-up period. Later, following the storm damage of September 1986, undulations in the concrete mat slope caused by wave-induced mat uplift, generated irregularities within the mat surface upon which incoming ice forces could act. As a result, deformation and displacement of the concrete mat armor occurred as large ice features collided with the irregular island slopes. With time, therefore, the ability of the island slopes to safely withstand large ice impacts degraded. Damaging mat displacements during both winter and summer were noted. Photo 5 shows the results to a particularly forceful ice collision with the north slope of Northstar Island during late July 1988. The nature of the concrete mat damage that occurred as a result of this incident is shown in Photo 6, following the natural ablation of the ice that caused the damage.
