STABILISATION OF THE TIDAL ENTRANCE AT HORNAFJORDUR, ICELAND

Abstract

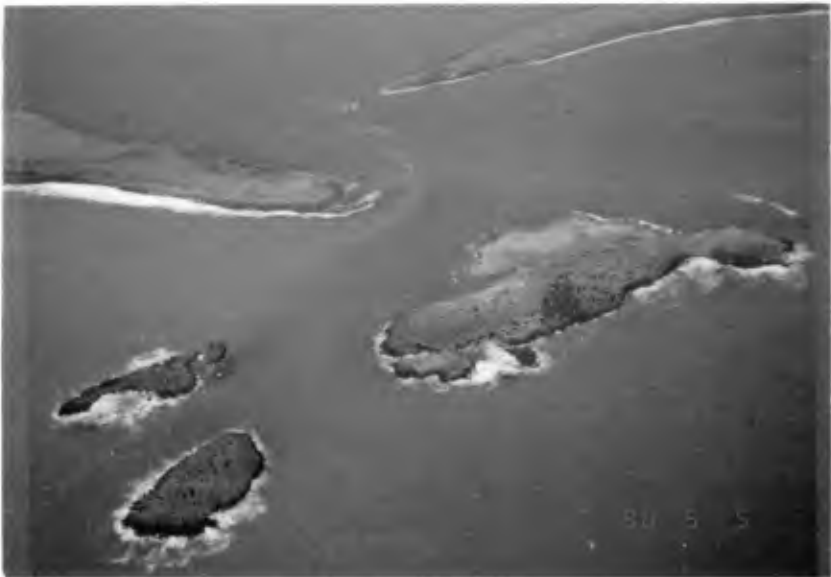
Figure 2. About 700,000 m³ of material flushed into the navigation channel and a breakthrough through the South Barrier

On January 9, 1990, a severe south-west storm struck, with offshore wave heights exceeding 16.7 m. The storm was followed by unusually high wave activity and a breakthrough through the South Barrier occurred in March as shown on Figure 2. It is estimated that over 200,000 m³ of material was flushed over the East Barrier into the navigation channel during this period and about 500,000 m³ were flushed over South Barrier. As a result, the inlet was closed for coasters for several weeks.

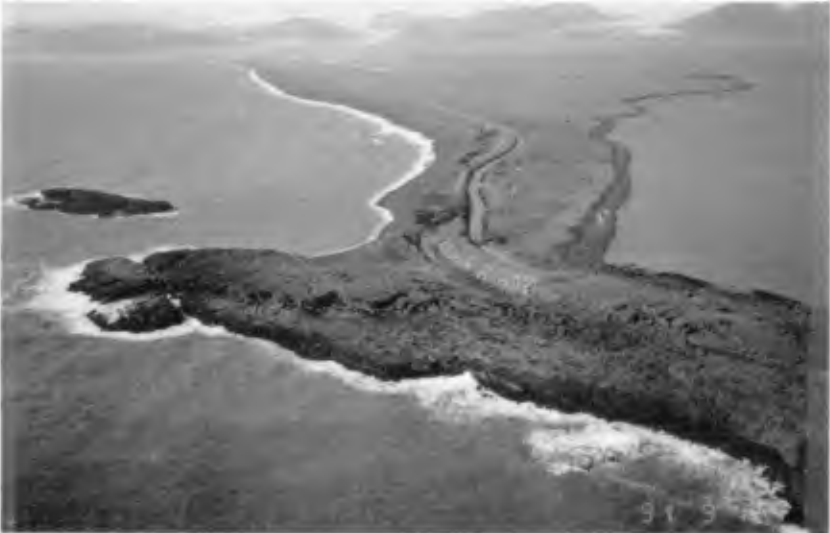
Figure 5. Construction of the shore protection on the South Barrier. The alignment of the shore protection is set according to the maximum known scouring from the entrance

After the gap between Hvanney and South Barrier was closed, a southerly swell started to build up the barrier. In 1991, a 665 m long rubble mound shore protection was built along South Barrier. The alignment of the shore protection are shown in Figure 5. To prevent overflowing of material over the South Barrier a decision was made to accelerate this phase as it did not affect the hydraulics in the entrance.

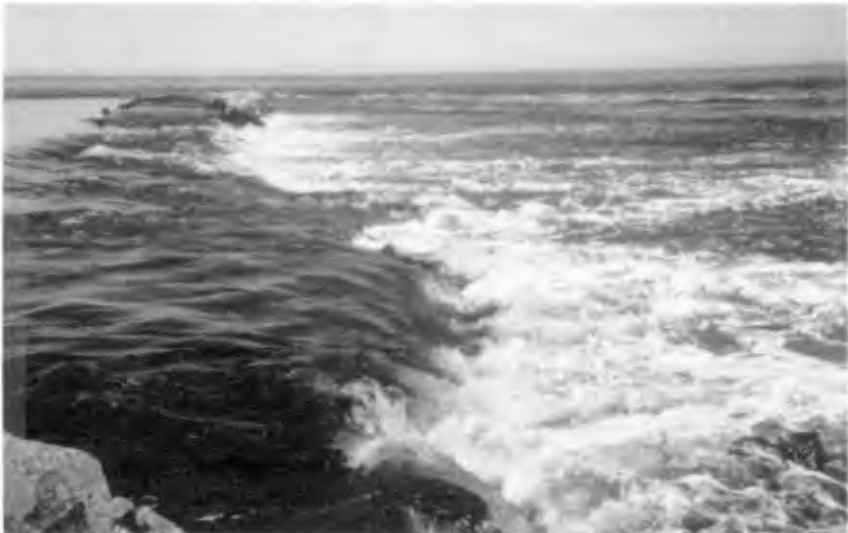
Figure 8. During spring tide after the completion of the construction "road".
Note the head difference of about 1 m.

In the tender documents the contractor was asked to build a construction road between station 262 and 462 during the neap tide from June 3 to 10, but this could be postponed in case of a bad weather. The purpose to minimise the risk of erosion in front of the construction road and at the toe of the breakwater during the construction period. The contractor constructed a 6 m wide low road of quarry run and managed to complete the structure to station 500 within this period, Figure 8. At the same time the road was secured with 0.2 - 2 tonne rocks at the inlet side. Due to the fast progress of the work the erosion in front of the tip was limited, a maximum of 30 cm was observed. The outcome from the quarry was carefully monitored and a 100% utilisation of the quarried material was achieved.

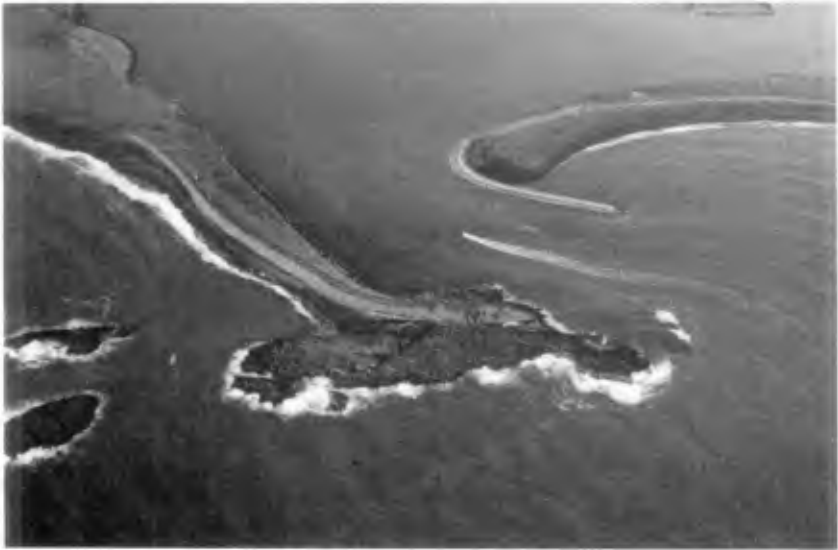
Figure 9. Aerial photo of the tidal entrance at Hornafjordur

Depth soundings in the entrance are performed regularly at an interval of 2 - 3 months and the breakwaters are visually inspected every two months. During the construction phase, bottom changes were in accordance with the predictions of the mathematical model (Viggosson et al, 1998). Figure 9 and 10 show an arial photos of the tidal entrance at Hornafjordur on the completion of the stabilisation.
