ANALYTICAL INVESTIGATION OF SLAB BRIDGE DAMAGES CAUSED BY TSUNAMI FLOW

Keywords: tsunami; damage of bridge; Cadmas-Surf; EERC/Fiber

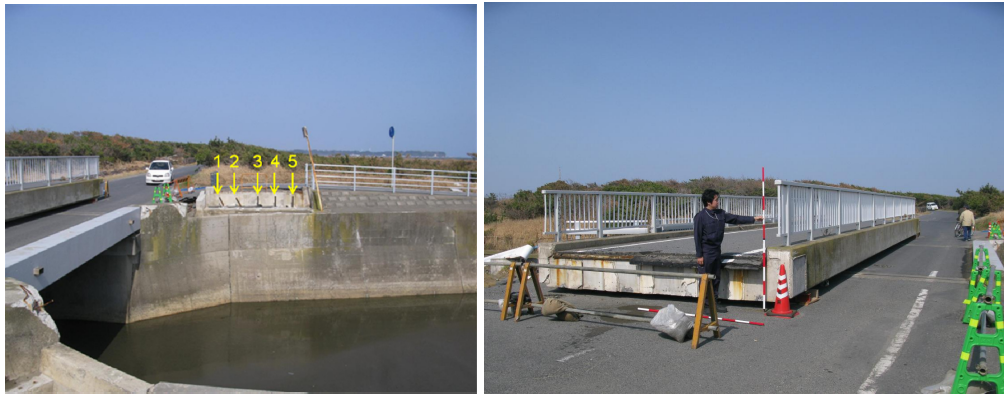
The Tohoku earthquake tsunami in 2011 flooded this slab bridge onto the adjacent highway bridge as shown in Fig.2. There were five anchor bars on both bearing section. It was found that the anchor bars of No.1 and No.2 were bended a little to the landward. On the other hand, other anchor bars from No.3 to No.5 stood upright without any deformations. From these damages of anchor bars, it was assumed that the slab of this bridge was lifted up due to tsunami at first. After this action, the tsunami force acting on the bottom of the slab increases during tsunami, and finally the slab was flooded onto the adjacent highway bridge with counterclockwise rotation.

Figure 2. Right photo shows the flooded slab and left photo also shows the deformations of anchor bars.

On the other hand, the horizontal force acted on the slab was smaller than the vertical uplift force. Judging from the configuration of common slab bridge, this horizontal force also seems smaller than a yield stress. However, the damage of some anchor bars, which support the horizontal force, was observed after the slab section was flooded due to tsunami attack. As mentioned in above paragraph, the structural analysis showed that the seaside section of the slab was lifted and the slab turned with counterclockwise rotation during tsunami action as shown in Fig.13. Under this condition, only the anchor bars of No.1 and No2 support the flooding slab, because the seaside section of the slab was lifted upward, and anchor bars from No.3 to No.5 could not work as a bearing section. The number of effective anchor bars decreased during tsunami action, and it caused the damage of anchor bars at No.1 and No.2 which were bended to the landward as shown in Fig.2.

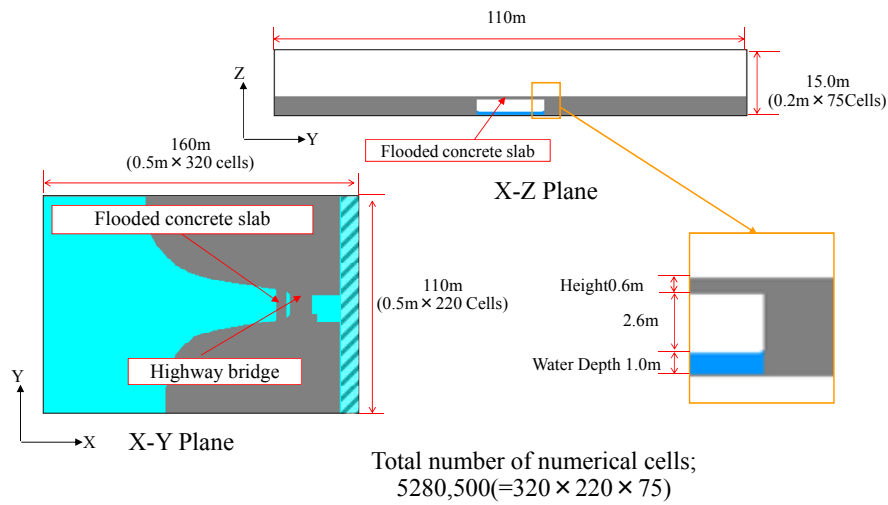
Fig.3 shows the numerical region and the dimension of model on x - y and x - z plane. Tsunami approaches the bridges from left hand side. Based on the field survey, the tsunami height on offshore of this coast was around 2.2m. As an input boundary condition, the time history of water surface elevation and velocity are needed to be applied on the left hand side of this numerical region. In this study, the time history of water surface elevation on input boundary was obtained from hydraulic experiment beforehand. A bore type tsunami with 20cm in height was generated in the wave tank, and the water surface elevation was obtained as Fig.4 by following Froude similitude. The velocity profile was calculated from Eq. 1, which was proposed by Fukui (Fukui, et. al. 1961).

Figure 3. Numerical region and its dimension on x-y and x-z plane.

Fig.5 shows some snapshots of propagating tsunami in numerical wave tank. The tsunami height is around 2.2m on offshore. The tsunami height gradually increases because the width of river mouth becomes narrow as shown in Fig.3. Fig.6 shows the tsunami height at A, B and C, where the locations are shown in this figure. The tsunami height reaches 5.5m at the front and the rear of the flooded bridge, and the bridges are fully submerged under this condition.

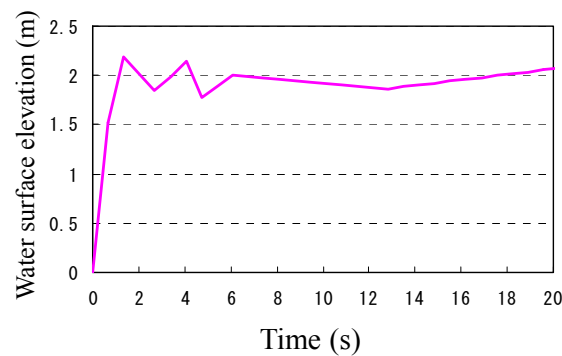
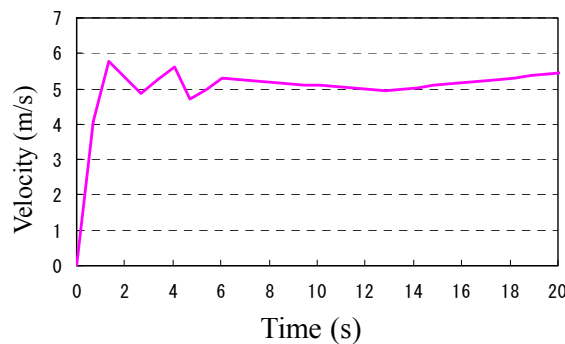
(a) Water surface elevation

(b) Fluid velocity

Figure 4. Time history of water surface elevation and velocity applied on the input boundary.

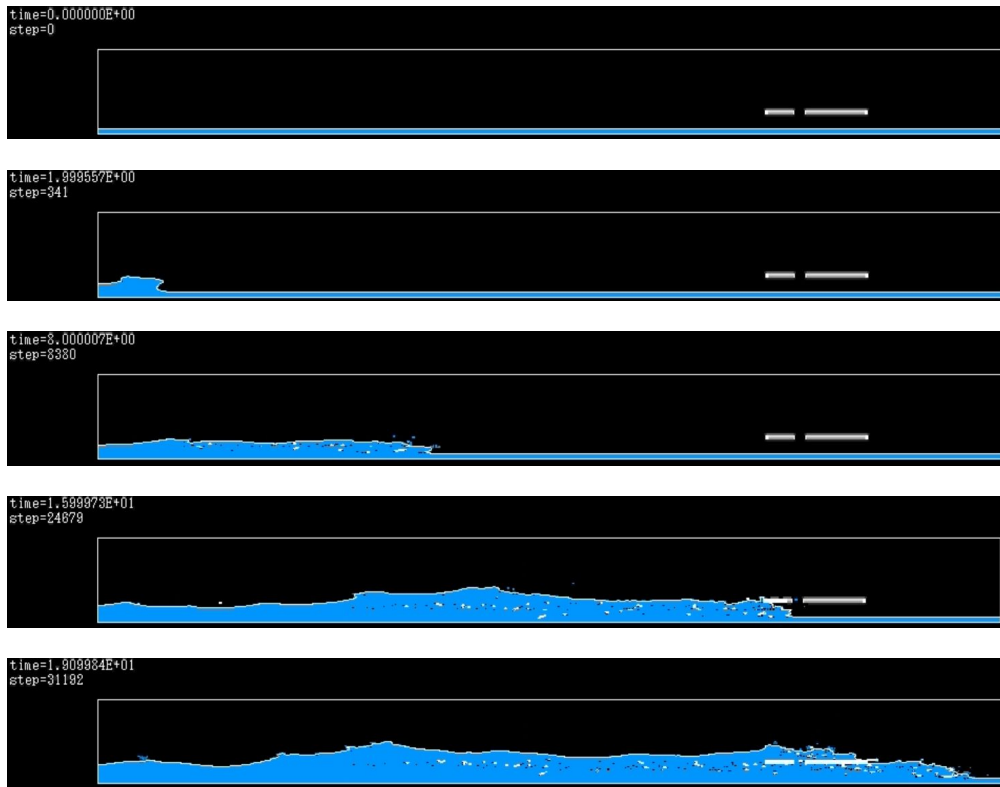
Figure 5. Snapshots of tsunami propagation in numerical wave tank.

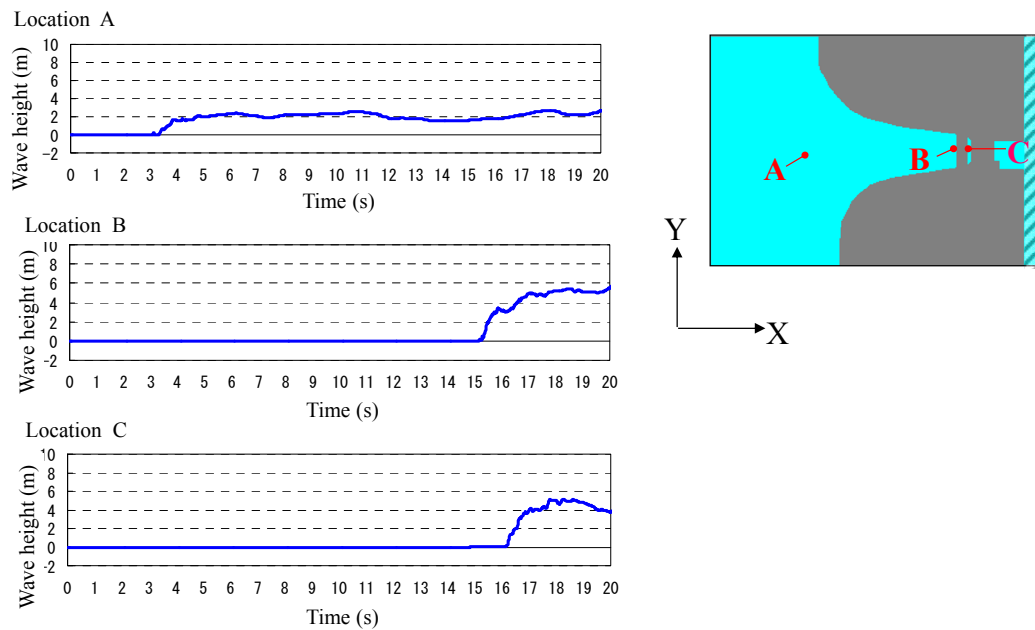
Figure 6. Time history of water surface elevation at the location A, B and C.

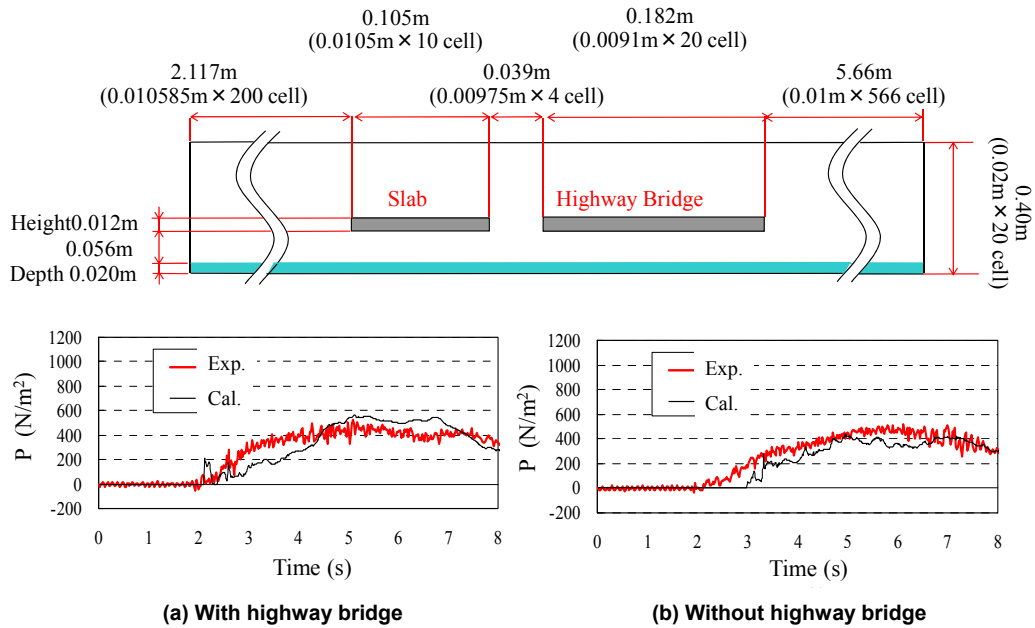
Fig.9 shows the comparison of wave pressure acting on the bottom face of the slab. As a reference, the result of the case without adjacent highway bridge is shown in this figure. This study confirmed that the pressure profiles on the slab obtained from numerical simulation show fairly good agreement with the results obtained from hydraulic experiment. In some cases, however, the small difference can be seen at the beginning of pressure increase as shown in Fig.9 (b). Front face of the bore type tsunami includes grate amount of air, and the repeatability of phenomena in hydraulic experiment was assumed one of the reason of above difference.

Figure 9. Comparison of the bottom pressure between numerical result and experimental one.

Fig.11 shows some examples of wave force profile applied on a computational node in structural analysis. These forces were obtained from the result of hydraulic analysis mentioned in the previous section. As shown in Fig.9, pressure profiles include small fluctuation due to complex phenomena under tsunami action. Those fluctuations were seemed negligible in structural analysis and smoothed by using running average. In Fig.11, the positive force acting on front and rear section means the force which floods the slab to the same direction as tsunami propagation. Also, the positive force on bottom and upper section means the force which uplifts the slab.

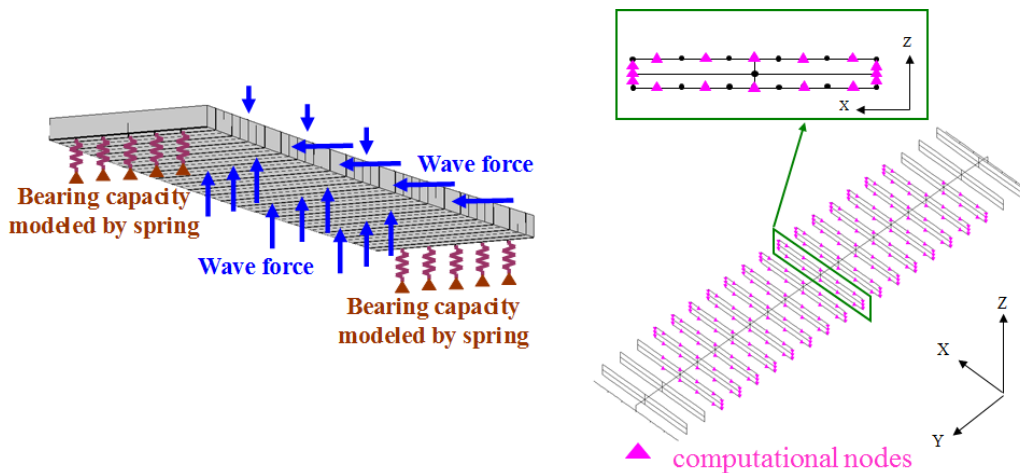
Structural analysis is conducted by introducing Fiber model (Nonaka et al., 2010). This model can simulate elasto-plastic system. The configuration of this model is shown in Fig.10. Fiber element was applied on the slab section. Bearing capacity at each support section was also modeled by introducing a spring model. In Fiber model, the slab was divided into 50 elements in horizontal direction, and 5 elements in vertical direction. Wave forces acting on the slab faces on each time step were applied on each computational node which was arranged on the element as shown in Fig.10.

Figure 10. Model of structural analysis based on Fiber model.

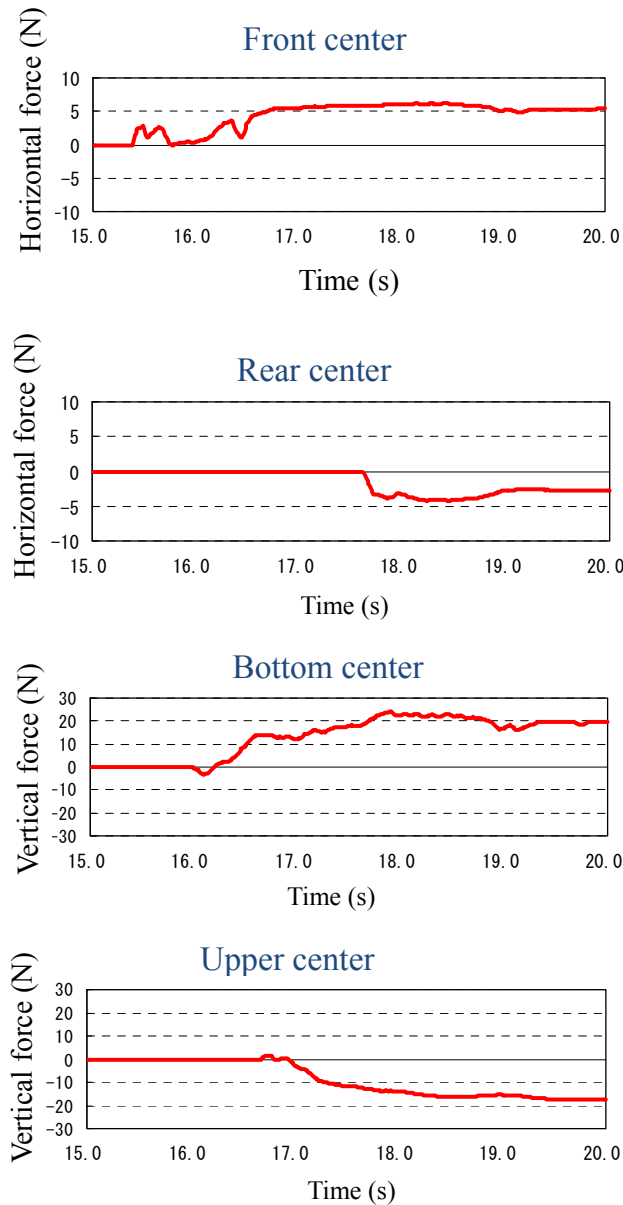
Figure 11. Examples of wave force applied on a computational node in structural analysis.

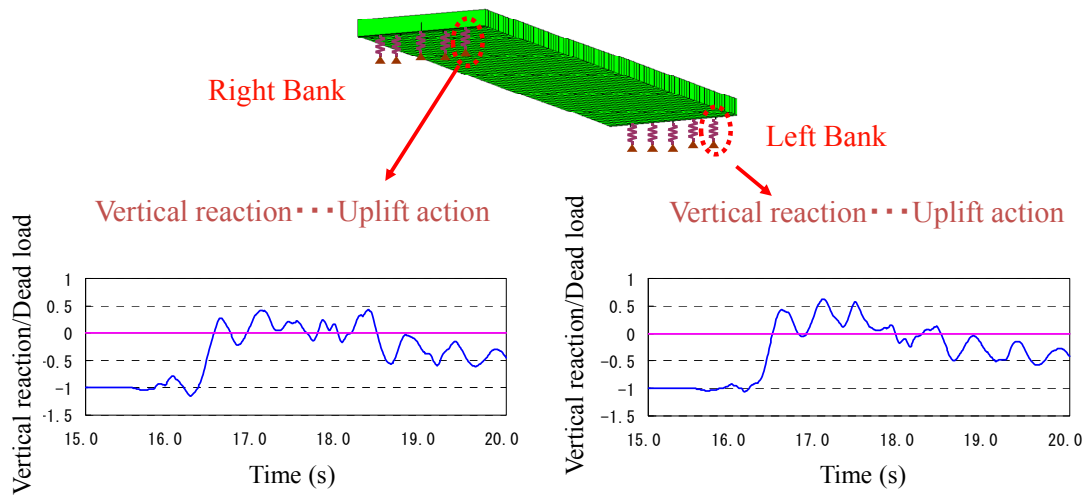
There are five anchor bars on both bearing section of the flooded bridge. Fig.12 shows the vertical reaction force at the anchor bar No.5 during tsunami action, where the No.5 is the most seaside anchor bar. The vertical reaction is normalized by the dead load of the slab, and negative value in these figures means an uplift force. The numerical simulation revealed that the uplift force acted at the anchor bars from No.3 to No.5 during tsunami action. This result means that the seaside section of the slab was lifted at first, and the slab was flooded onto the adjacent highway bridge with counterclockwise rotation during tsunami action as shown in Fig.13.

Figure 12. Vertical forces act on the bearing section at No.5 anchor bar.
