# PROJECT PERFORMANCE AND MONITORING OF A REVETMENT

## COCOS BAY, EAST TRINIDAD

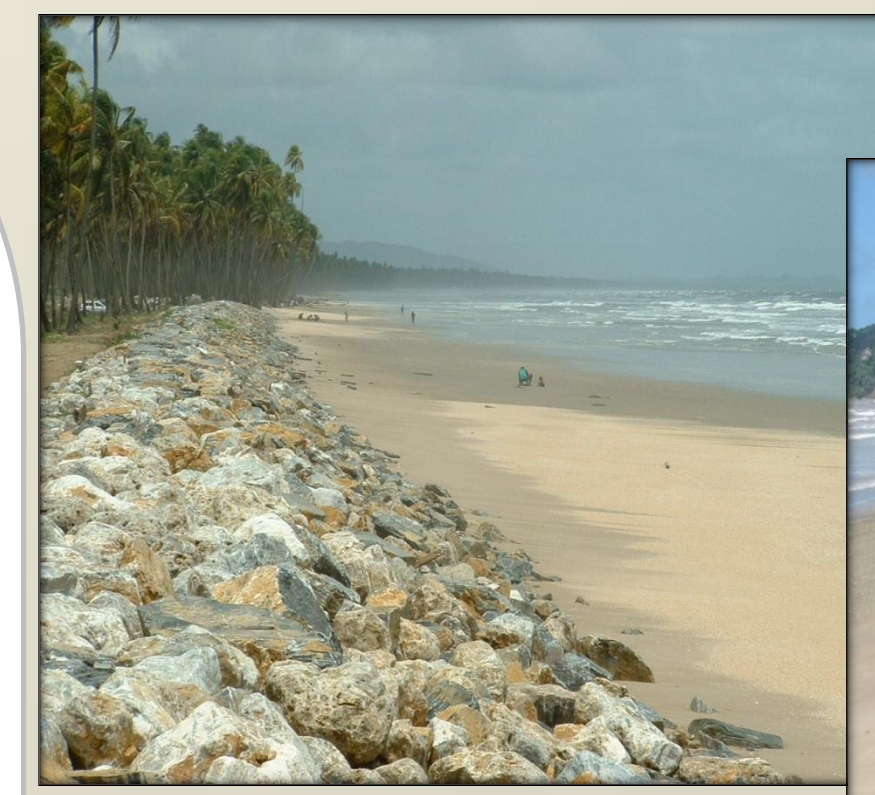
Revetment 1 year after completion

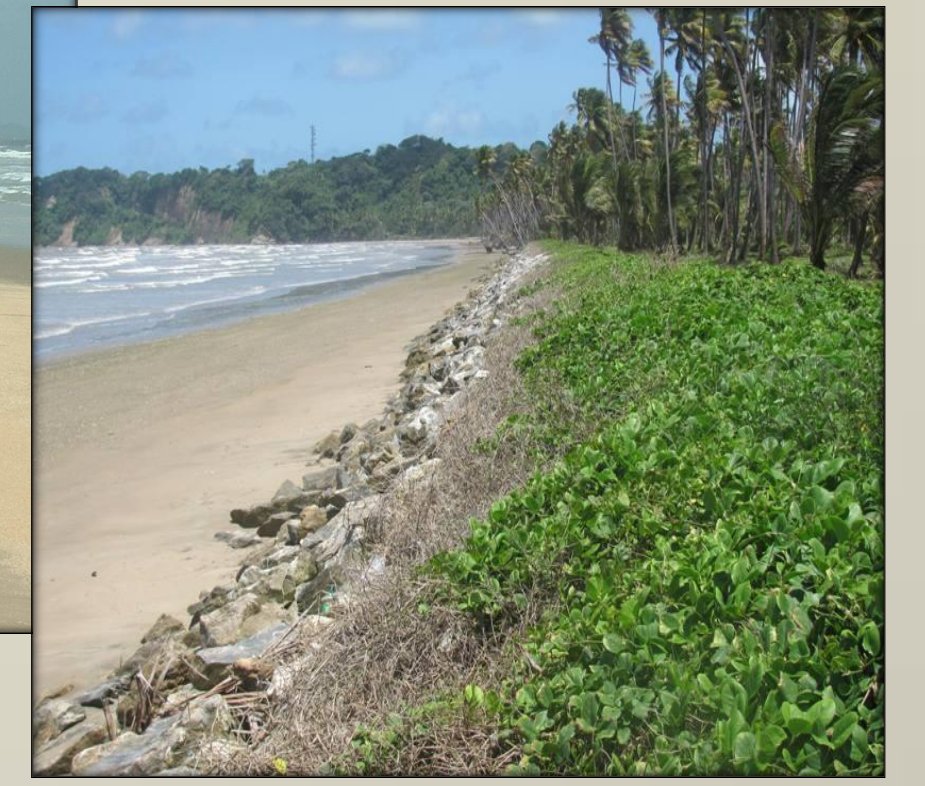
Revetment 6 years after completion

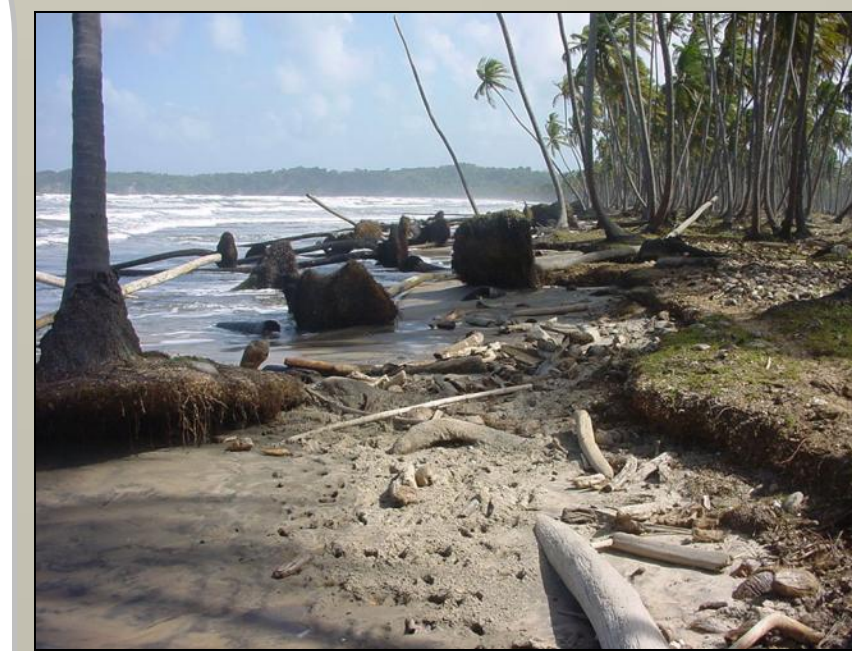
Erosion north of Ortoire River prior to construction of revetment (2000)

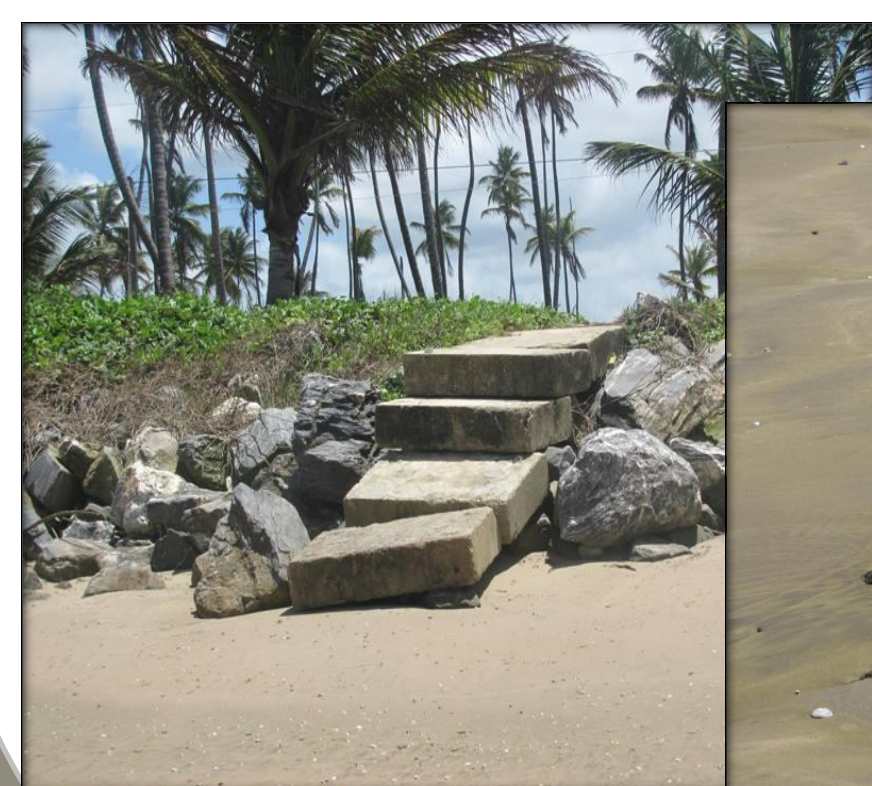
- Vegetative growth has occurred on top of the revetment including coconut palm trees within the structure.
- Public access to the beach has become difficult due to the structural failure of the public access steps.

Failing Steps

- Immediately design and implement an Operation and Maintenance Program: routine structural inspection, control vegetative growth and replace armour units.
- Develop and implement a shoreline management policy to address the erosion that is continuing to occur both south and north of the revetment.

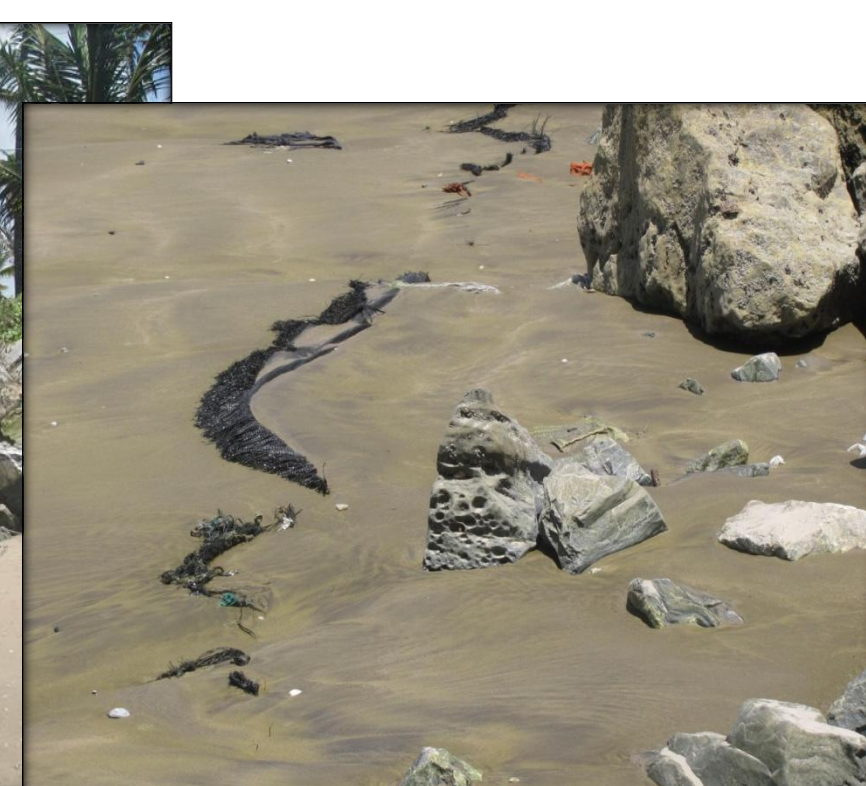
- Incorrect placement of the armour units have resulted in large spaces in the armour.
- Local "blue" limestone rocks used by the contractor have shown signs of disintegration and weathering.

Exposed Geotextile

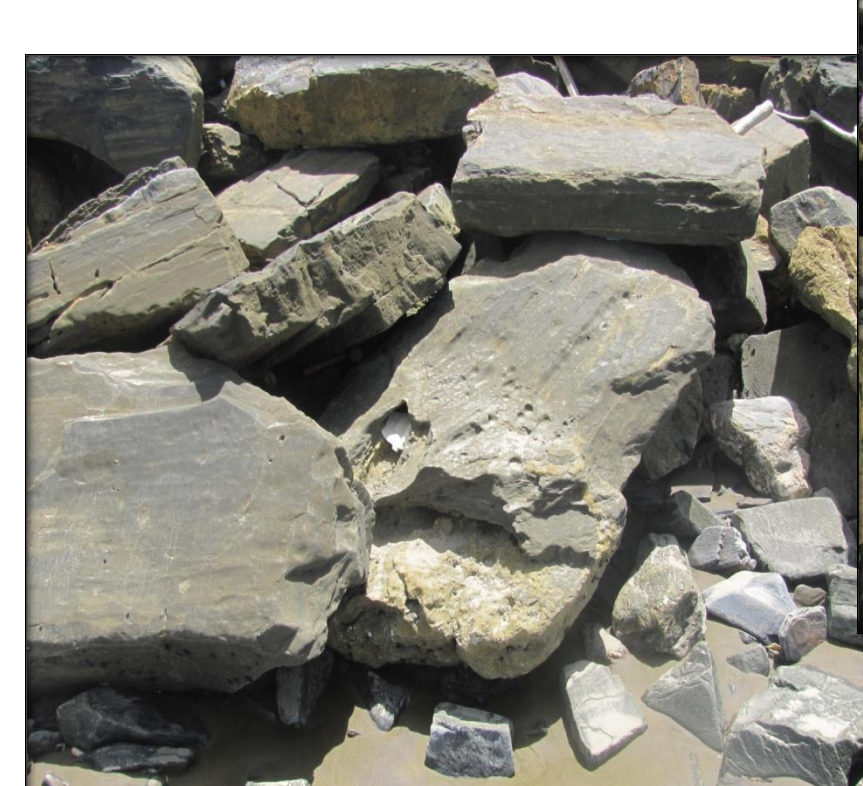
Weathering of the local "Blue" Limestone used to construct the revetment

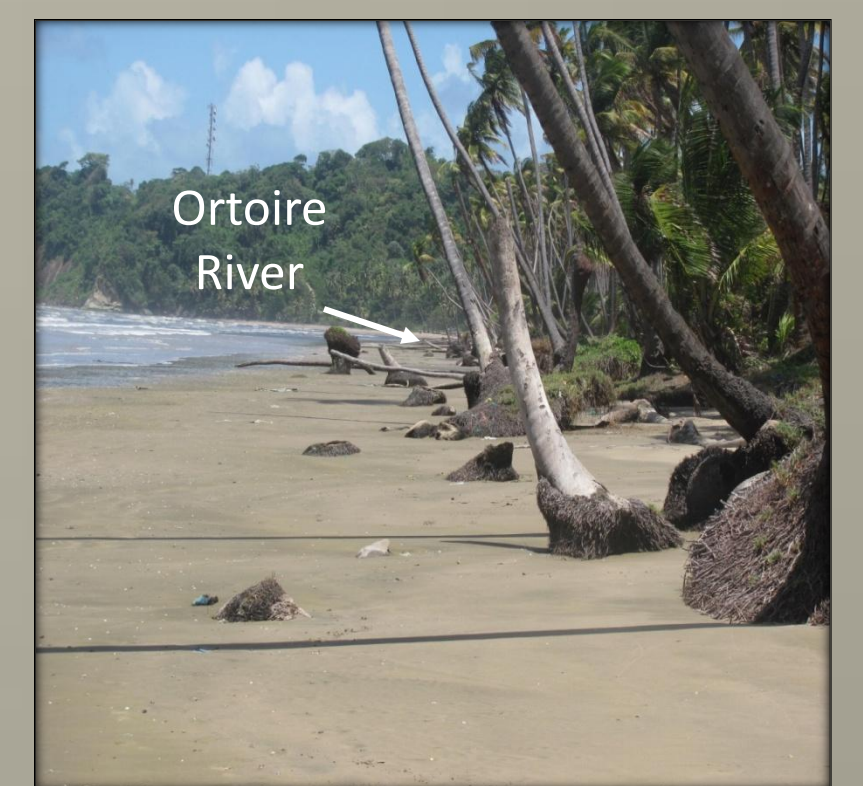
- There is continuous erosion between station 16, and Ortoire River mouth; at IMA Station 5 the shoreline receded 8 m within 3 years which is more than during the pre construction period.

Erosion between station 16 and the Ortoire River (2012)

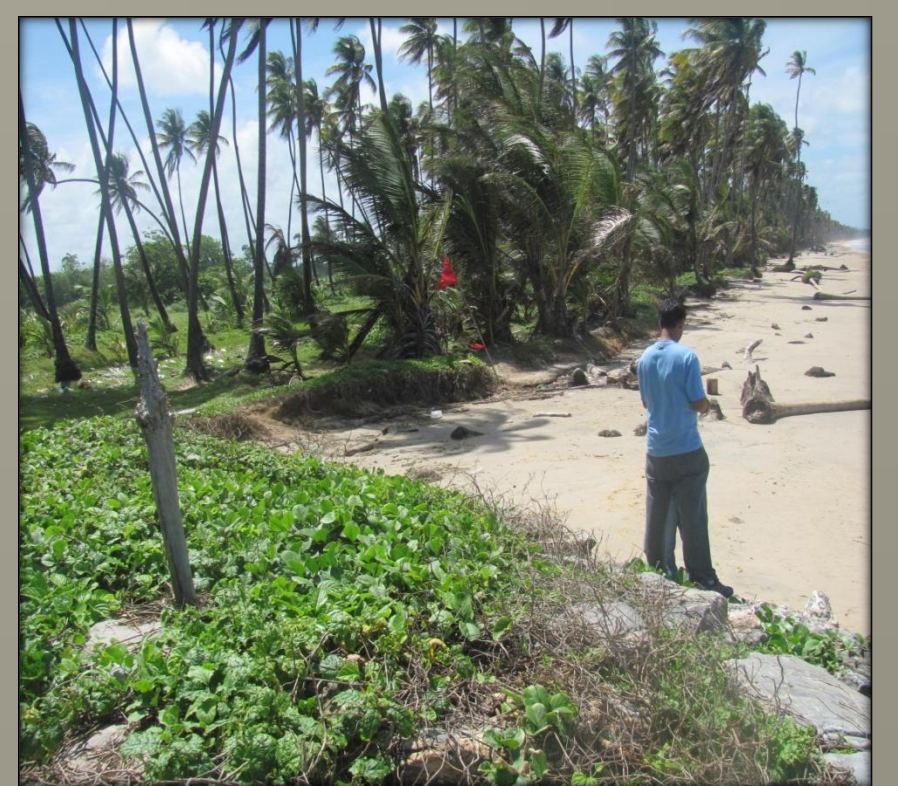
Flanking on northern end of north revetment

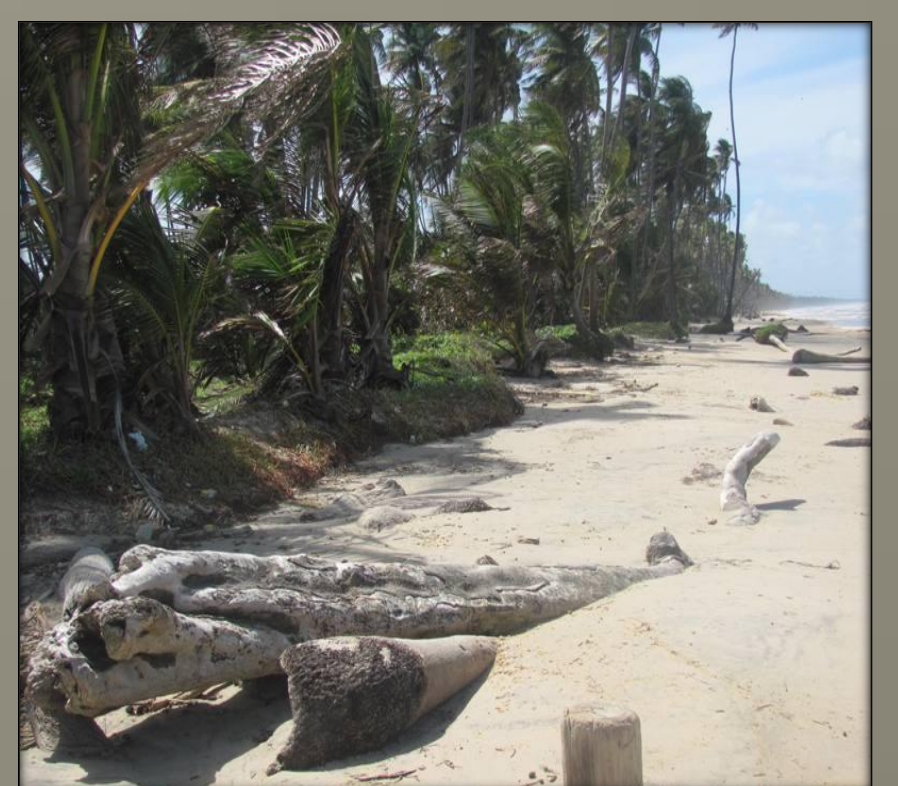
- The shoreline between the two structures continues to recede at an average rate of 0.8 m per year.
- At the southern revetment there has been an increase in beach width of 1.0 m.

Erosion between the two revetments.
