Hydrodynamics of the Condado Lagoon

Alfredo Torruella, PhD
University of Puerto Rico

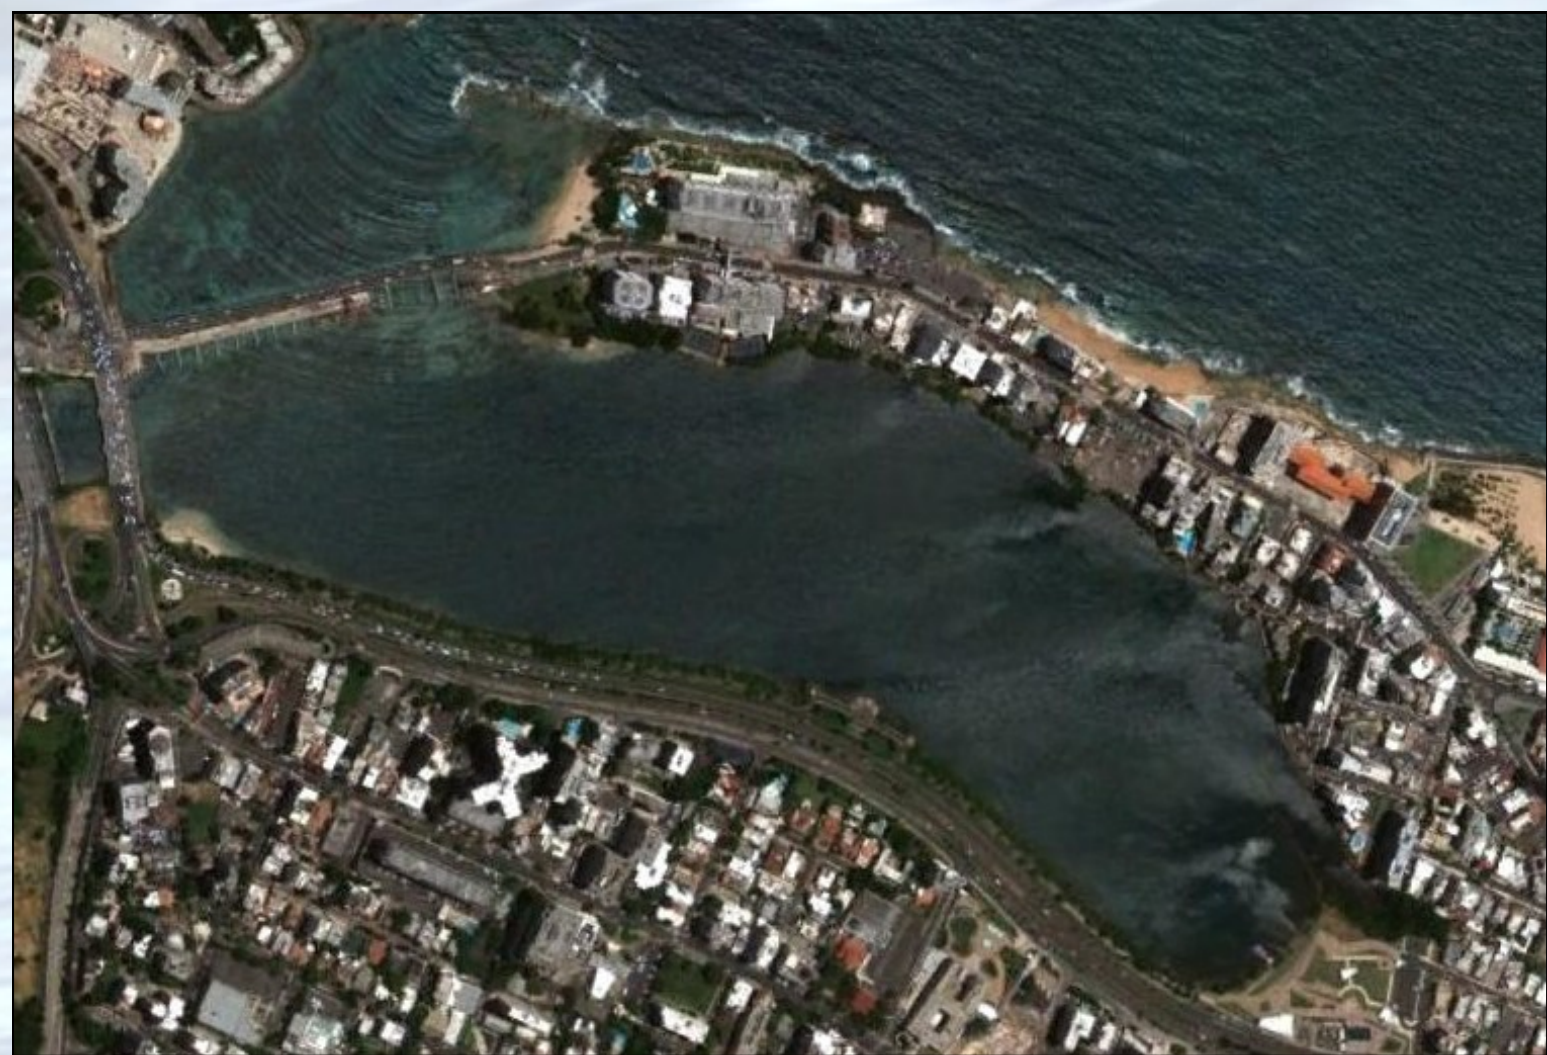
Condado Lagoon at Present. Note Baldorioty de Castro Avenue along southern border. Material for the foundation of the avenue was obtained by dredging the lagoon (See image of Multi-beam Sonar bathymetric data at right, courtesy Kyle Enright, TetraTech).

The Condado Lagoon was dredged in the late 1950's in order to obtain fill material for the foundation of the Baldorioty de Castro Avenue, which borders the lagoon to the south. Biological surveys indicate that the lagoon's flora and fauna were severely affected by the dredging activities, with essentially zero life surviving within the dredging footprint. In an effort to restore the lagoon to its original pristine condition, Caribbean Oceanography Group was engaged to determine the grain size requirements necessary to ensure the stability of any fill material to be placed within the dredging footprint. The Environmental Fluid Dynamics Code (EFDC) Hydrodynamic model was implemented in order to determine the required characteristics of the fill material. The results are shown below.

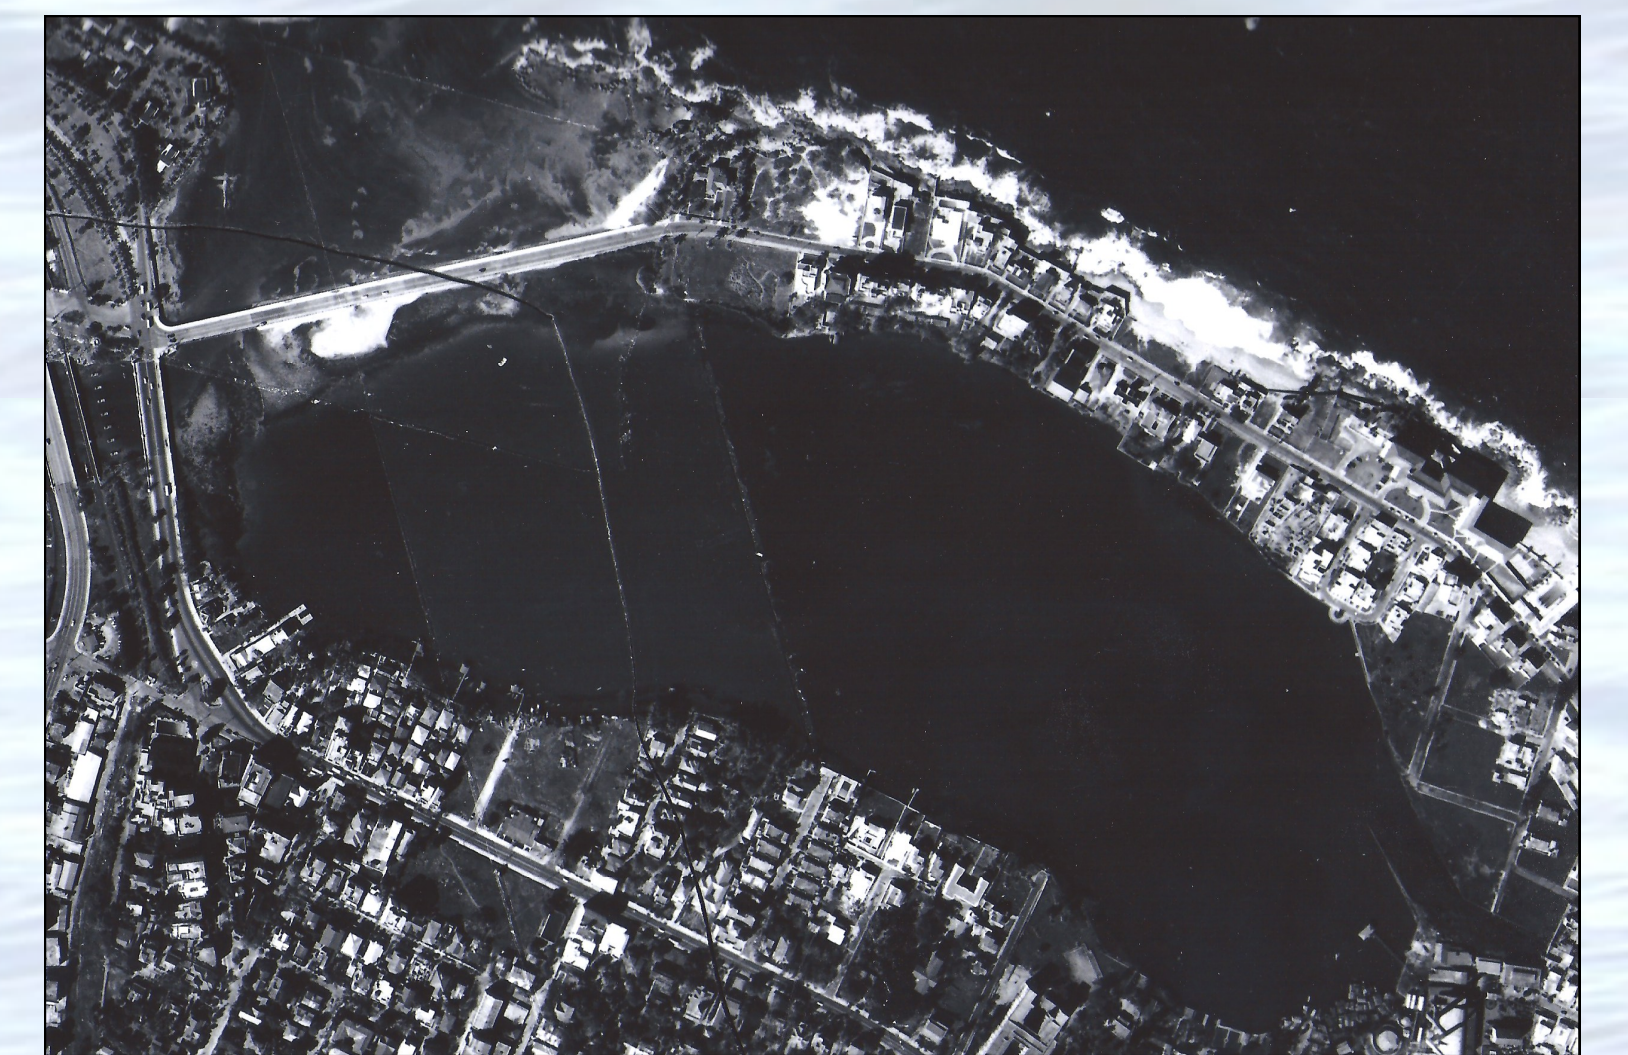
Condado Lagoon circa 1951. Note absence of Baldorioty de Castro Avenue.

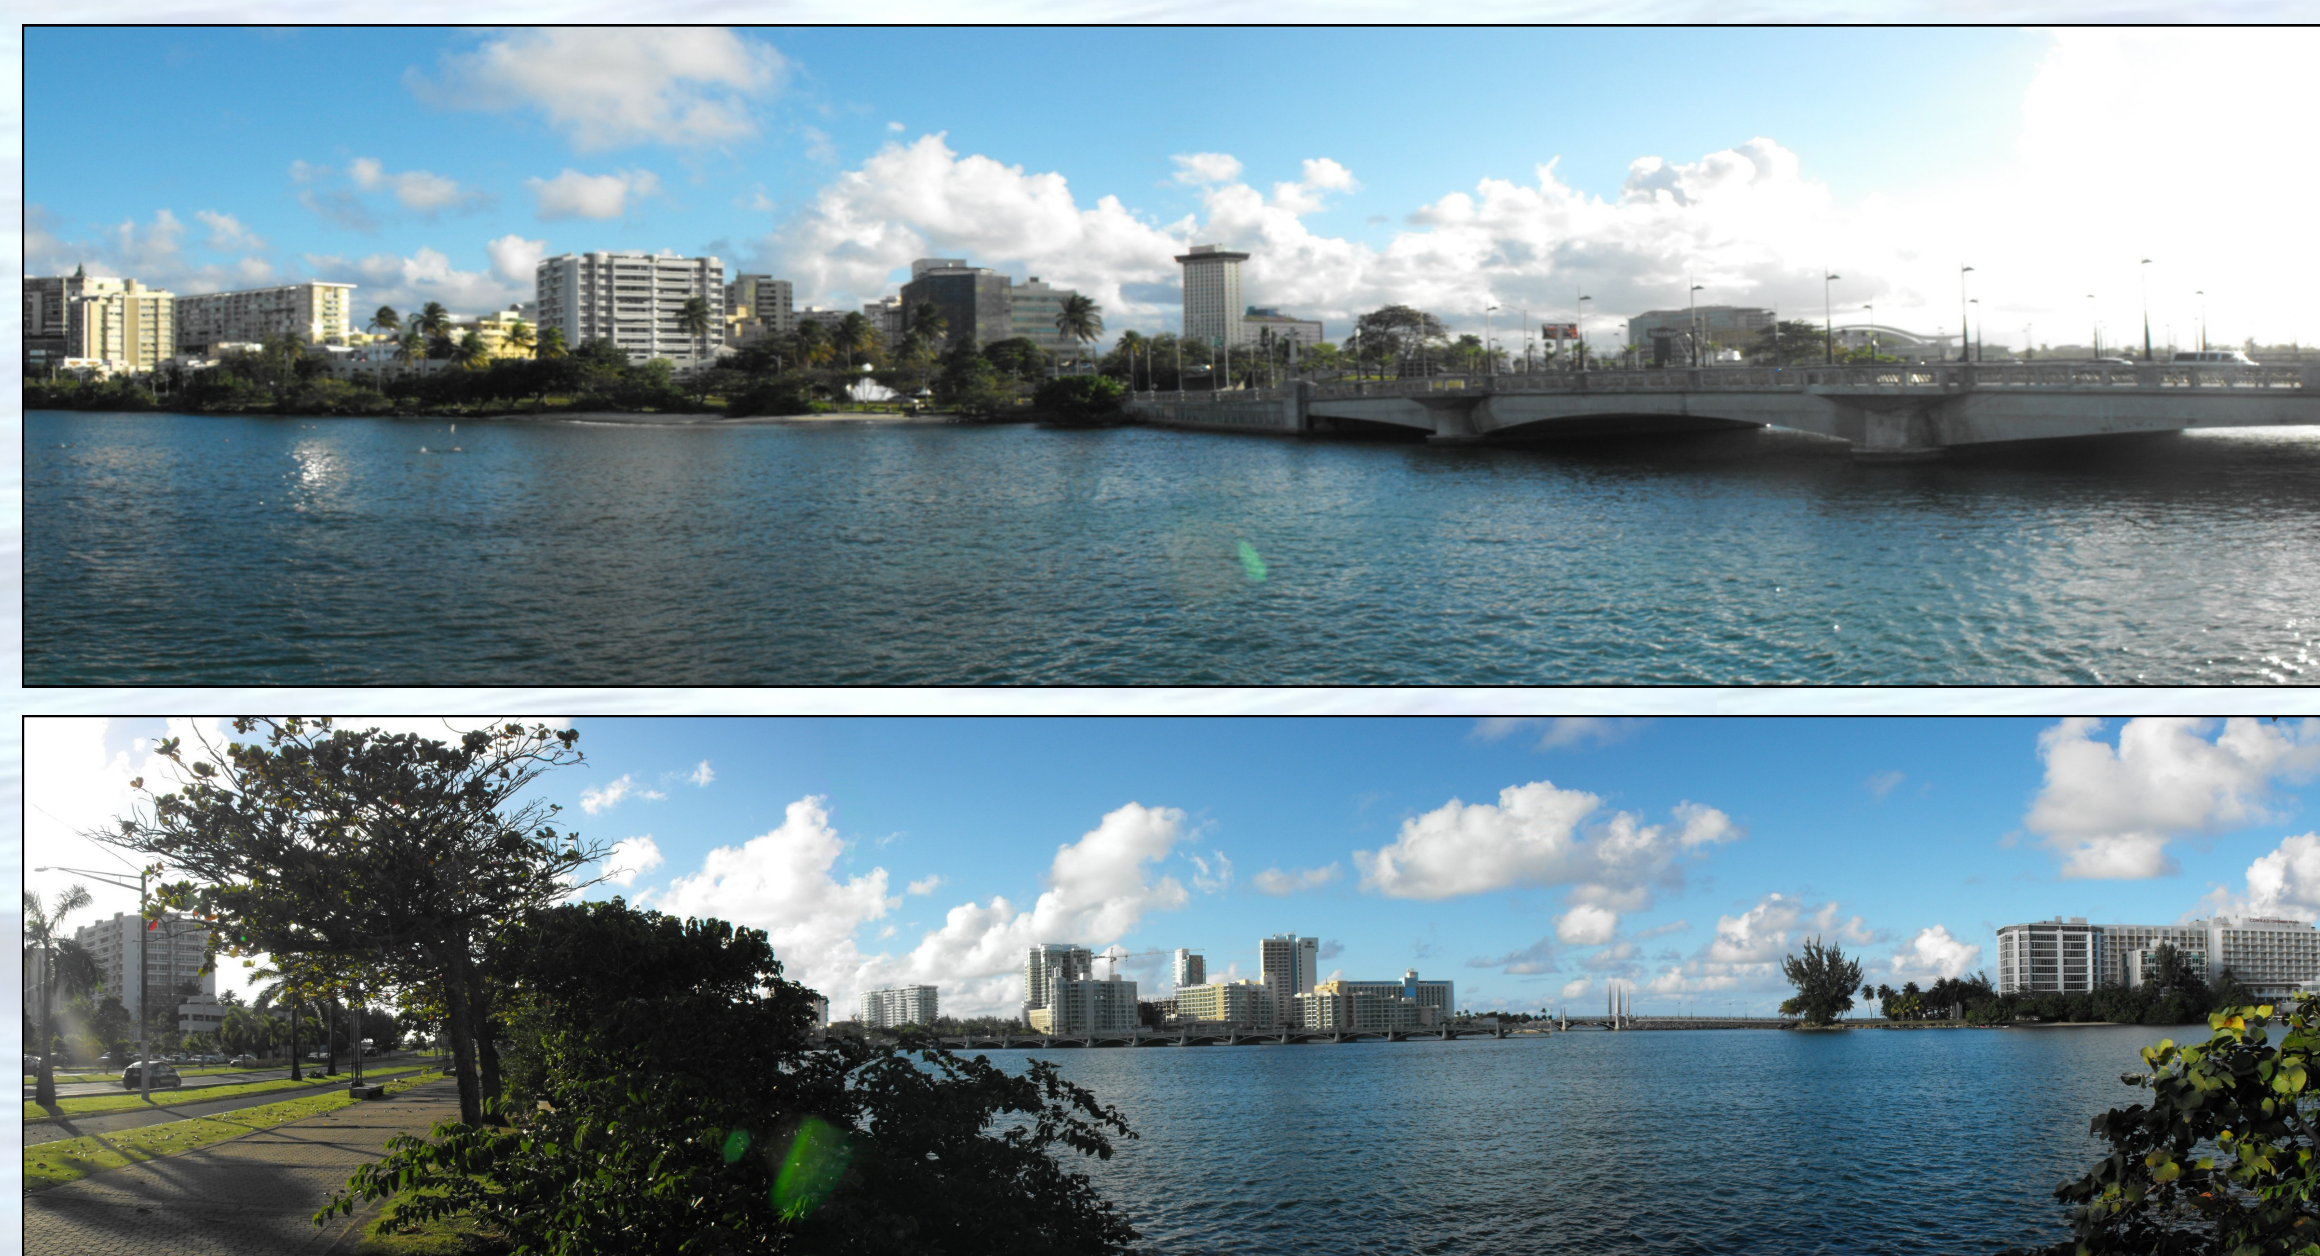
Southwest shore of Condado Lagoon. Note accreting shoreline.

In addition, note the circulation pattern at the southwest corner of the lagoon. Every tidal cycle brings a decelerating, sediment laden current to the area. This results in the deposition of sediment, and the consequent accretion leads to the formation of a beach at this location (See photo below right).

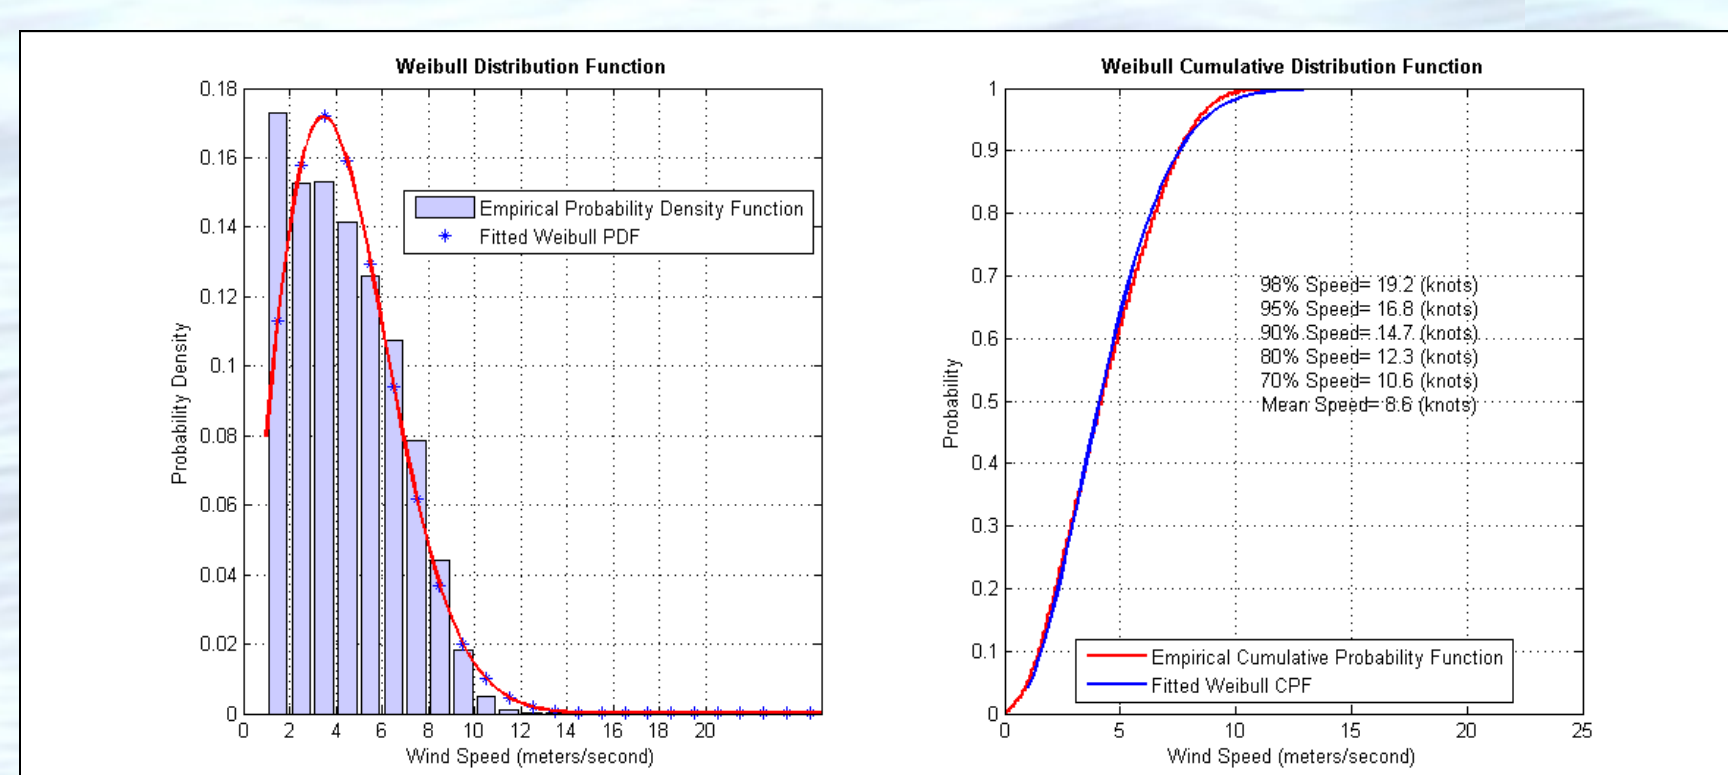
Local wind records were analyzed to determine exceedance levels. The model was run using various wind speeds, including that corresponding to the 98% exceedance level. The shear stress under such a scenario is shown in the center plot. Note direction of shear stress within the restoration area.

A statistical analysis of the wind records for the area was carried out (See results, bottom left). The model was then driven with winds corresponding to a 98% exceedance scenario. The direction of the shear stress was confirmed to be towards the northeast. In addition, the Shields relation was used to determine the allowable grain size for fill material. It was found that the maximum shear stress occurred at location A-2, where a median grain diameter of 0.46 mm was required for stability. It was also found that any material smaller than the stated minimum would be transported towards the remaining fill locations, where the stability requirements are smaller. Thus the fill material will remain stable and within the restoration area.
